AN OVERVIEW OF NON-DESTRUCTIVE AND MINIMALLY INVASIVE TECHNIQUES FOR MOISTURE CONTROL IN THE CULTURAL HERITAGE

This article describes the use of non- or minimally destructive methods to study damp in San Juan Bautista Church at Talamanca de Jarama in the Spanish province of Madrid. The combination of ground penetrating radar (GPR), electrical resistivity tomography (ERT) and wireless sensor network (WSN) techniques provided sub-surface information, while data on wall surfaces were collected with contact hygrometry and infrared thermography. The respective findings and ranges of observation were inter-related to identify the decay associated with the damp and determine the advantages and drawbacks of each instrumental method.

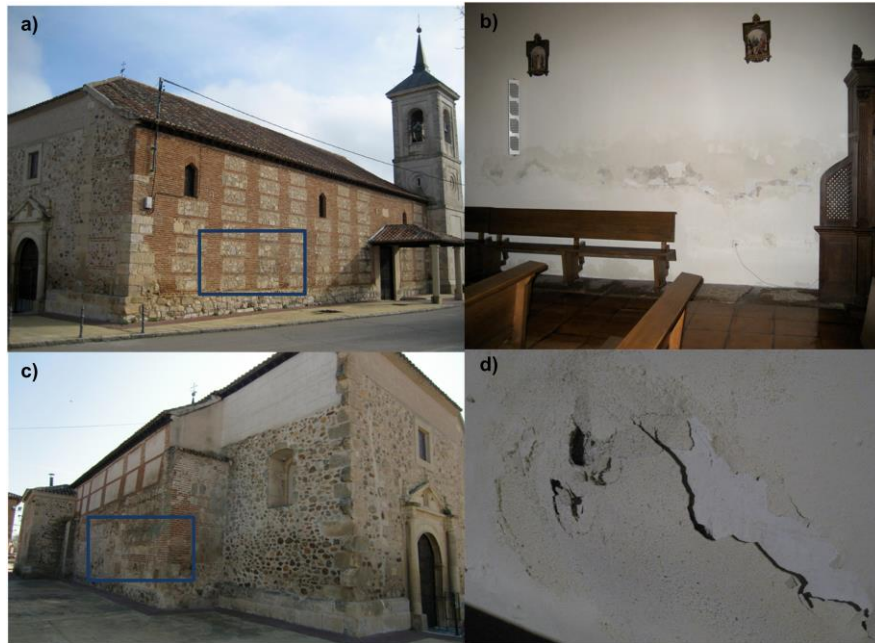
Its north (Figure 1c) and south (Figure 1a) perimetric walls are severely affected by damp, visible mainly from indoors around the west entrance (Figures 1b and 1d).

Figure 1. a) South façade of the church showing the indoor area studied from the outside; b) indoor south wall near the confessional alongside the main (west) entrance; c) north façade showing the indoor area studied from the outside; d) detail of damp on indoor wall

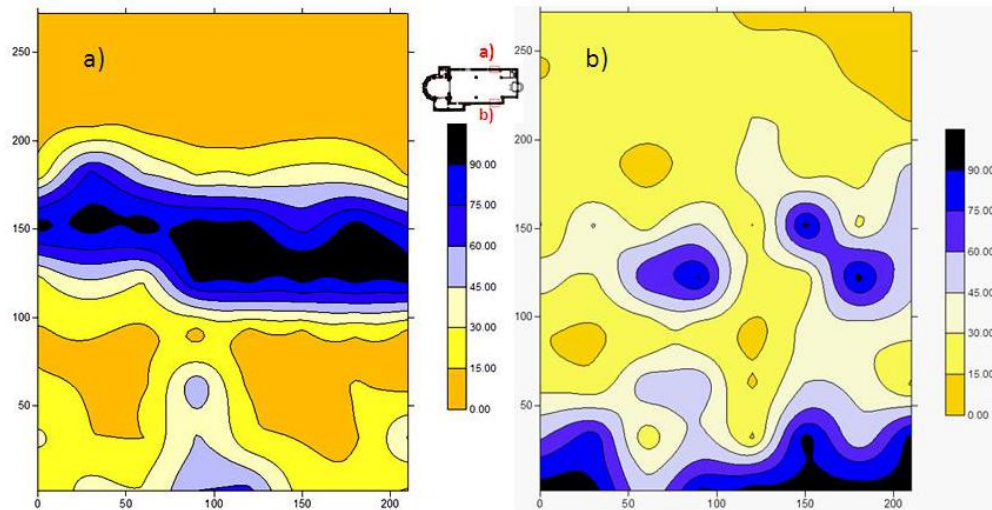
Wintertime readings were repeated on 18 February 2014 in the areas most severely affected (west end of the south (Figure 5a)) and north (Figure 5b)) walls). The findings revealed a similar distribution of WME values by area and height, confirming the persistence and pattern of the damp problems detected. Further to these findings, the study areas chosen were the north and south walls around the west entrance. Figure 5 shows the hygrometric results of readings taken on the same day in those two areas. Note the high %WME values on the northwest wall, possibly due to capillary water rise, where problems associated with the stone dado on the southwest wall were also observed.

Figure 5. Results of electrical conductivity meter readings taken on 18 February 2014 a) on the southwest wall; and b) on the northwest wall of the church [x-axis: (cm); y-axis: (cm); colour scale: %WME]

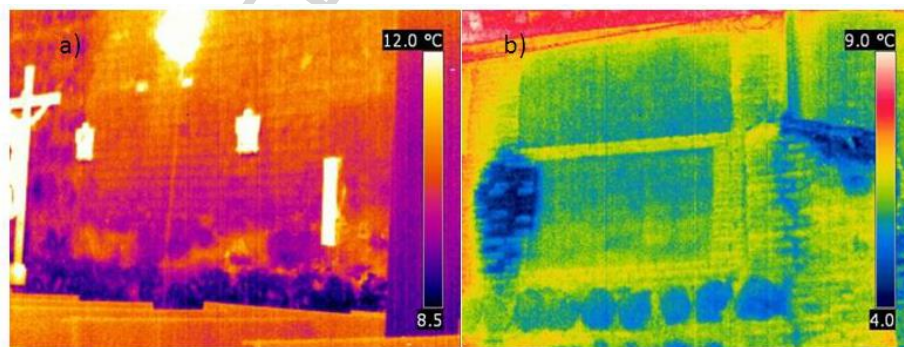
The lower apparent surface temperature in the underside than in the rest of the north wall (Figure 6a)) was attributed to two factors: its different masonry and a moisture front that reached a height of 1.0 m to 1.5 m. Surface temperature was highest at approximately 1.5 m off the floor in an area that warmed more quickly with the heating, for its rendering had fallen away, lowering its thermal mass. The change in wall masonry visible on the left in Figure 6a) (west), near the foot of the church, identifies the area where the façade consists in small rubblestone panels flanked by brick. In the rest of the wall, the stone dado at the base can be clearly distinguished from the upper brick masonry. As the thermographic images of the interior and exterior wall around the crucifix (Figures 6a) and 6b, respectively) show, the masonry substrate under the indoor rendering was not the same as in the exterior wythe. The indoor image also revealed a number of thermal anomalies on the surface attributed to rainwater leaks through a crack and the shrinkage joint between the rubble masonry and the brick wall. The layers comprising these wythes and the inward extent of the leakage were studied with ERT and GPR.

Figure 6. Infrared thermographs taken on 18 February 2014 of a) the indoor north wall after heating the church for 30 minutes; and b) the outdoor north wall at around midday

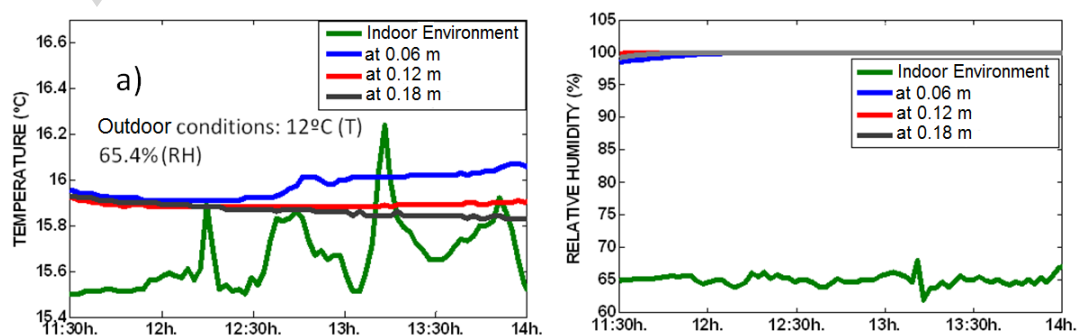
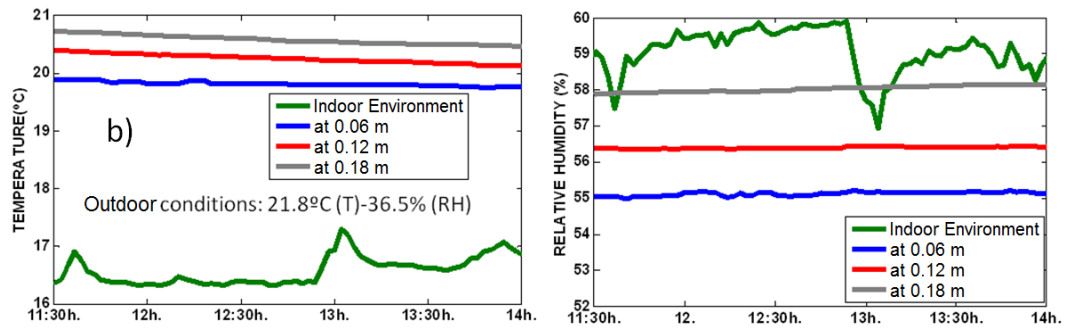
Figure 7 shows the Smartmote wireless sensor network findings for T and RH inside the wall. Relative humidity values were close to saturation in the north wall, with severe damp in the upper levels. A temperature gradient was observed, with values tending to rise slightly in the inward direction. The temperature gradient in the south wall followed the opposite pattern, with the highest temperatures in church exteriors. Surface temperatures were slightly higher and less variable in the southwest than in the northwest. In-wall relative humidity on the south side rose with increasing depth in the outward direction.

Figure 7. Smartmote WSN temperature and relative humidity curves at a height of 1.8 m and in-wall depths of 0.06 m, 0.12 m and 0.18 m for a) the north wall and b) the south wall

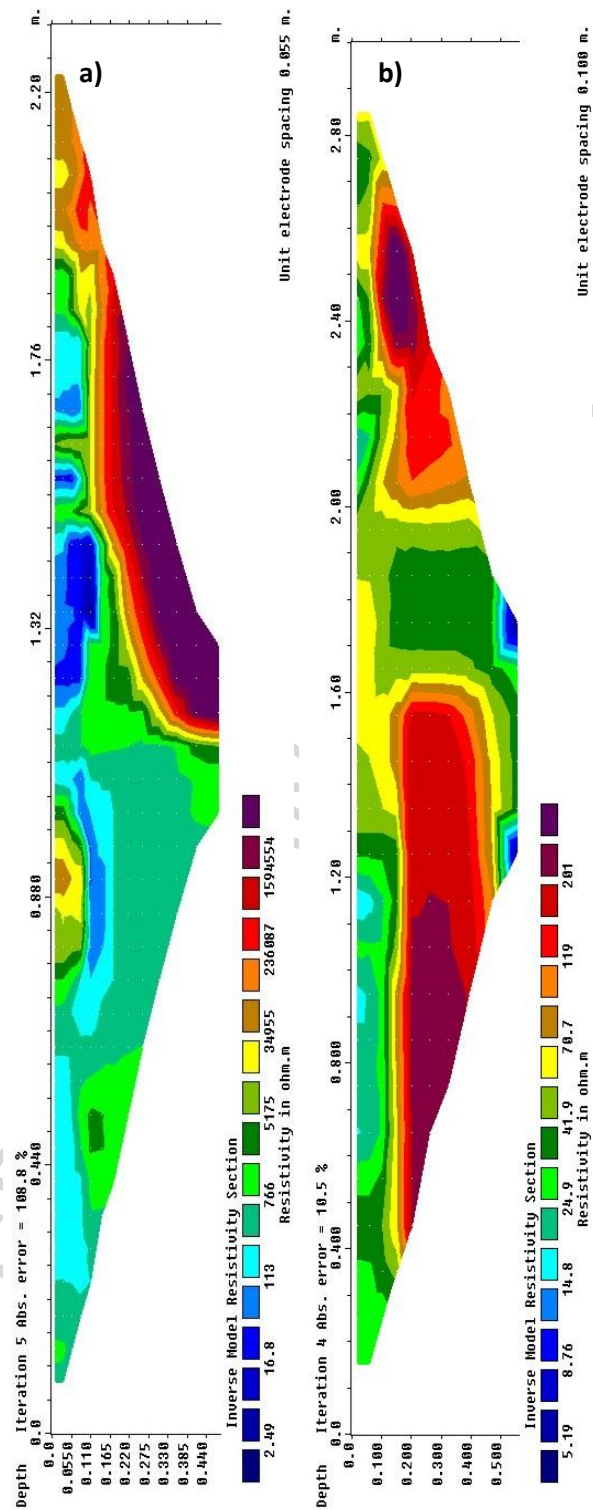
In the cross-section for the southwest wall (Figure 8a)), the highest apparent resistivity values ($>236087 \Omega$), possibly denoting low moisture, were found above 1.0 m and below 0.2 m off the floor. Moreover, several ranges of resistivity values were detected. In the shallowest layer, to a depth of 0.16 m, resistivity varied with height, with lower apparent values ($<113 \Omega$) over around 1.0 m, which were associated with a higher relative moisture content. That finding confirmed the presence of the moisture front detected with the electrical conductivity meter. A threshold height at 1.0 m to 1.2 m was also observed, with resistivity values in the intermediate range ($113 - 776 \Omega$) below it and in the low range (interpreted to denote higher moisture) above it. The exception was a thin horizontal layer just over 1.2 m that concurred with the moisture front detected with the electrical conductivity meter, where apparent resistivity was lowest ($<16.8 \Omega$, denoting maximum moisture, salts or both).

The study conducted on the floor on the southwest side of the church (Figure 8b)) showed substantially lower apparent resistivities than the vertical cross-section, with

maxima of around 200 Ω , indicating that the moisture or salt content or both was generally higher than in the wall. This cross-section also revealed the presence of a surface layer with a higher moisture content (lower electrical resistivity, $\approx 14.8 \Omega$) and two large areas with values upward of 119 Ω and depths greater than 0.2 m, interpreted to be a tomb in light of their morphology and the context. Since the floor had such low resistivity, particularly where its outer surface abuts with the wall, and intermediate values (24.8 Ω - 41.9 Ω) at depths of 1.6 m to 2.0 m, the origin of the damp in this case was interpreted to be capillary water rising from the subsoil. That effect would be intensified by surface water, inasmuch as the church stands below street level and is flanked by a slightly downward sloping outdoor pavement.

Figure 8. GeoTom profiles in the southwest a) wall; and b) floor of the church

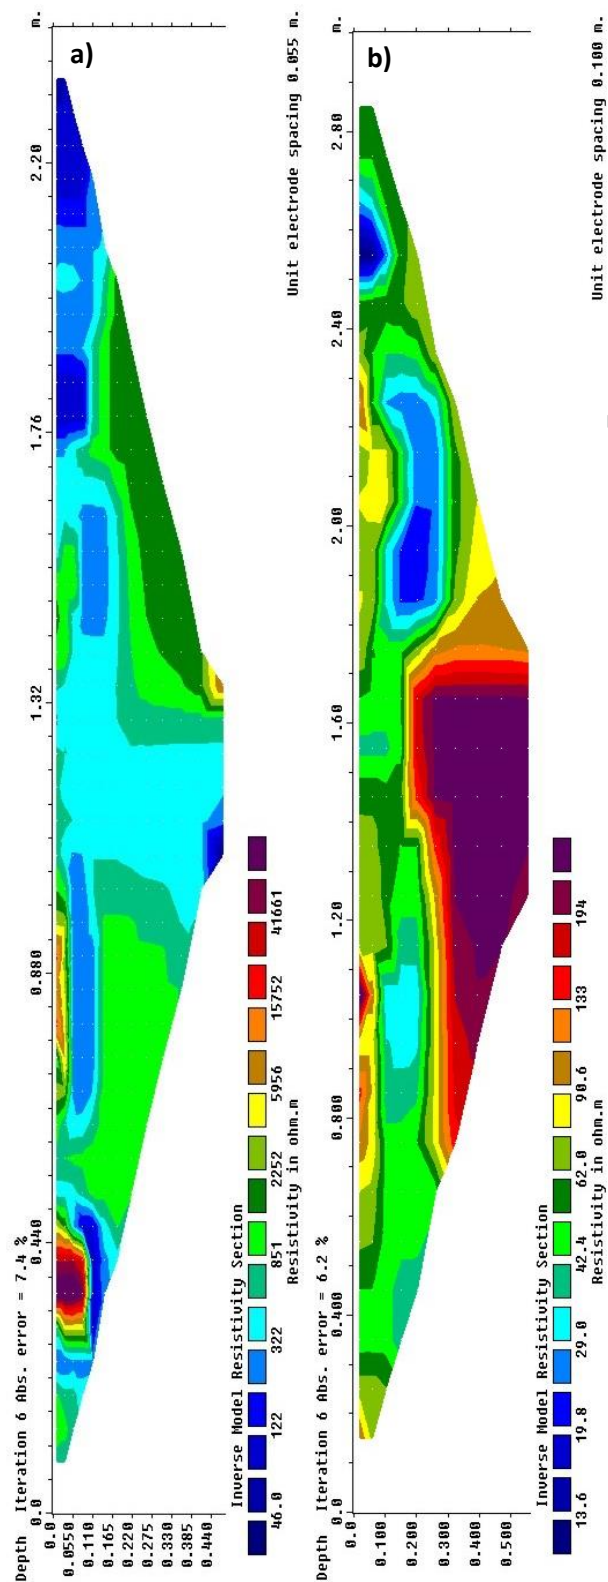
On the north wall, in turn (Figure 9a)), the moisture content was observed to be high ($\approx 300 \Omega$) in the medium-high part of the wall, at heights greater than 0.88 m (y-axis). This moisture (low resistivity) persisted up to a depth of 0.22 m (x-axis) across the entire vertical profile and up to 0.44 m at around mid-height (1.0 m to 1.3 m). The resistivity gradient was indicative of a predominant downward flow of moisture from the upper part of the wall, for the moisture content was lower in the mid-low heights, with resistivity values of over 851Ω . Nonetheless, moisture peaks (resistivity nadirs) were detected in the shallowest areas on the lower wall (at a height of around 0.3 m and depth of around 0.11 m and a height of 0.6 m and depth of 0.05 m), along with moisture nadirs (resistivity peaks) likewise near the surface at higher elevations (height of 0.7 m and depth of 0.30 m).

As in the south cross-section (Figure 8), resistivity values were found to be generally lower in the floor than in the wall. That the lowest resistivity (highest moisture) values were not found in the shallowest layers along the wall-floor joint (Figure 9b)) provided further support for hypothetical rainwater leakage in the upper part of the wall as the origin of the damp. Nonetheless, low resistivity ($< 62 \Omega$) was also observed at depths of up to 0.20 m, interspersed with areas of very low resistivity ($< 29 \Omega$). The highest resistivities ($> 133 \Omega$) were recorded at the greatest depths (> 0.33 m), perhaps due to the presence of tombs. This somewhat higher resistivity area appeared to persist across the greatest depth studied, contrary to what was observed for the south-side floor, where low resistivity areas (0.45 m deep, resistivities $< 41.9 \Omega$) were observed to be interspersed, due in all likelihood to the presence of filler materials that would favour capillary water absorption in that wall.

Figure 9. GeoTom profiles in the northwest a) wall; and b) floor of the church

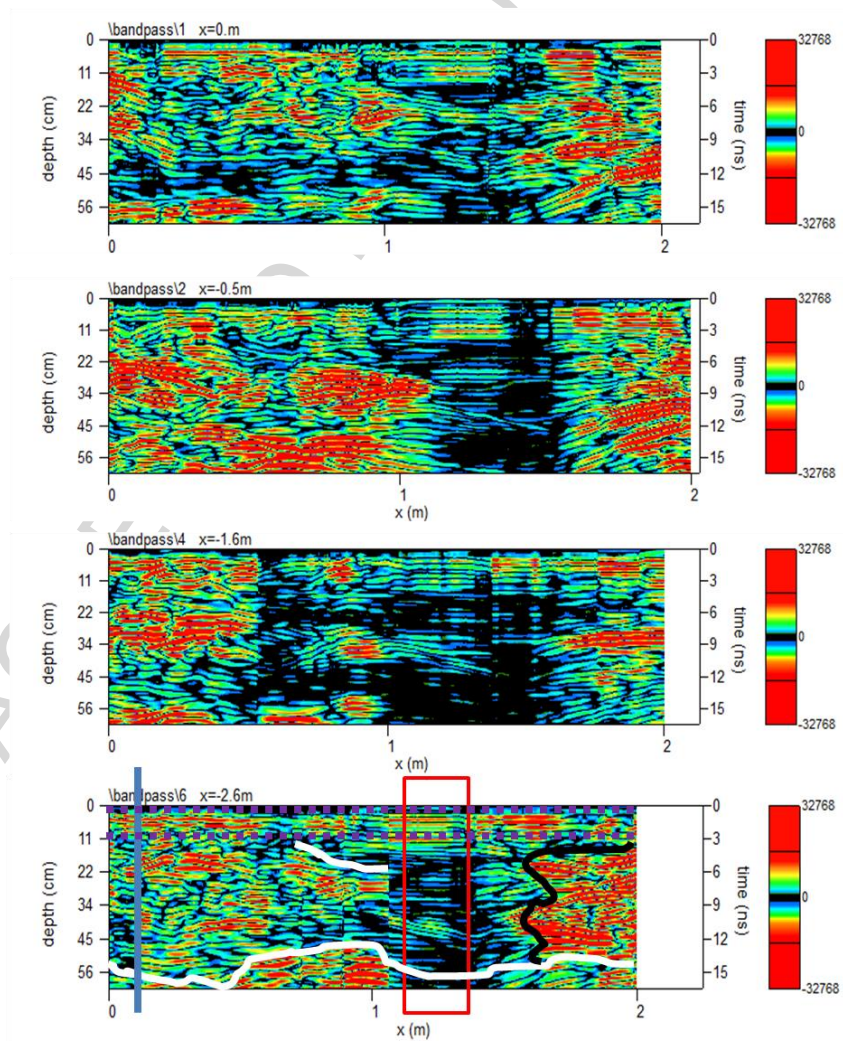
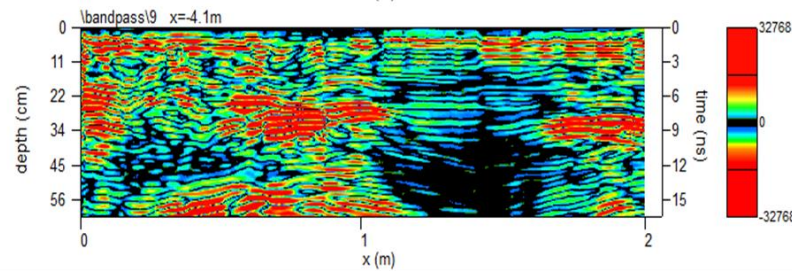
GPR confirmed the presence of moisture at heights of approximately 1.0 m to 1.5 m (red outline in Figure 10), where electrical resistivity values were very low ($< 20 \Omega$) in the shallowest layers. Reflections were barely received in this area at any depth. Although according to the ERT findings, moisture at these heights declined substantially in the deeper layers (> 0.10 m, $> 766 \Omega$), GPR recorded scant reflections in that height range across the entire thickness of the wall (Figure 10). That finding was attributable to

the moisture in the surface-most layers in the wave path, which slowed its velocity, inducing a loss of energy and perhaps adversely affecting the reliability of the results.

The vertical radargrams for this south wall also showed a series of greater reflections at heights of over 1.5 m (see black line in bandpass\6, Figure 10) which, in the absence of medium differences, were interpreted as lower moisture content. That concurred with the high electrical resistivity and low humidity (Figure 8a)) found with ERT, possibly reflecting the effect of solar radiation. In other words, whilst moisture (resistivities $\approx 100 \Omega$, Figure 8a)) was present in the shallowest layers, its impact on the cement mortar and hence on wave attenuation was lower, from which it may be surmised that even in the presence of moisture in shallow layers, GPR can detect lower moisture in layers at greater depths.

Figure 10. Radargram for the vertical survey profile that coincided with the electrical resistivity profile on the south wall; solid red outline: areas with scant reflections indicative of high moisture content; dashed purple outline: plaster and cement mortar layers; solid blue line: street level; solid white line: characteristic reflections or reflections for outside surface of wall; solid black line: lower boundary of area affected by solar radiation.

Amplitudes were greater in the dado than at other heights in all the vertical cross-sections. This lower part of the wall exhibited areas with greater or lesser intermediate moisture content and areas with no reflections (cross-sections 4 and 9, Figure 10) at heights under 1 m.

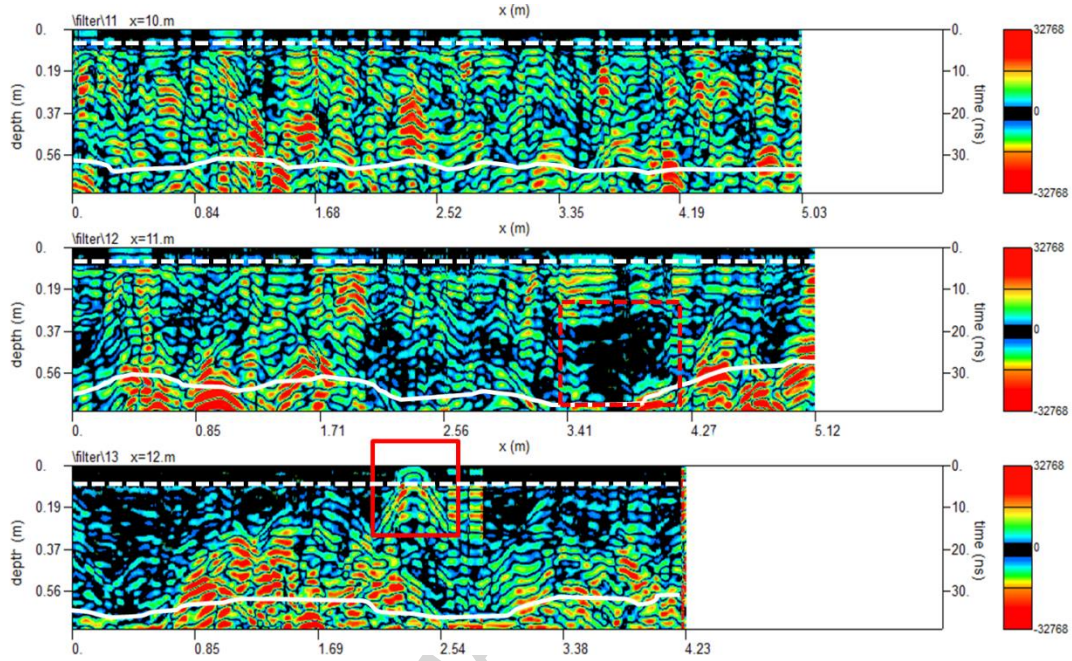
Substantial differences were observed among the horizontal cross-sections for the south wall (Figure 11) depending on whether they were on (profile 12, 1.0 m), above (profile 13, 2.0 m) or below (profile 11, 0.0 m) the moisture front (see Figure 4).

Figure 11. Horizontal radargrams on the south wall of the church; solid red outline: electrical wire; dashed white line: inward boundary of shallow mortar layers; solid white line: reflection indicating outside surface of wall

A high moisture content was observed in the plaster and cement mortar, with no reflections in these shallow layers in any of the cross-sections. Reflection amplitudes were generally similar for the profile 11 and 12 cross-sections (Figure 11), with a few areas with greater amplitude in 11 attributable to the dado and cavities in the dolostone. The moisture composition in the profile 12 cross-section was less uniform along the moisture front. The areas lacking reflections (dashed red lines, Figure 11), which are indicative of a high moisture content, delayed the reflection denoting the outside surface of the wall. Nonetheless, the cross-section for profile 13 exhibited reflections with very large amplitudes at depths of 0.37 m to 0.56 m, denoting lower moisture content due to solar radiation, as this profile was located above the moisture front. This cross-section also contained a reflection in the shallowest layers (solid red outline in Figure 11) at a distance of around 2.2 m attributable to an electrical socket that feeds power to one of the church lamps.

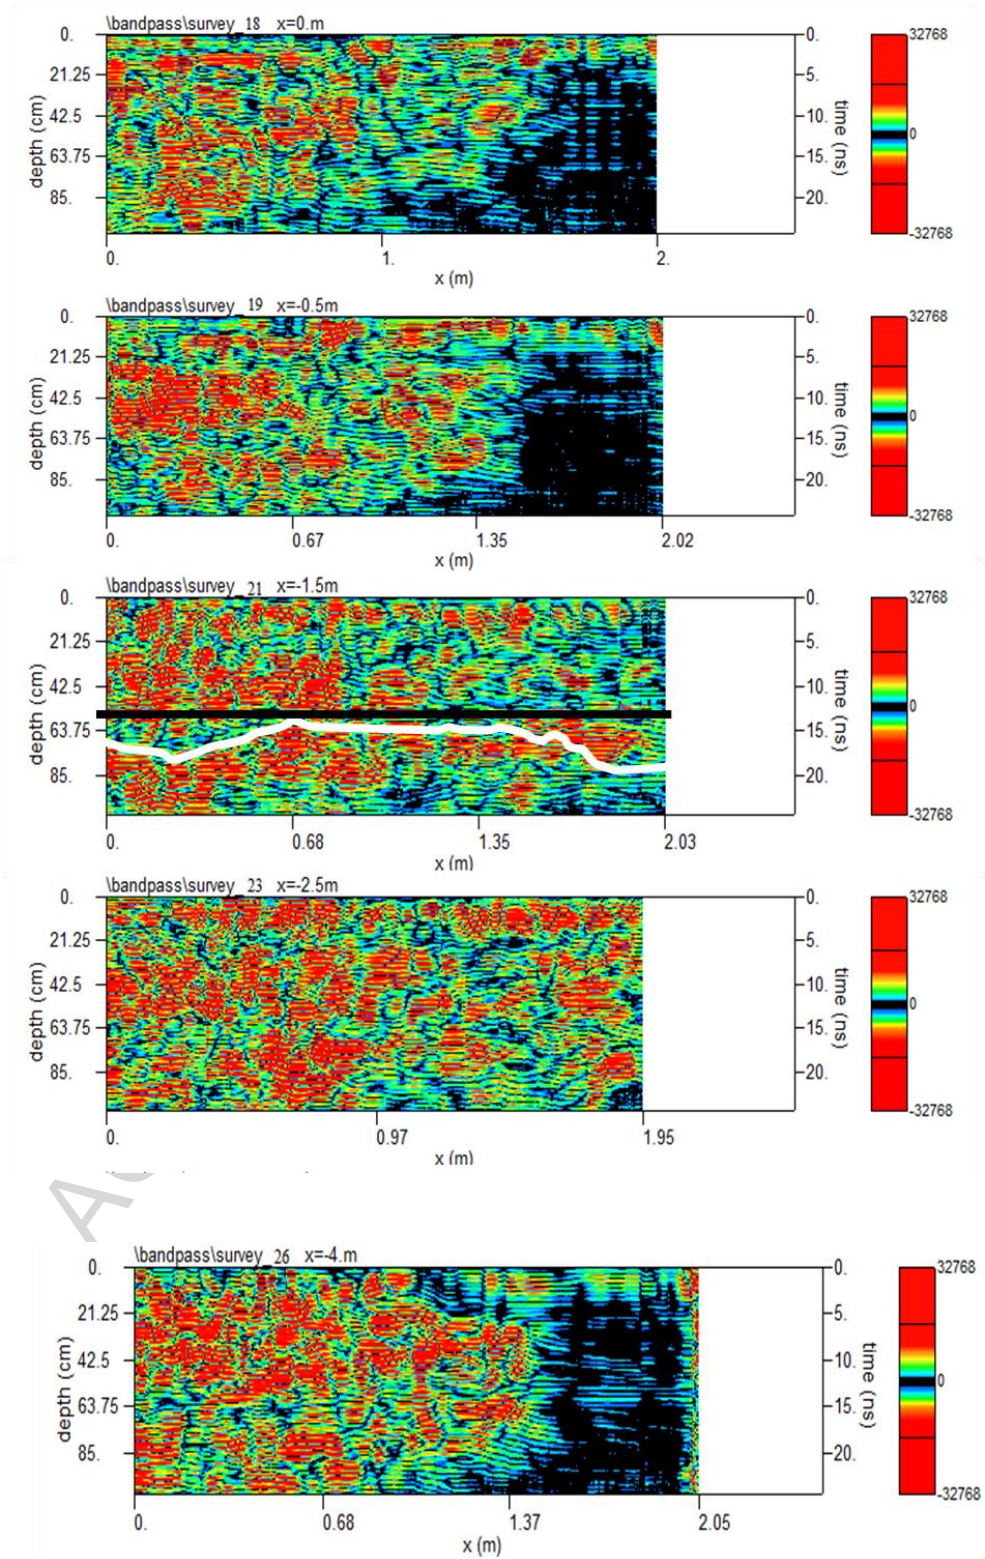
In the cross-section for the profile that concurred with the electrical resistivity profile (\\bandpass\\survey_21, Figure 12), the GRP findings showed that the reflection denoting the outside surface of the wall (white line) was deeper in the shallowest 0.50 m than in the rest of the cross-section. In other words, the wave travelled more slowly (two-way time around 18 ns) in those first few centimetres, indicating the presence of a higher moisture content there. The two-way times recorded here were similar to the times observed for the moisture front observed at a height of 1.0 m to 1.5 m on the south wall (Figure 10). This was consistent with the electrical conductivity meter readings for that wall, which detected the highest moisture range, with values of 60 % to 95 %, at a height of 1.30 m to 1.40 m. On the north wall, heights of under 0.5 m (dado), and occasionally and randomly up to 1.5 m also exhibited moisture in this range.

Variable phenomena were detected in the shallowest layers in the aforementioned cross-section, while amplitudes were smaller at heights of just under 2 m, which concurred with the minimum resistivities observed with ERT (Figure 9a)). Despite the large amplitudes in the area around 1.35 m, the two-way time for the respective reflection was greater. That finding was consistent with the ERT resistivity readings for the intermediate heights: 200 Ω to 300 Ω (Figure 9a)).

Figure 12. Radargram for the vertical profile that coincided with the electrical resistivity profile on the north wall of the church; solid black line: outside surface of wall; solid white line: reflection indicating outside surface of wall

Figure 12 shows a difference in wave behaviour between the moister layers closest to and the dryer layers farthest from the surface (>0.20 m), where interspersed larger amplitudes were observed. The electrical resistivity readings (Figure 9a) at the depth reached with that technique, in turn, were upward of 800Ω at heights of over 1.4 m. The inference to be drawn from these two findings is that in this medium and this cross-section, GPR detected and distinguished between moist and dry areas (Figure 12). Therefore, in the cross-sections with scant reflections at heights of over 1.4 m, moisture was interpreted to extend to the outside of the wall. That interpretation was supported by the surface moisture detected by electrical conductivity in this area (Figure 5). Evidence was also found for the heavy impact of surface water leakage in these upper areas, which penetrated through to the shallowest indoor layers (<0.20 m) where saturation had been detected by wireless sensors [25]. High moisture content was observed along the wall exteriors in some cross-sections.

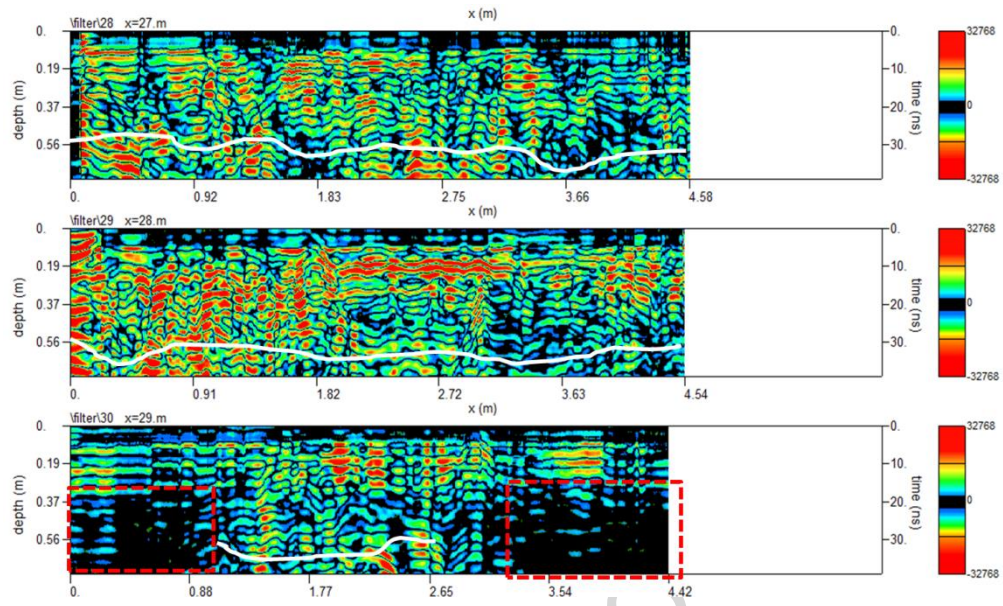
As shown in Figure 13, which reproduces the radargrams for the horizontal profiles on the north wall, the highest moisture content in deep layers was detected in the cross-section for profile 30 (2.0 m), confirming the hypothesis established on the grounds of the ERT findings to the effect that the origin of the damp was rainwater leakage from the upper levels. The cross-section for the lowest height profile (28) exhibited a wave amplitude distribution visibly similar to the pattern observed on the south wall.

Figure 13. Horizontal radargrams for the north wall of the church; dashed red outline: area with no reflections; solid white line: reflection indicating outside surface of wall

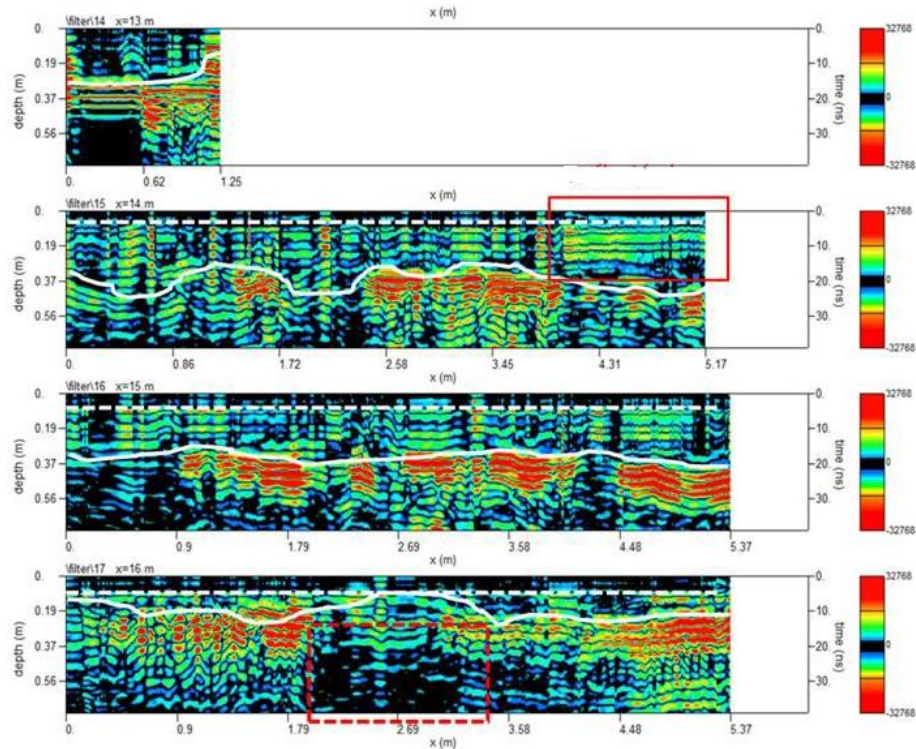
Figure 14 shows some of the floor cross-sections analysed on the south side of the church. In the cross-sections for profiles 15 and 16 (Figure 4), a change from a more to a less compact medium was detected at a depth of around 0.37 m, where the infill gave way to the original soil. A few reflections attributed to the pavers were observed in the profile 15 cross-section, which had no underlying structures, according to the church staff. The change from infill to soil appeared at a depth of 0.19 m in the cross-section for profile 17, sited at a farther distance from the wall. The cross-section for profile 14, which was perpendicular to the other cross-sections in Figure 14, also exhibited a reflection denoting a change of medium, represented by a white line present at a depth of 0.37 m in the profile 15 and 16 cross-sections and at 0.19 m in the cross-section for profile 17.

Figure 14. Under-floor radargrams alongside the south wall of the church; solid red outline: pavers; solid white line: change of medium; dashed white line: lower boundary of upper-most mortar layers severely affected by damp

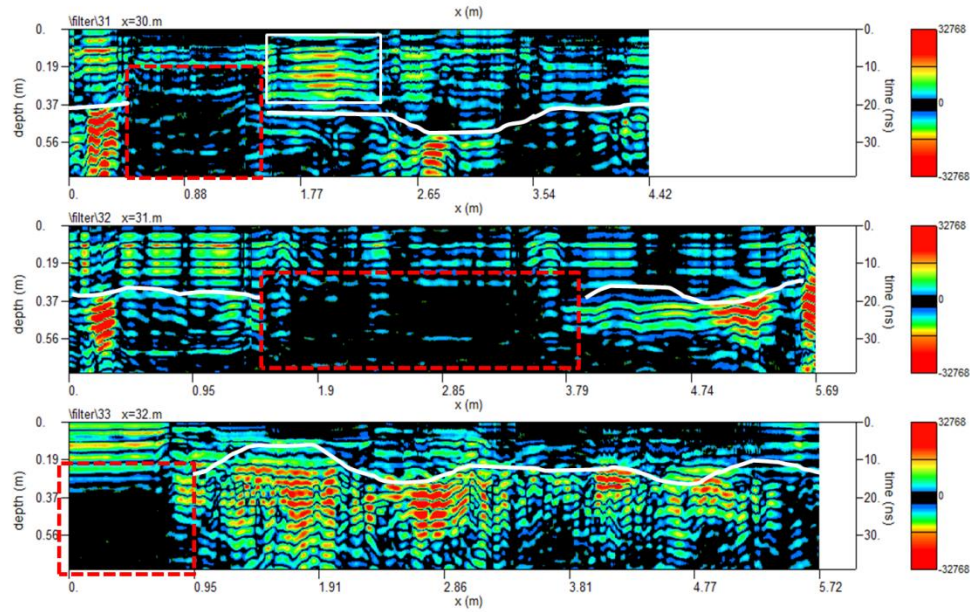
Figure 15 shows some of the wave transmission findings for the under-floor cross-sections alongside the north wall. Profile 31 was closest to the ERT profile (Figure 4). Overall, large areas with no reflections were observed at depths of over 0.37 m, where the medium was observed to change, as it did under the floor along the south wall. On this north side, the reflection denoting the change of medium also appeared at 0.19 m in the cross-section for profile 33, the one farthest from the wall. The GPR findings likewise confirmed that the original soil contained more moisture along the north than along the south wall. In the former, larger areas with scant reflections were found primarily in the cross-sections closest to the wall (profiles 31 and 32), which was consistent with the results of surface monitoring in this area (Figure 5).

Figure 15. Under-floor radargrams alongside the north wall of the church; dashed red outline: area with no reflections; solid white line: change of medium; solid white outline: pavers
