# A Case Study of a Large Unstable Mass Stabilization: “El Portalet” Pass at the Central Spanish Pyrenees

**Abstract:** This case study presents the engineering approach conducted for stabilizing a landslide that occurred at “El Portalet” Pass in the Central Spanish Pyrenees activated due to the construction of a parking lot. Unlike common slope stabilization cases, measures projected here were aimed at slowing and controlling the landslide, and not completely stopping the movement. This decision was taken due to the slow movement of the landslide and the large unstable mass involved. The degree of success of the stabilization measures was assessed by stability analyses and data obtained from different geotechnical investigations and satellite survey techniques such as GB-SAR and DinSAR conducted by different authors in the area under study. The water table was found to be a critical factor in the landslide’s stability, and the tendency of the unstable slope for null movement (total stability) was related to the water table lowering process, which needs more than 10 years to occur due to regional and climatic issues. Results showed a good performance of the stabilization measures

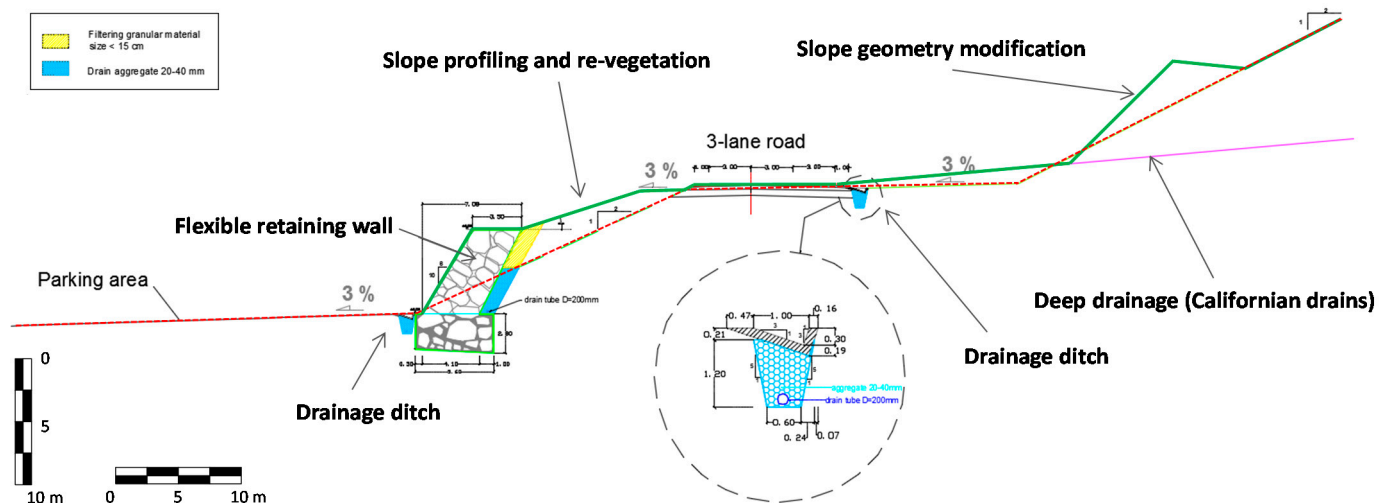
**Figure 3.** Stabilization measures projected; red dotted line and green line show the slope profile before and after implementing the stabilization measures (highlighted in bold), respectively.

A series of corrective measures were proposed to be performed on the slope to stabilize the landslide. Those measures (Figure 3) were not aimed to stop the hillside movement immediately and absolutely but to slow it down and prevent any damage to surrounding infrastructures. Eventually, the measures projected were expected to completely stabilize

- A slight modification of the slope geometry by means of the excavations of intermediate areas (benches) on the slope.
- Installation of deep drainage measures (Californian drains) as well as ditches to improve slope drainage and remove water coming from seepage and runoff; in total, 47 single drains were installed with a separation of 15 m; the horizontal slope was 6% following Serrano and Gómez [29] and Forrester [30]. Drains were executed with slotted PVC pipes with a thickness of 1.5 mm and a diameter of 75 mm.
- Implementation of slope conservation and stabilization measures such as slope profiling and re-vegetation.
- Performance of a flexible retaining wall at the slope toe; wall height was 6 m from the ground and 9.2 m from the bottom of the foundation and its width was found between 3.5 and 4.1 m; its vertical slope was 6:10.

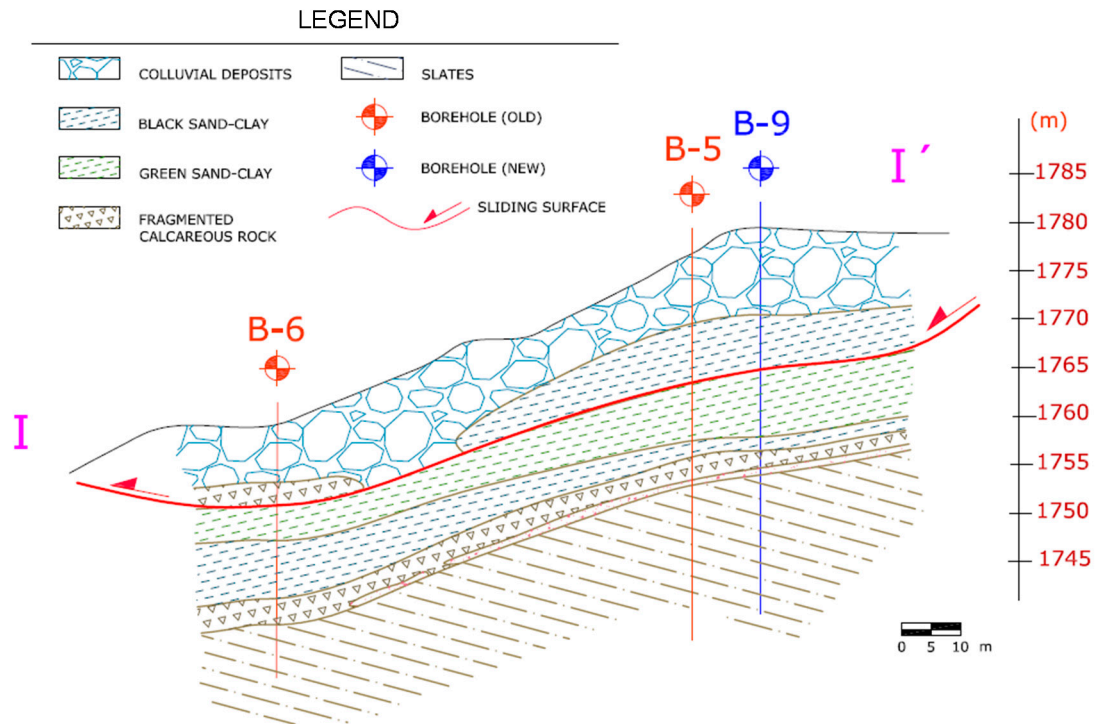
Data from boreholes, inclinometers and surface movements led to defining a failure surface located at depths between 5 m and 19 m (see Figure 5), with a fairly planar shape and with greater curvature in the slope toe area. The failure surface daylights on the slope and is observed on the ground surface (at both the slope head and toe) as seen in Figure 6. Surface movements in the E-SE direction, topographically recorded during the previous geotechnical investigations [15], showed small movements on the head of the slope as well as on the excavated slope. Those movements ranged between 1 cm and 3 cm, with movements in the northern area being slightly inferior to southern areas.

Figure 5. Geotechnical profile I-I' (see Figure 2) of the area under study; failure surface detected is shown in red.

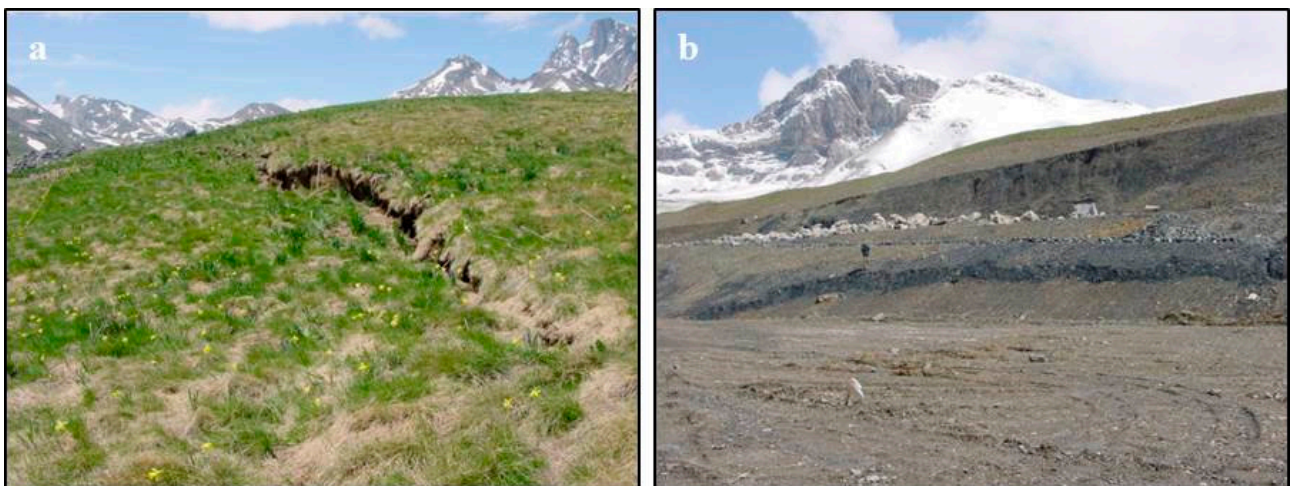
Figure 6. Daylight of the failure surface: (a) stress crack; (b) warped plane morphology.

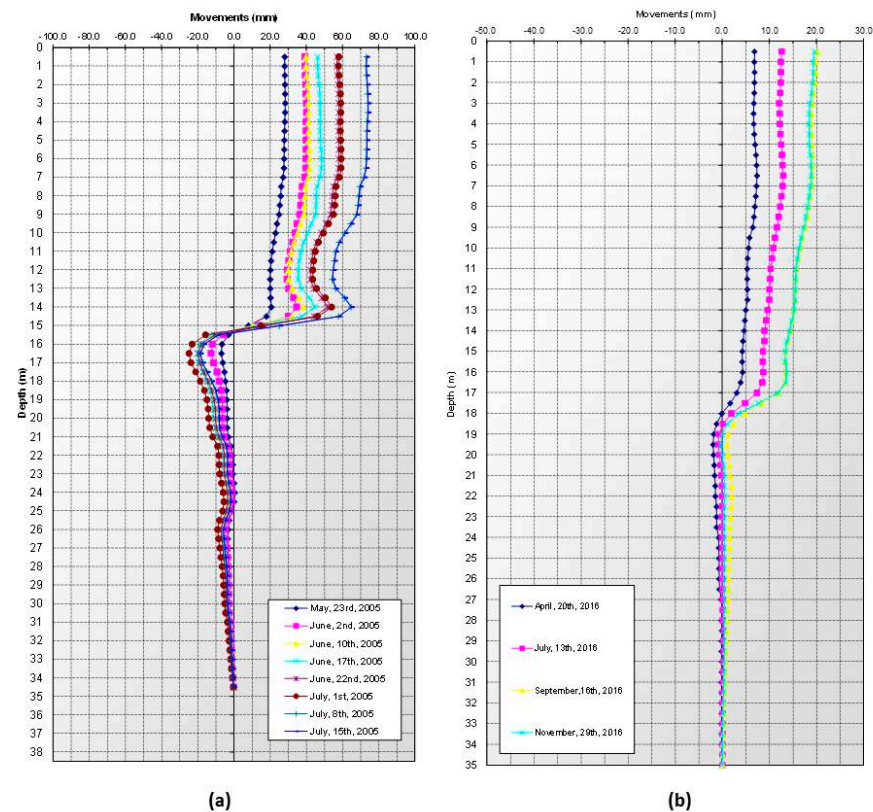
Inclinometers revealed the development of the failure surface mainly through the sandy clay materials in contact with the fragmented calcareous rock. An example of inclinometer data obtained in the previous study [15] and new geotechnical investigations

is shown in Figure 7 (note that those inclinometers belong to profile I-I' shown in Figure 5; failure surface may be easily identified).

**Figure 7.** Inclinometers records: (a) Inclinometer placed in borehole B-5, reprinted with permission from ref. [15], Copyright Year 2005, Copyright Owner's F.J. Torrijo (old geotechnical investigations [15], conducted in 2005); (b) Inclinometer placed in borehole B-9 (new geotechnical investigations, conducted in 2016).

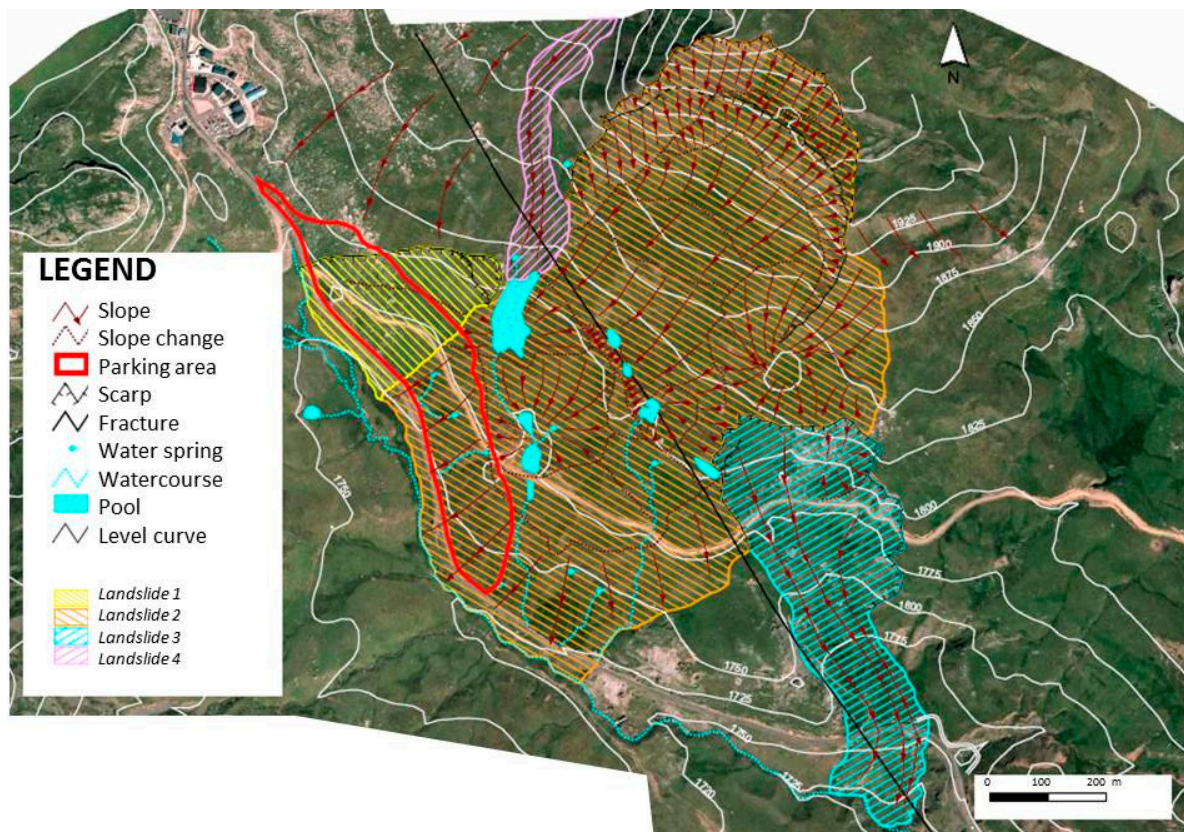
Topographical works developed during the previous investigation [15] detected the existence of three main landslides in the area under study (landslides, 1, 2 and 3 in Figure 8). This information was confirmed by the DinSAR data [21,22]. One of those landslides (landslide 3) was not affected by any anthropogenic activity (i.e., was not the consequence of the parking excavation) and was an extremely slow movement [46,47] with an estimated average velocity [22] of approximately 16 mm/year and affected by seasonal rainfalls. The second landslide (landslide 1) was activated by the parking excavation and corresponds to the slope movement under study. Its movement rate, estimated by the auxiliary DGPS campaign of approximately 0.1 m/year, meant it was not possible to compute its velocity with the DinSAR technique [22]. The third landslide (landslide 2) was located next to the previous one, was also activated by the parking excavation and its average velocity was estimated [22] at approximately 25 mm/year. The ALOS PALSAR differential interferometry [24] was also applied to this last landslide, obtaining similar results.

**Figure 8.** Main landslides detected in the area under study.

DGPS measurements [14], conducted after performing the stabilization work on the slope (i.e., landslide 2 according to Figure 8), showed that maximum displacement rates were around 1 mm/day in the summer while rates increased up to 2 mm/day in the fall. Those measurements also identified that the landslide's most active part was an area located below the main scarp. GB-SAR technique discovered that the landslide displacements were fairly linear in time, although slight differences were observed due to daily rainfall variations. Generally, an acceleration of the landslide occurs when rainfall events take place.

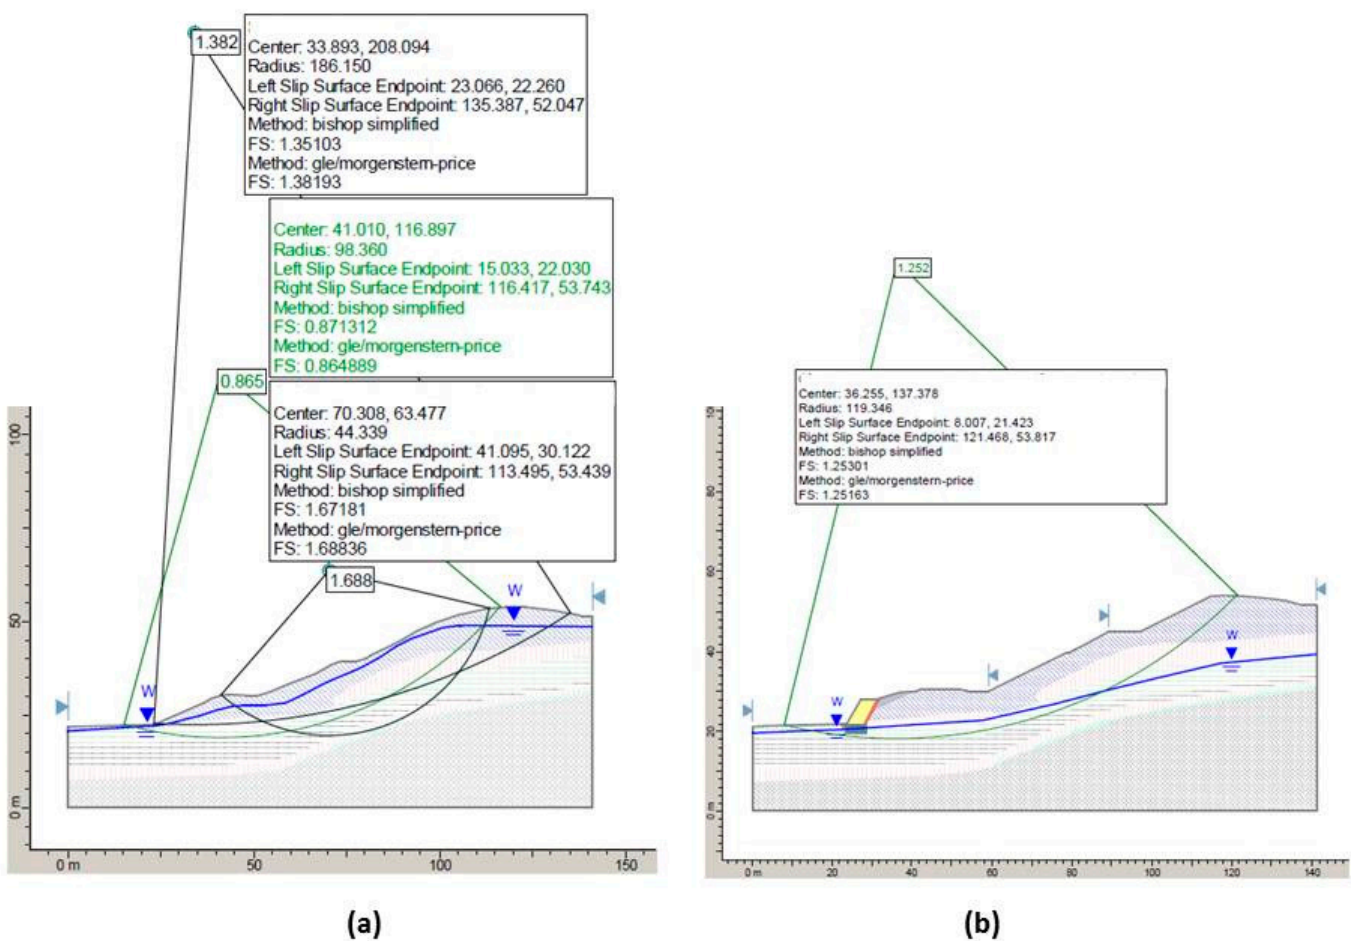
Under natural conditions, once the parking area was excavated and prior to implementing any corrective measure, profile I-I', according to Figures 2 and 5, was found to be the most unfavourable profile. Without taking into account the seismic component, the safety factor at that profile resulted in 0.86. That confirms the existence of the landslide produced by the parking excavation and the subsequent movement of the slope. It should be mentioned that this landslide was a first-time failure, not a reactivation of a previous one. When the seismic action was taken into account, a safety factor of 0.59 was obtained for the same profile (i.e., about 30% lower).

The analyses were run again introducing the projected measures and considering the final stage of the projected slope. The water table was located following the data obtained from the inventory of water points carried out in the new investigations and considering that the capacity of California drains is greater than the recharge of the aquifer (an average level was considered since the water table depends on rainfalls, see the next section). Profile I-I' was still found to be the most unfavourable. In this case, the safety factor without taking into account the seismic component increased to 1.3; taking into account the seismic acceleration, the safety factor was 1.1 (about 15% lower). That result indicates that the slope is stable and the landslide is expected to be under control with the projected measures. Figure 9 shows the results computed by the Bishop's method for profile I-I' before and after implementing the stabilization measures using the software Slide v5.028 [48].

**Figure 9.** Safety factor analyses of profile I-I' (see Figure 2): (a) slope in its natural state after the parking excavation; (b) slope state after implementing the stabilization measures.

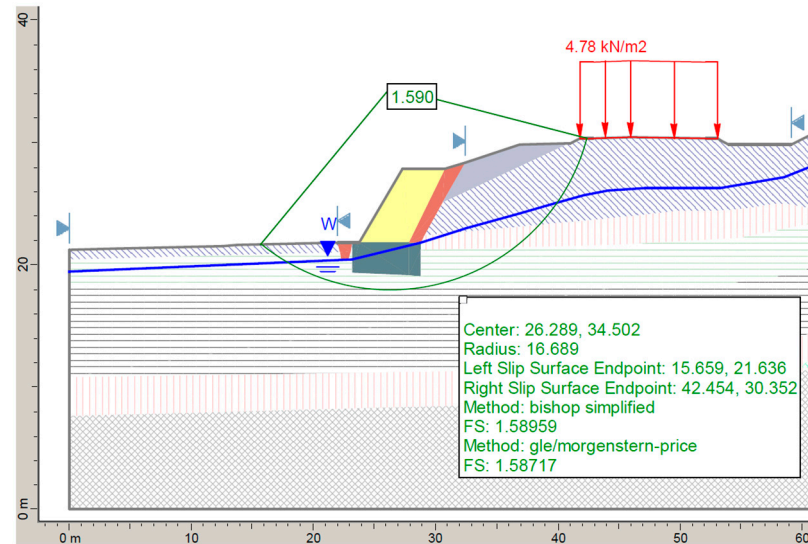
instance, Figure 10 shows a stability analysis carried out by both the Bishop [44] and the Morgenstern–Price [45] methods taking into account only the area around the toe wall. The safety factor obtained was nearly 1.6 in both cases, about 23% and 45%, respectively, greater than that computed in the scenario considered in Figure 9b. This may have led to an assumption that the installation of that wall was the unique corrective measure needed, which resulted in it not being enough for controlling the hillside movement.

**Figure 10.** Stability analysis considering the projected wall alone.

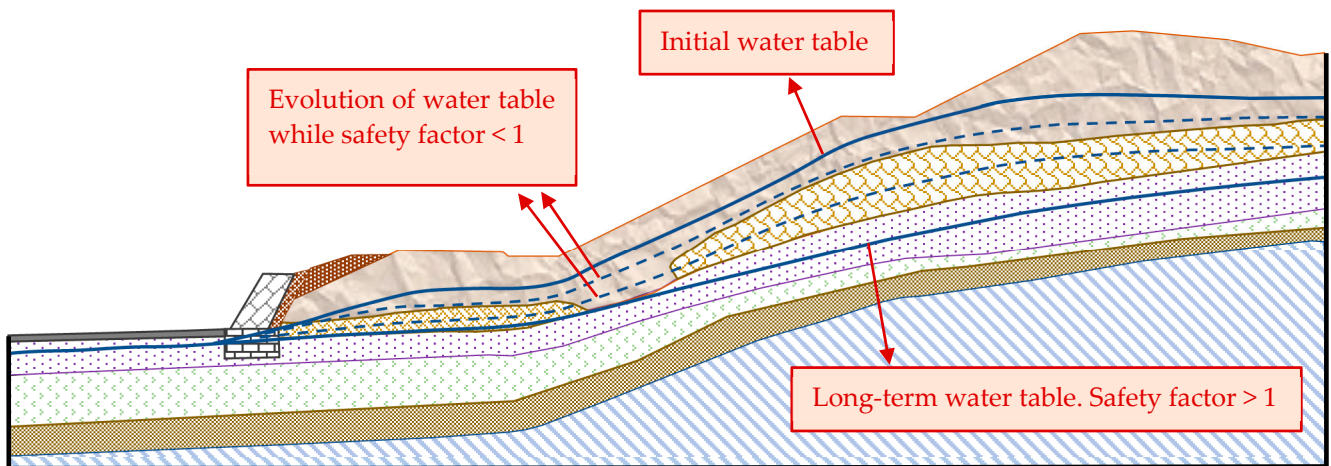
As a consequence, the water table lowering does not only depend on the drainage capacity and the efficiency of the Californian drain but also on the weather and the annual recharge (Figure 11). As a result, the drainage of the slope needs time. During that time, the slope is expected to have a safety factor lower than 1.0, which explains the movement of the slope recorded by the different investigations (in fact, the safety factor increased from the situation depicted in Figure 9a to the one given in Figure 9b). Thus, although the future solution in the long term will be stable, attaining this situation will need to wait for some time during which the slope will exhibit unstable behaviour.

Figure 11. Expected evolution of the water table and its qualitative relationship with the safety factor.

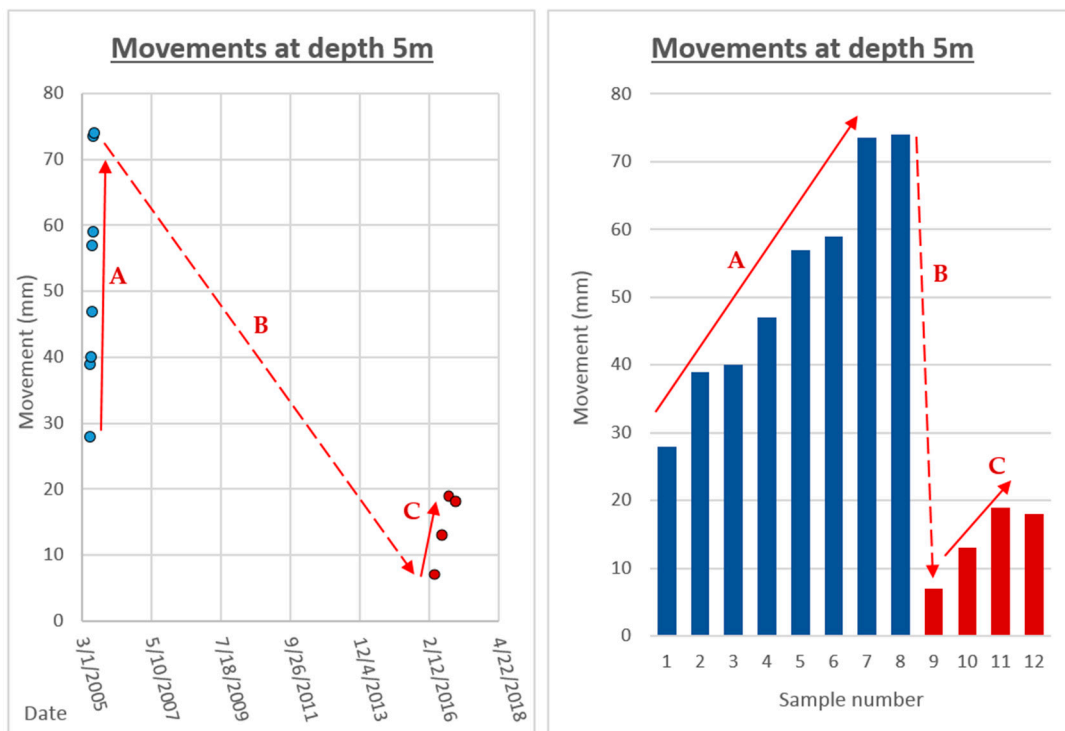
Figure 12. Evolution of the movements at a depth of 5 m. Long-term trend. The movements are represented in blue for borehole B5 (installed in year 2005) and brown for borehole B9 (installed in year 2016), Date given in Day/Month/Year. Letter A refers to the fast increment in deformations in 2005; B refers to the reduction of deformations between 2005 and 2016; C refers to the acceleration of deformations registered in 2016.

Figure 12 shows that, in 2005, the deformations were increasing and the slope was moving faster (A). Between 2005 and 2016 the deformations were greatly reduced, so the landslide was stopping (B). Finally, according to 2016 records, the slope continued to accelerate; from April to September the movement evolved from 5 to 20 mm, although from

September to November it seemed to stabilize (C). This acceleration in a given year was also observed in 2005 for the same period, April to September. That period corresponds to the spring season when precipitations normally occur in the area under study together with the snowmelt phenomenon [49]. Thus, these results confirm the influence of the water table in the landslide stability, the long-term tendency observed in the evolution of the slope movement and the long time needed to attain drainage of the ground mass (Supplementary Materials).
