1 **Drainage network evolution and reconstruction in an open pit** 2 **kaolin mine at the edge of the Alto Tajo Natural Park**

26 **Abstract:** Landform instability of the abandoned Nuria kaolin mine, surrounding the Alto
27 Tajo Natural Park in Spain, has caused frequent and severe environmental impacts due
28 to deficient mining practices, environmental mismanagement and closure planning.
29 Geomorphic instability has caused widespread soil erosion and elevated sediment yields
30 with off-site effects. We quantified such land instability, the evolution of the resulting
31 drainage networks and catchments, and ensuing gully processes. High Resolution
32 Topography sources were compared with historic maps and photos. The current mine
33 rehabilitation practices are depicted based on a geomorphic approach that introduces a
34 sustainable drainage system designed to avoid detected risks. Our aim is reconstructing
35 fluvial channels and related hillslopes that mimic their natural counterparts adapted to a
36 rehabilitation of pre-existing gradient terraces. We demonstrate that: i) mining activity

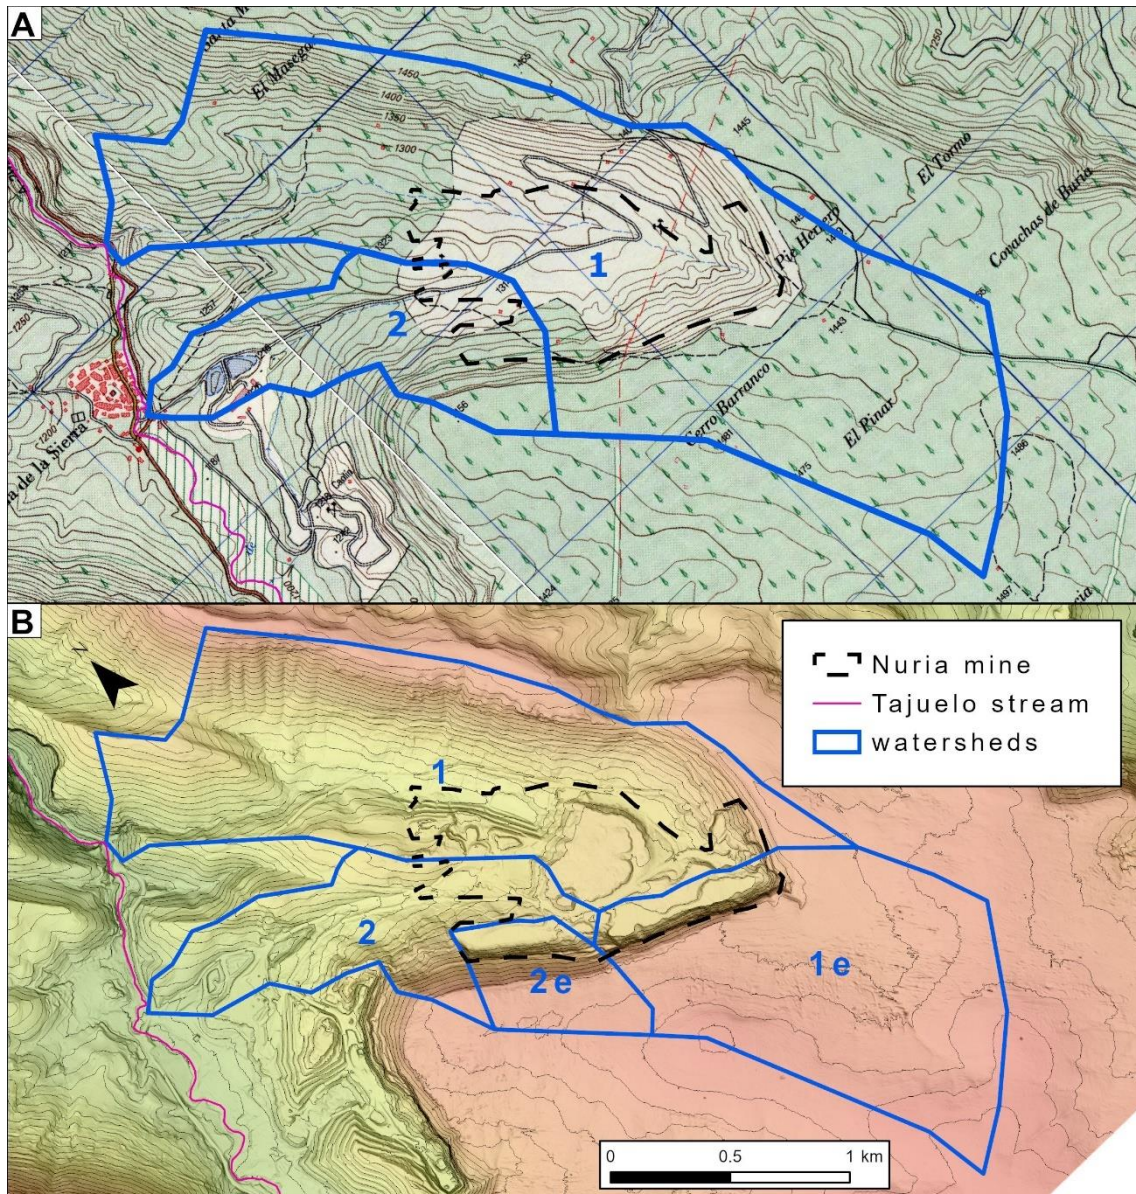
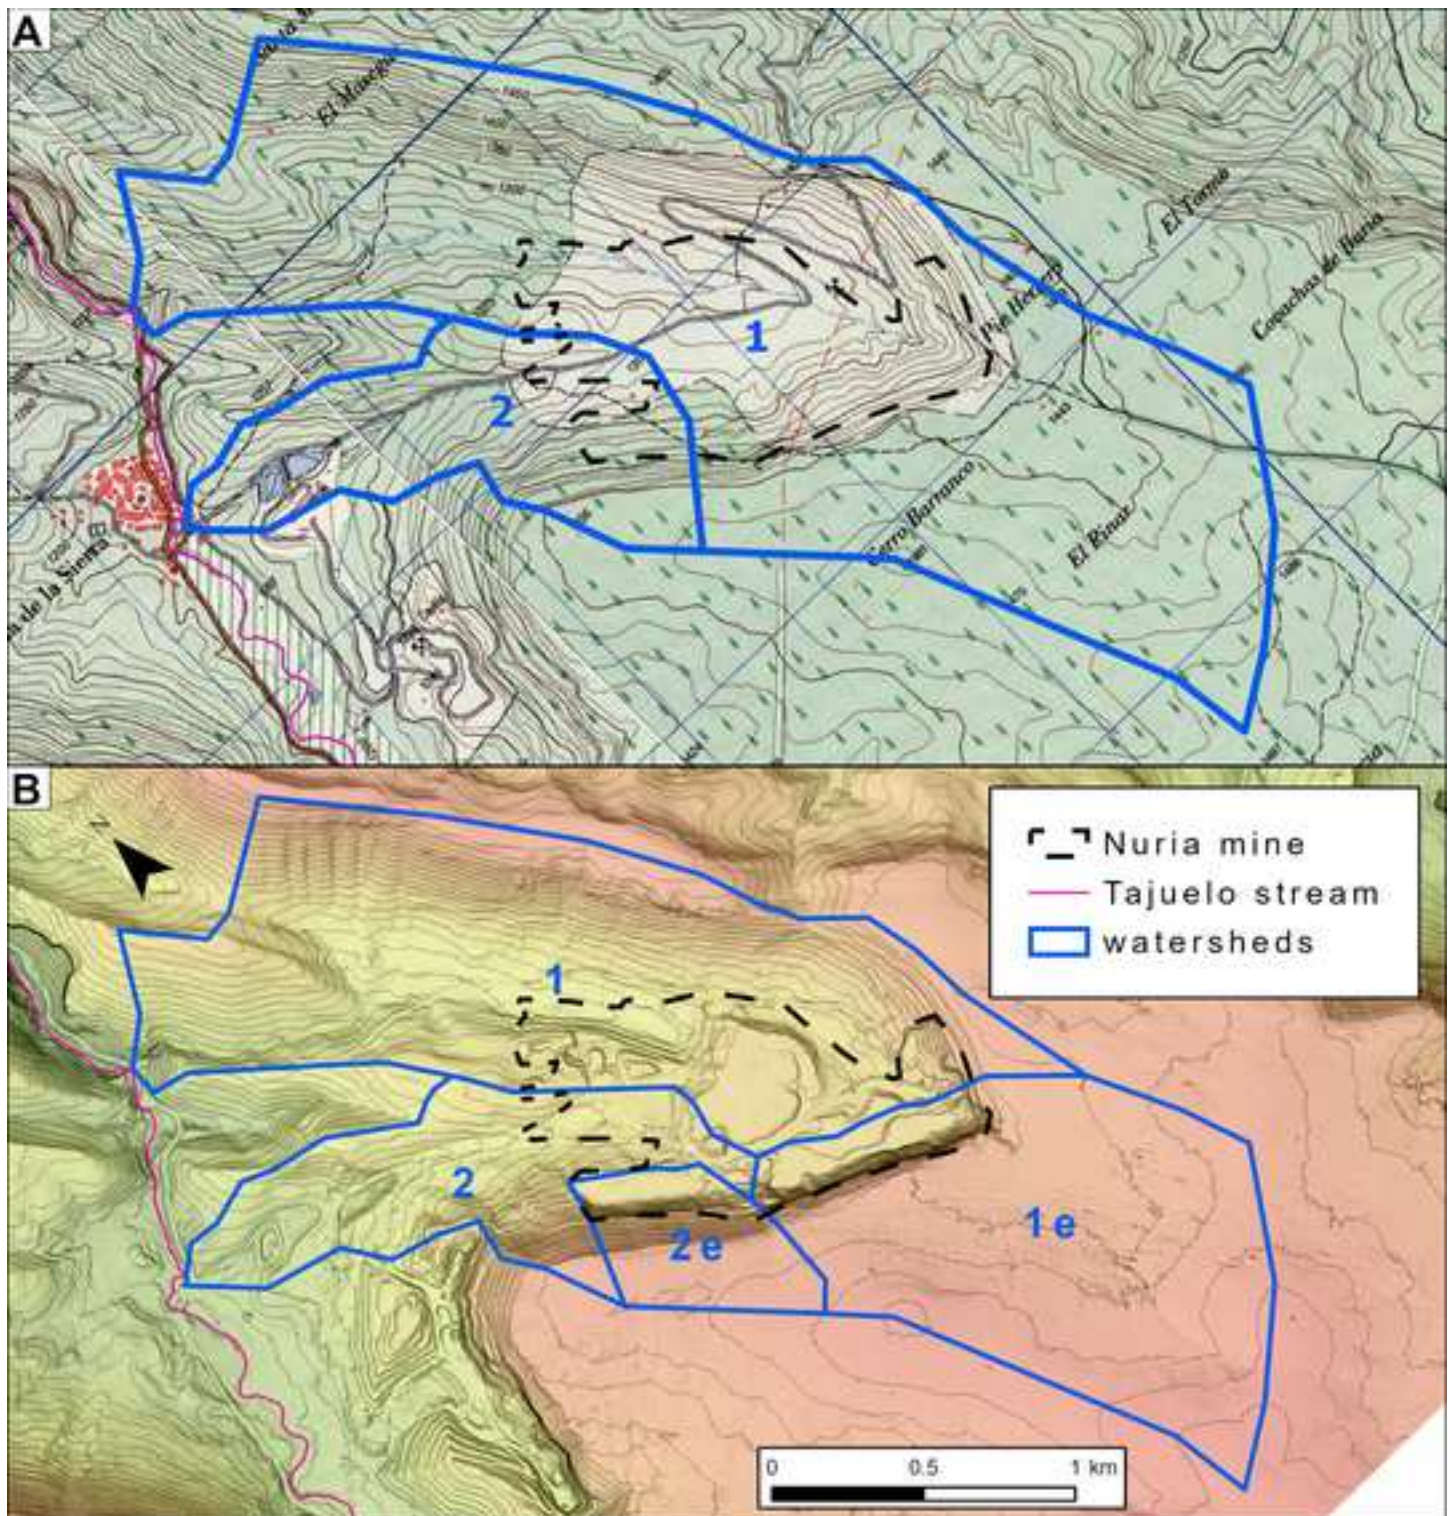
Figure 2

281 The Nuria mine, located in the intermediate part of two sub-catchments of the Tajuelo
282 stream, drained water from 449 ha before mining activity ensued. These natural
283 catchments thereafter drained 62% of the catchment, the remaining area forming two
284 endorheic sub-catchments draining to ponds located at the bottom of the pits at the
285 highwall toe (Fig. 2). The drainage network developed in three stages: before the mining
286 activity in 1984 at the pre-mining stage; near the end of mining activity during 2009-2010
287 with the drainage network based on ditches and gullies; and, after eight years that natural
288 processes shaped the drainage network and undertaking three geomorphic
289 stabilization/rehabilitation projects (Fig. 3 and Table 2). In 1984 the drainage network
290 had a fourth stream order and a typical dendritic shape. It was modified by the mining
291 activity, which removed the upper part of the network and introduced straight artificial

296
 297 Figure 2. Catchment evolution in the Nuria mine: (A) 1984, before mining; (B) 2018, after
 298 mining; (1, 2) natural catchments; (1e, 2e) mining-modified endorheic catchments with
 299 ponds at the highwall toe. A 25,000 map and a DEM and contours are the background
 300 for each date.

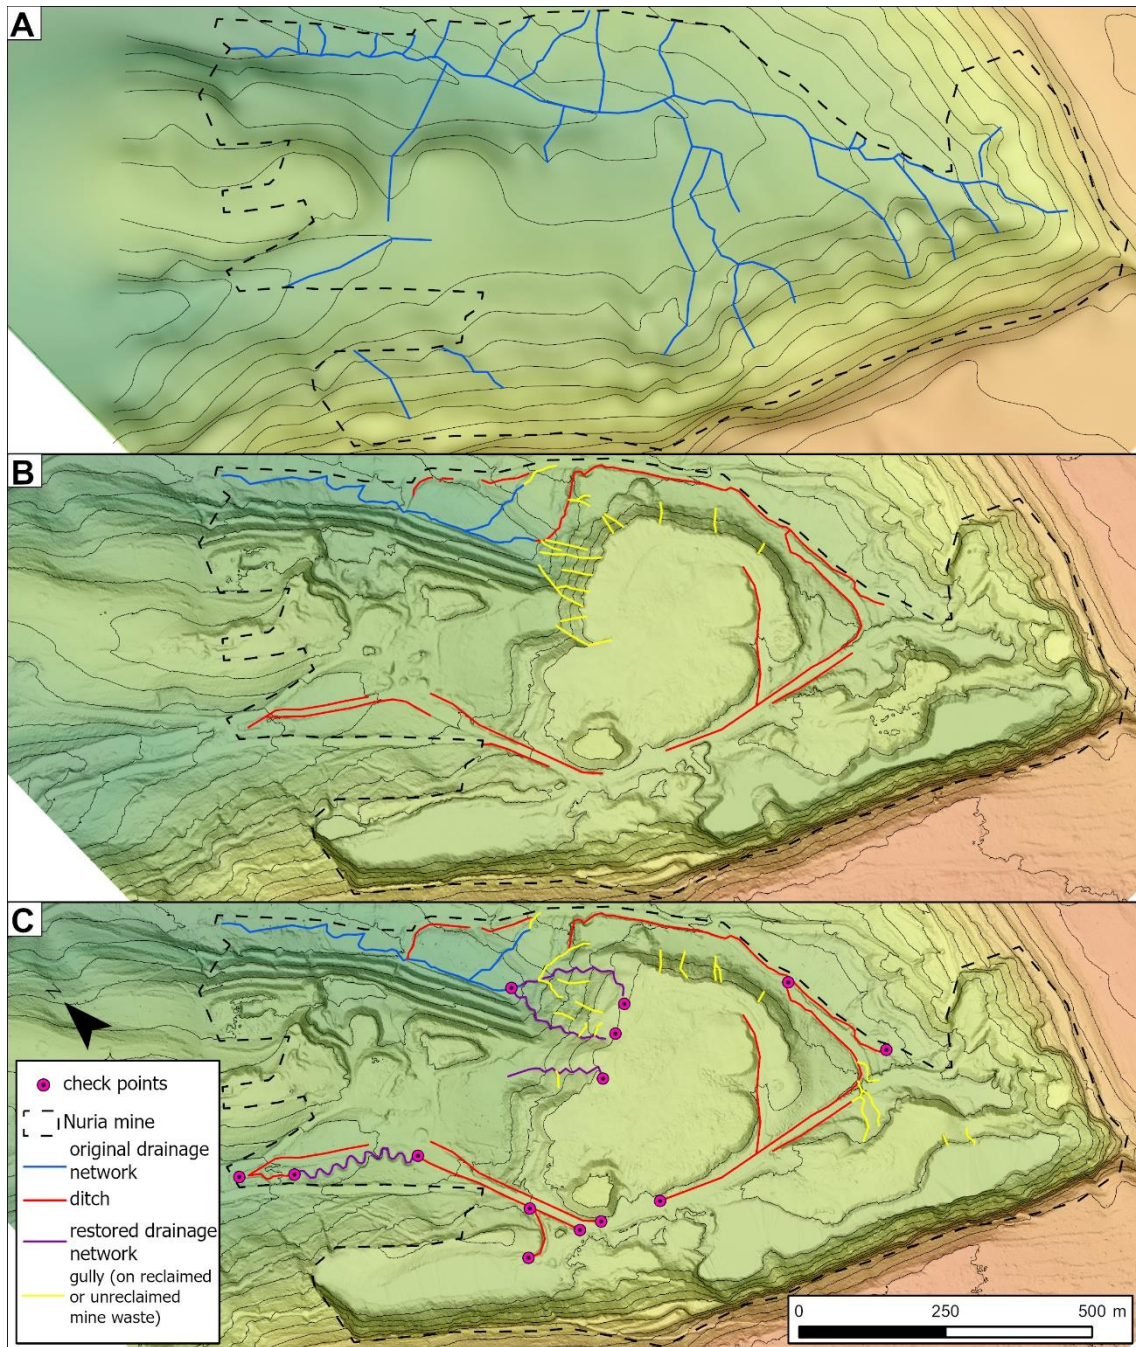
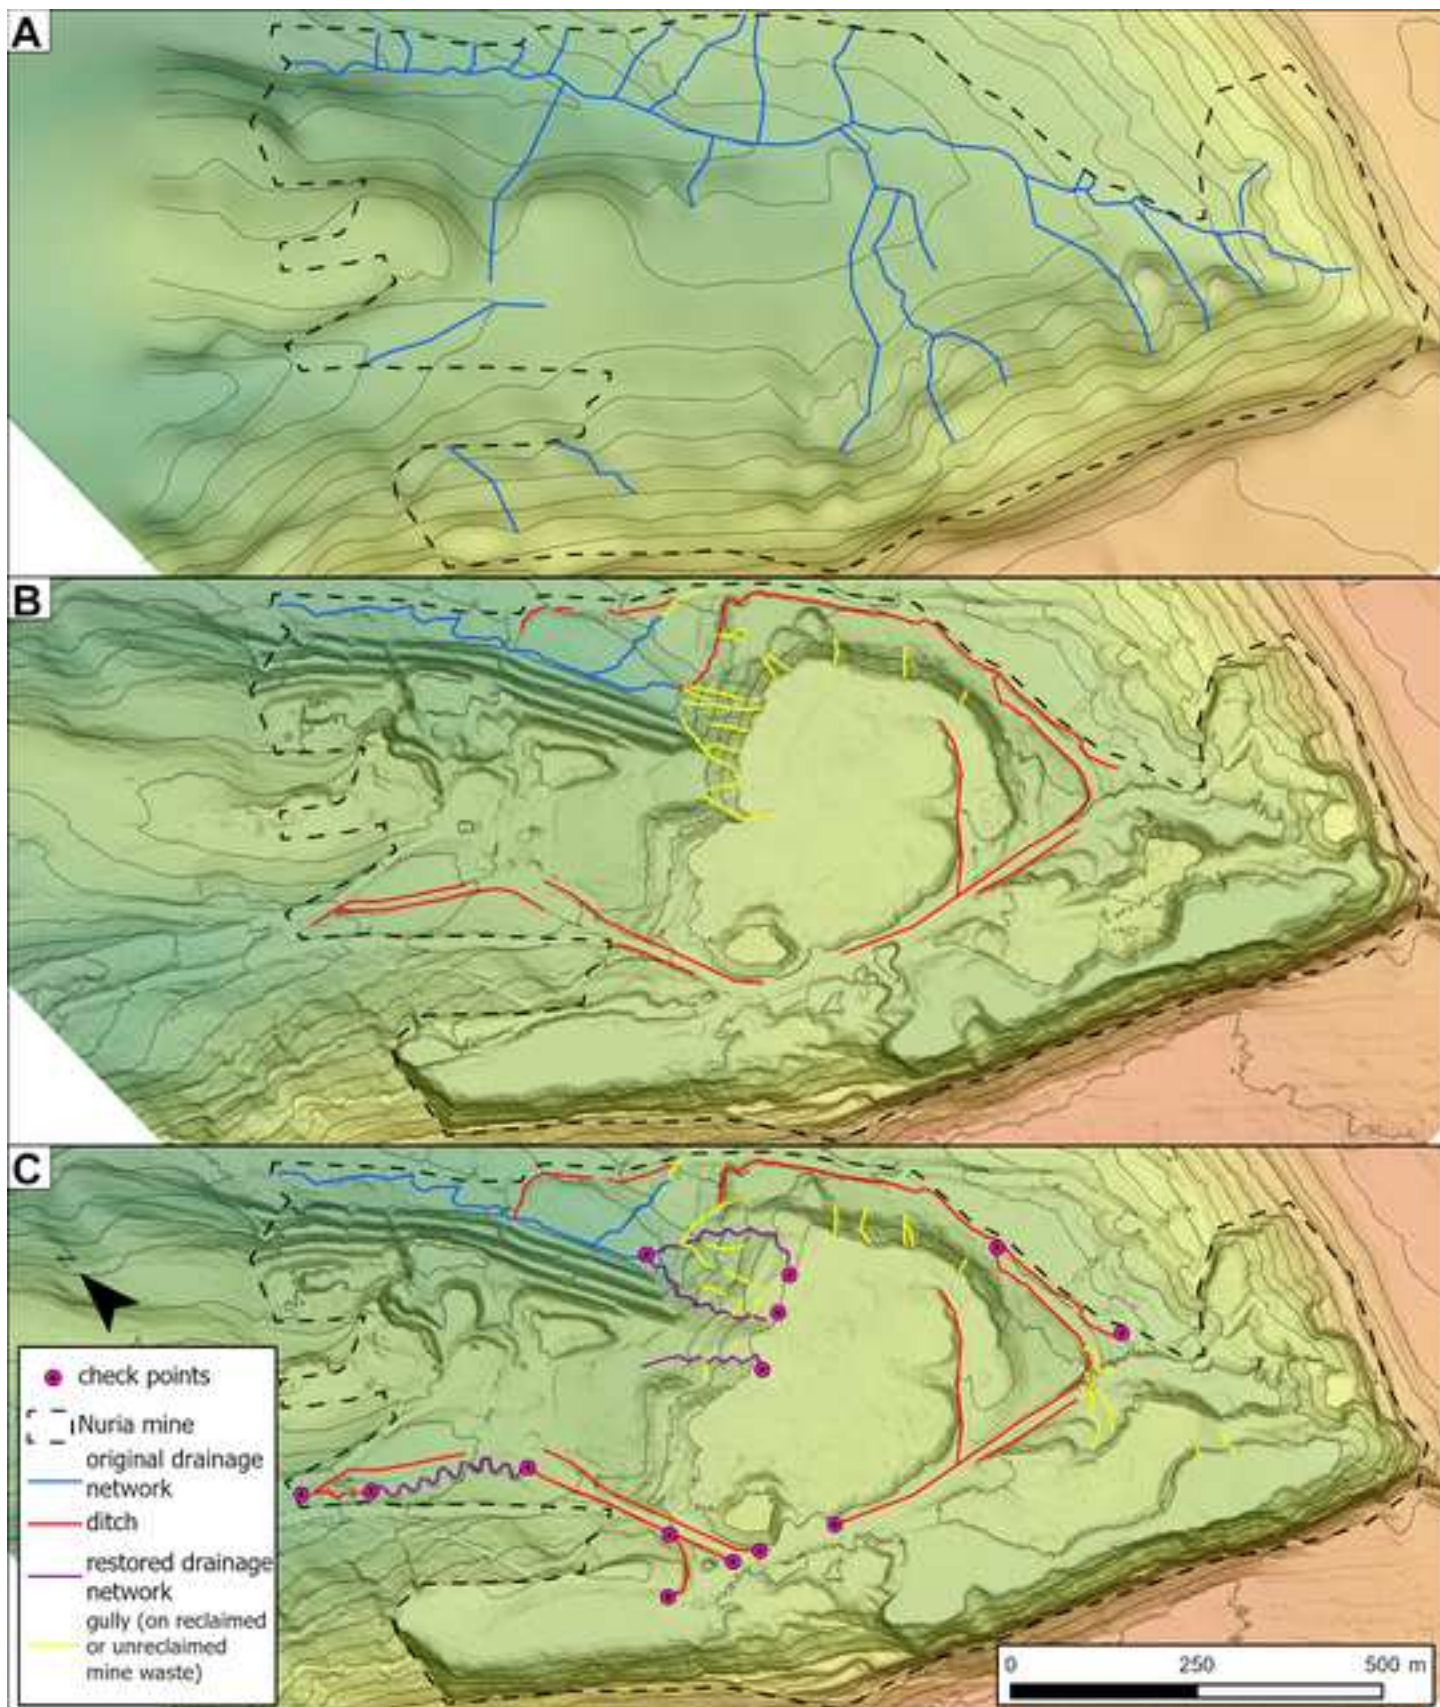
Figure 3

292 drainage ditches mainly at the edges of the mine. Some gullies also appeared within
293 zones having no drainage. In 2018 new gullies grew and others were stabilized by
294 geomorphic rehabilitation, reshaped into new fluvial channels with zig-zag and
295 meandering shapes, based on local natural analogues (Zapico et al., 2020).

302 Figure 3. Temporal change in drainage network and type of drainage lines around the
 303 Nuria mine: (A) 1984, (B) 2010 and (C) 2018. A DEM and contours are the background
 304 for each map.

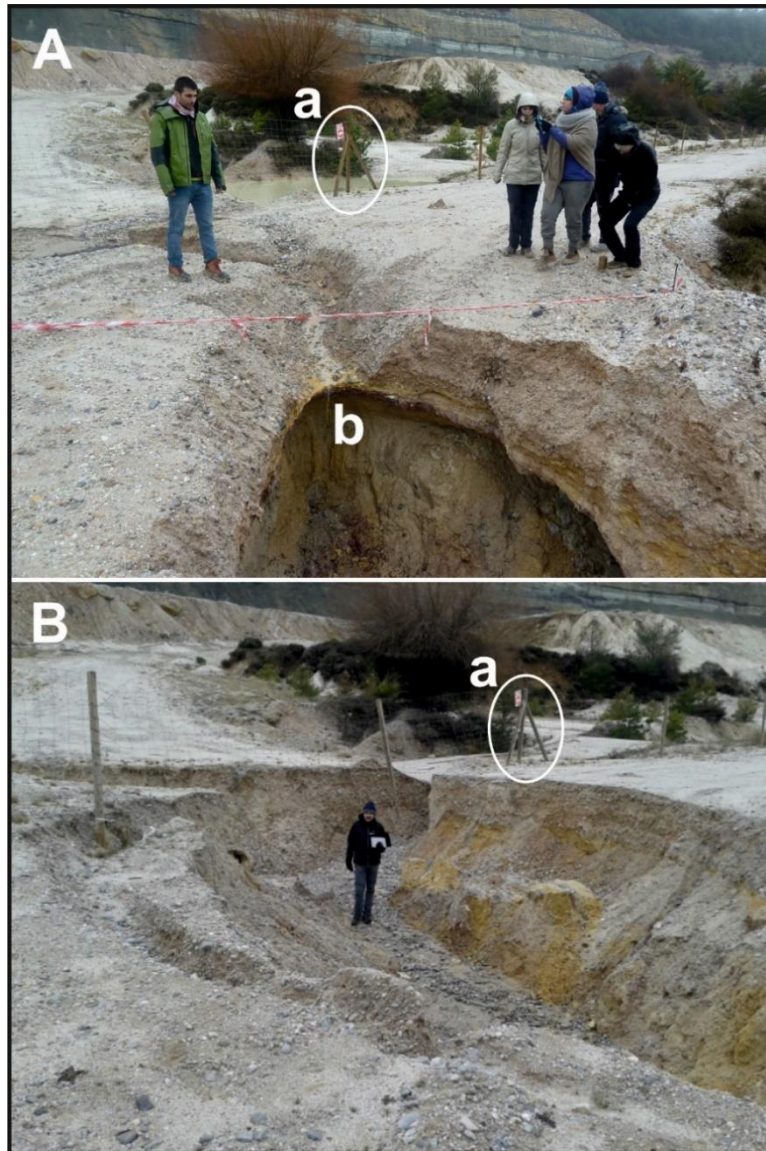
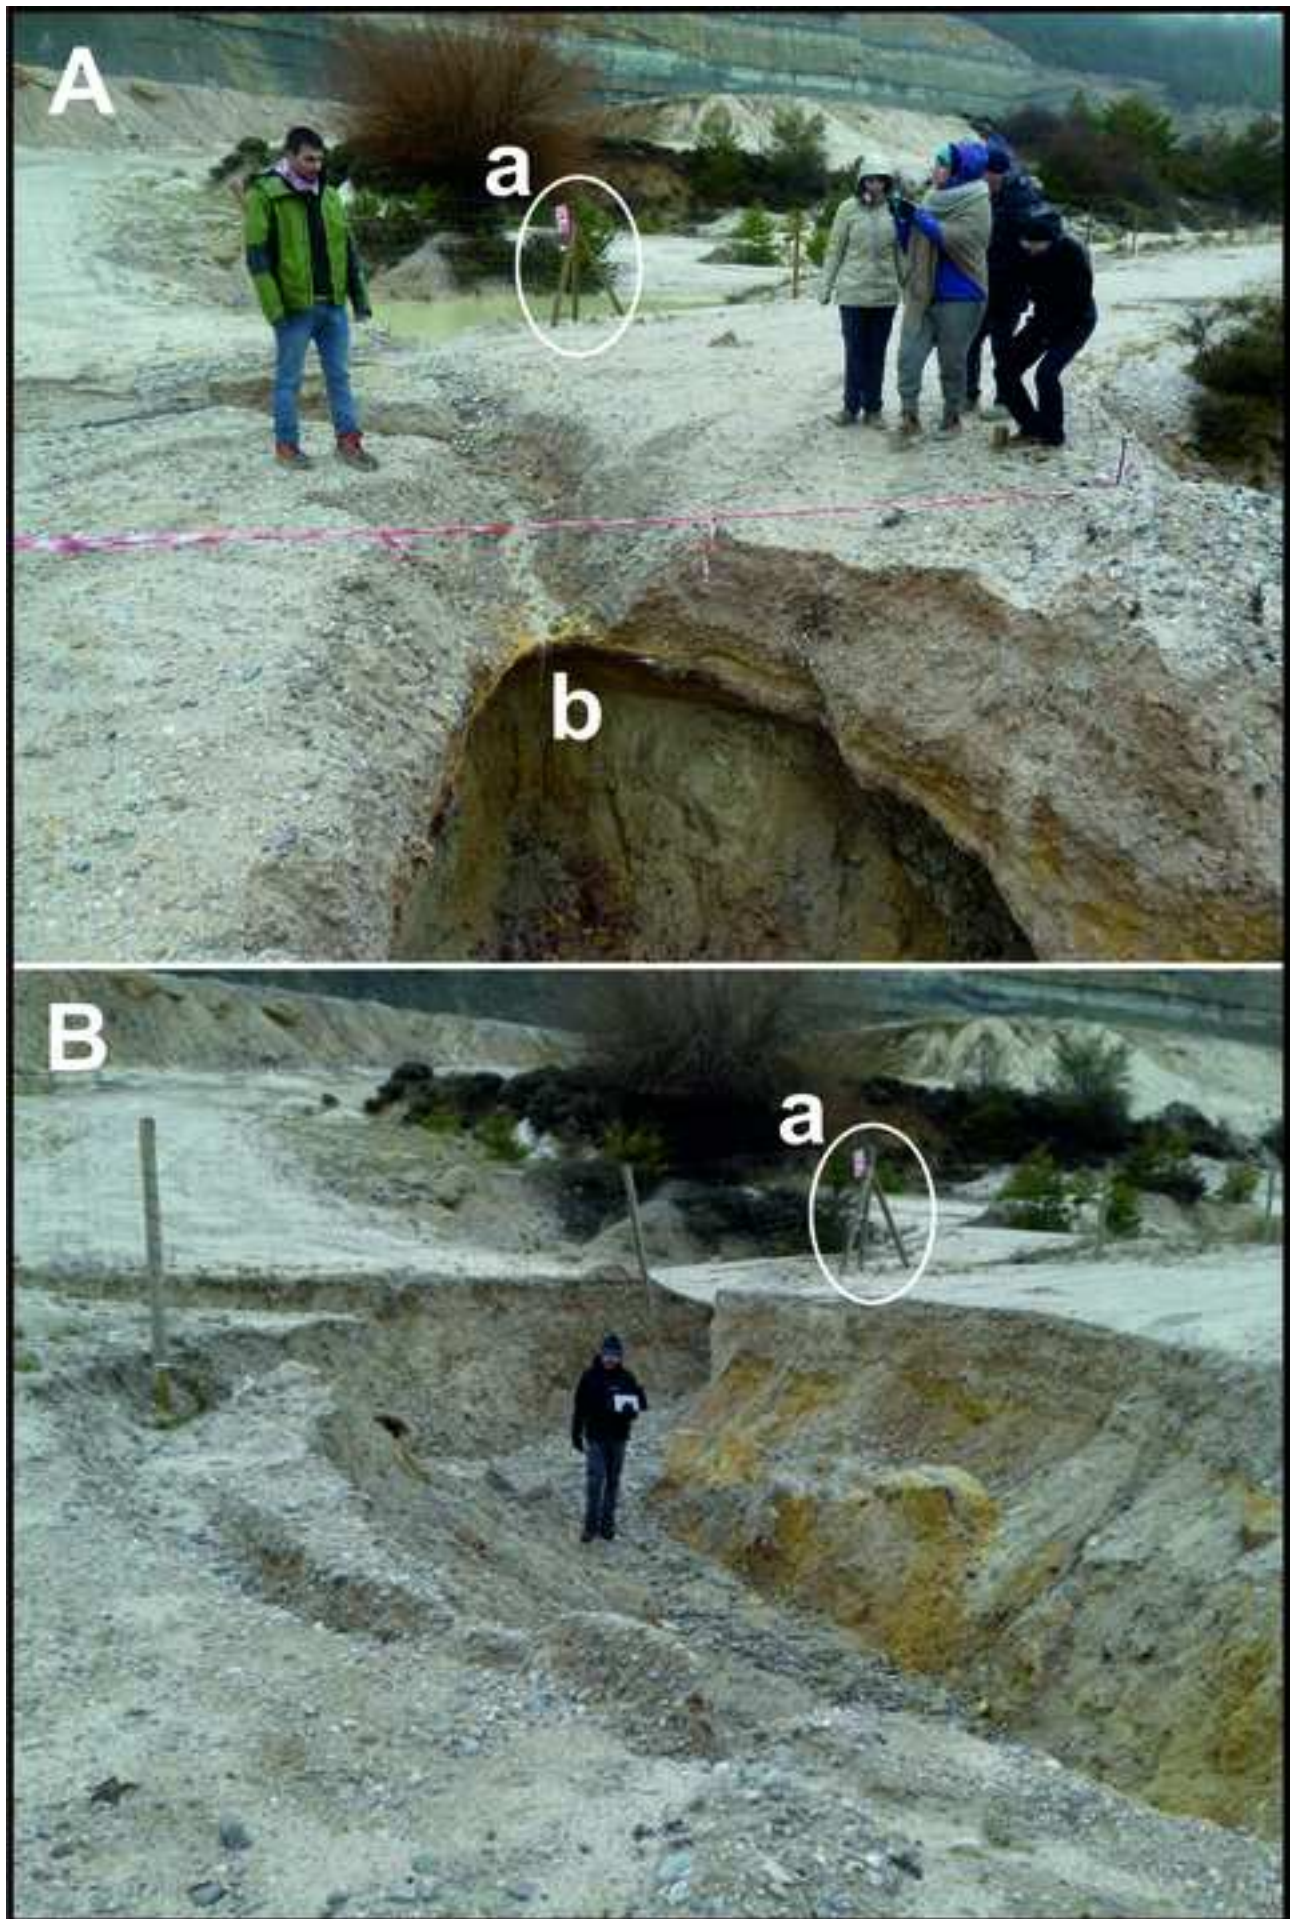
Figure 4

327
 328 Figure 4. Gully erosion cutting one of the roads in the Nuria mine. (A) knickpoint (b)
 329 migrating upstream (January 2016) and (B) erosion bisecting the road (February 2017).
 330 (a) the position of a wooden pole is used as reference. Modified from Hancock et al.
 331 (2020).

333 This gulying of the mine roadway was quantified by using the 2010-2018 LiDAR-ALS
 334 topographies (Fig. 5). The knickpoint advanced 25 m during 7.5 years having a 1.3 m
 335 average depth, maximum 2.5 m. This gully advanced an annual average rate of 3.3 m
 336 during the measurement period. This process can be clearly identified in the profiles of
 337 Fig. 6. Considerable (400 m³) sediment was eroded from the road, of which 300 m³ were
 338 deposited in a downstream ditch. The remaining sediment was transported downstream.

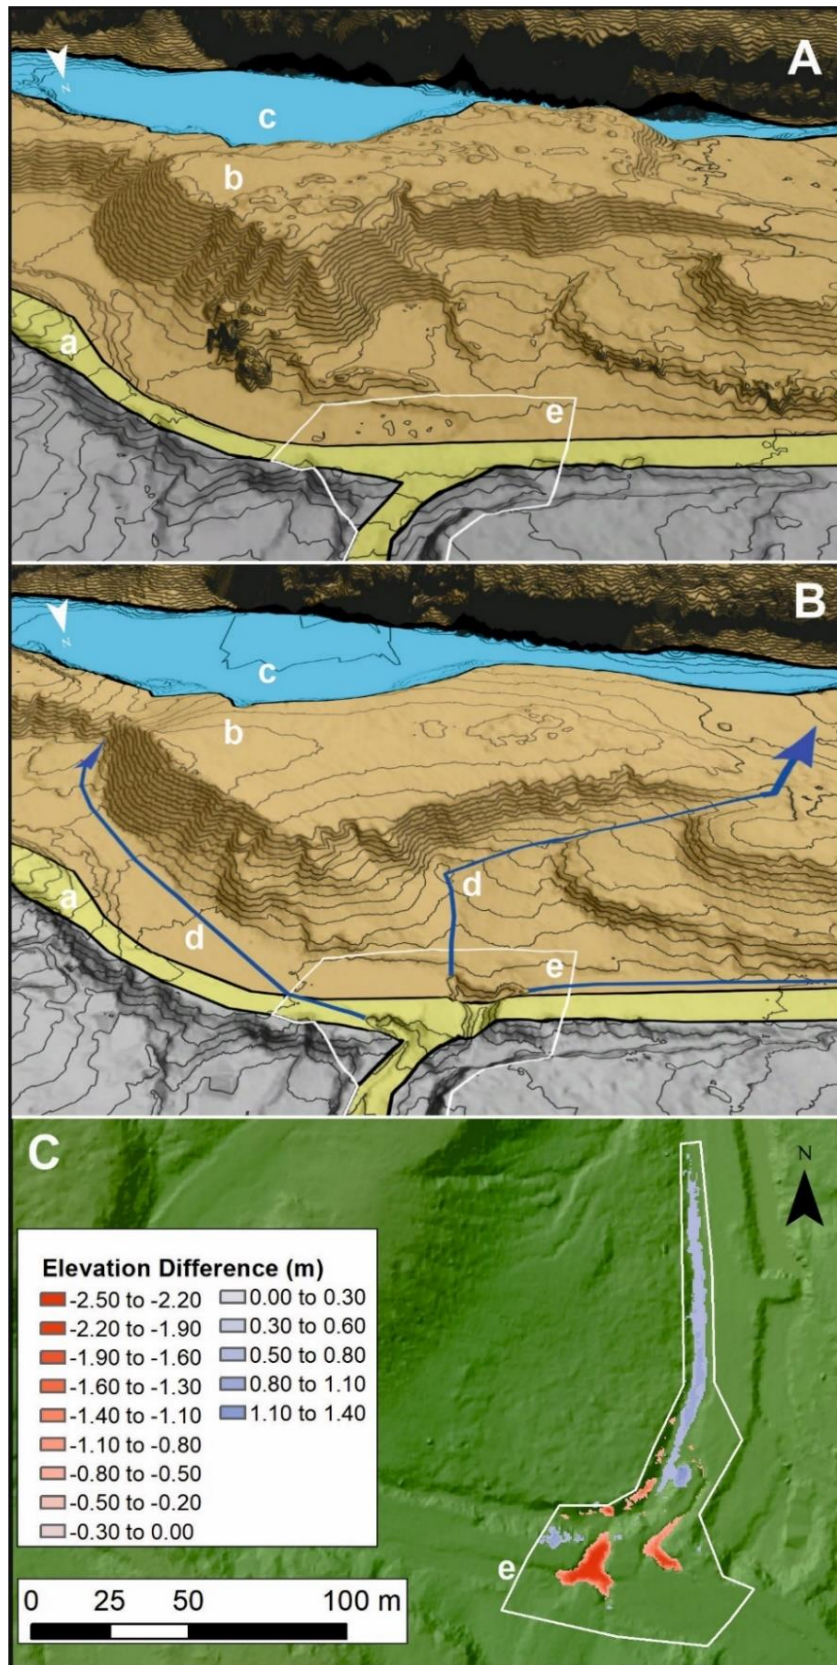
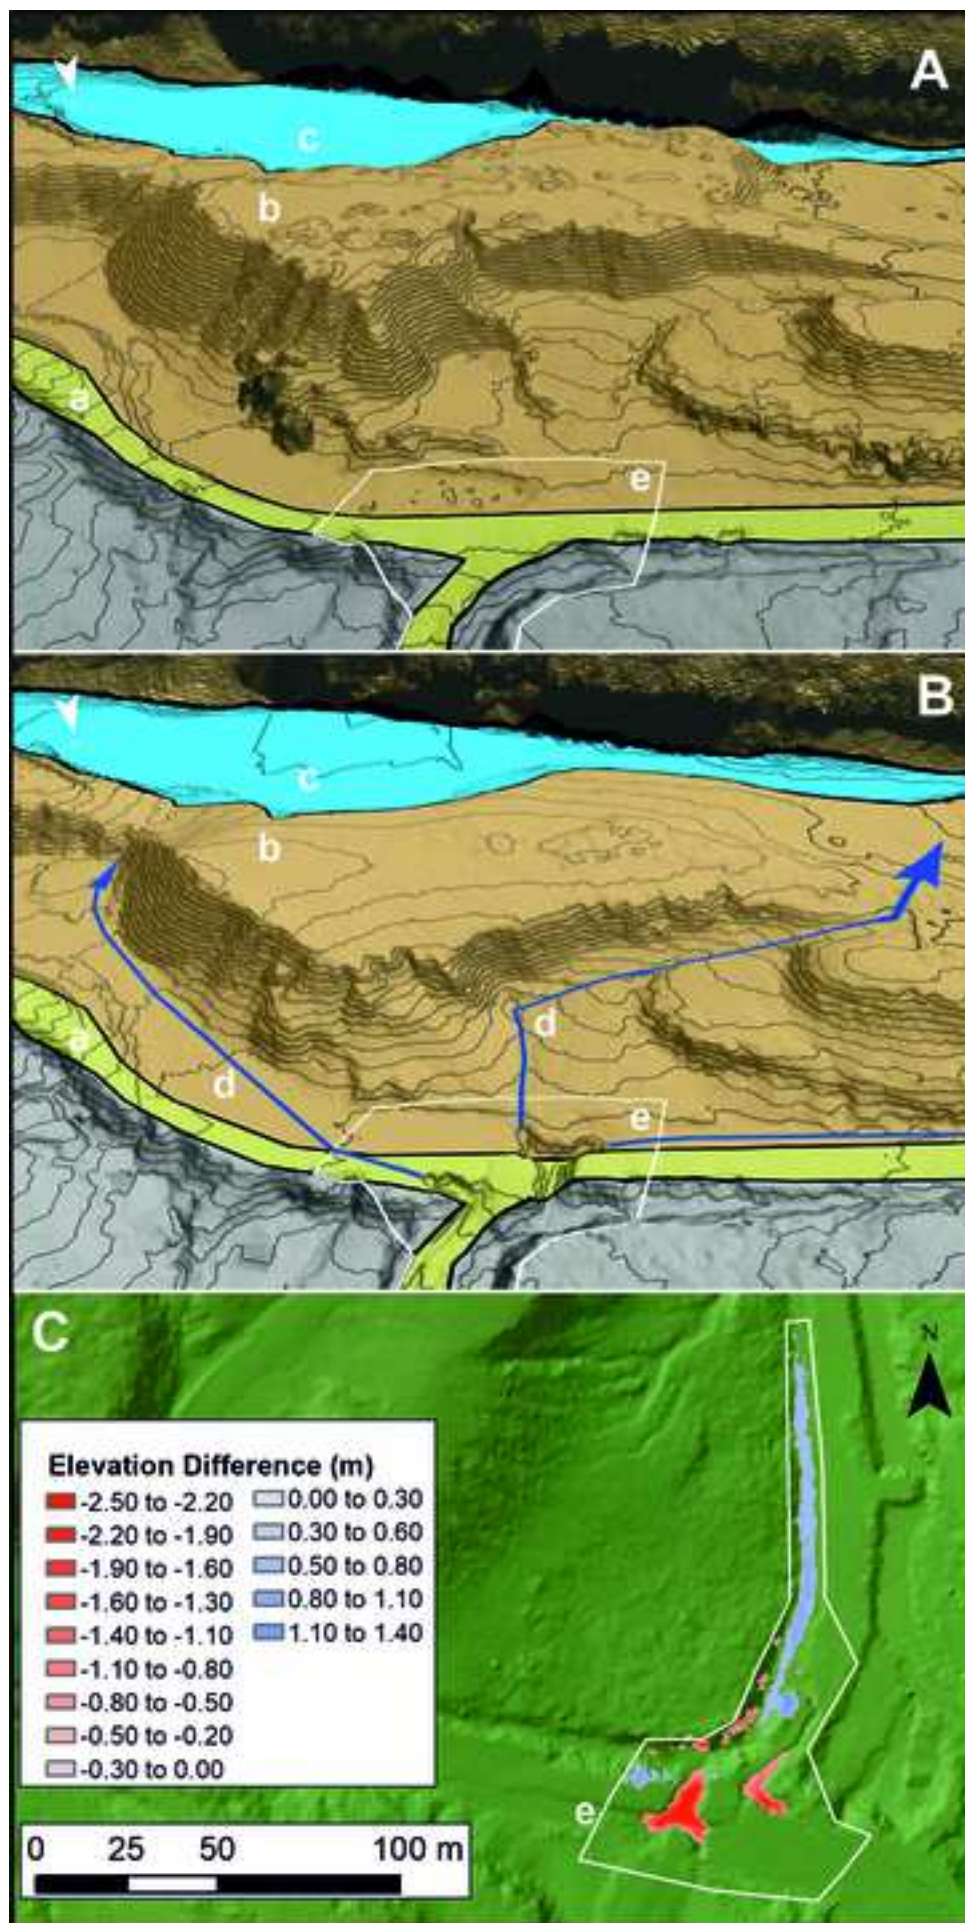
Figure 5

340 Figure 5. Topography before (A, 2010) and after (B, 2018) gully development. (C) DoD
 341 showing (a) unpaved road; (b) area between the ponds and the unpaved road; (c) pond;

342 (d) likely evolution of gully erosion; (e) polygon used to calculate the DoD in the gullied
343 area. The arrows in B show the direction of knickpoint migration.

349 To reassess the high erosive activity which took place between 2010 and 2018 (Fig. 5),
350 a new survey was conducted in 2020. The comparison between the 2020 and 2018
351 topographies shows that the left gully knickpoint (Fig. 5, B) advanced 53 m with a 0.8 m
352 average depth, resulting in a 26.5 m/yr average biannual advance. This gully activity
353 caused considerable (261 m³) erosion and deposition (64 m³), transporting 197 m³ of
354 sediment downstream.

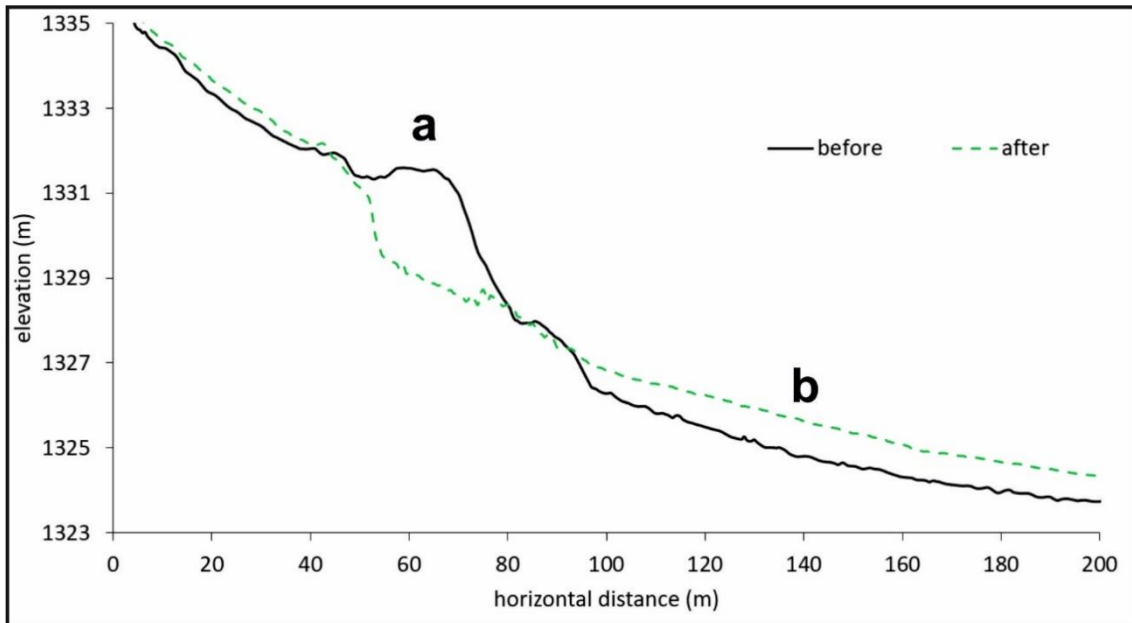
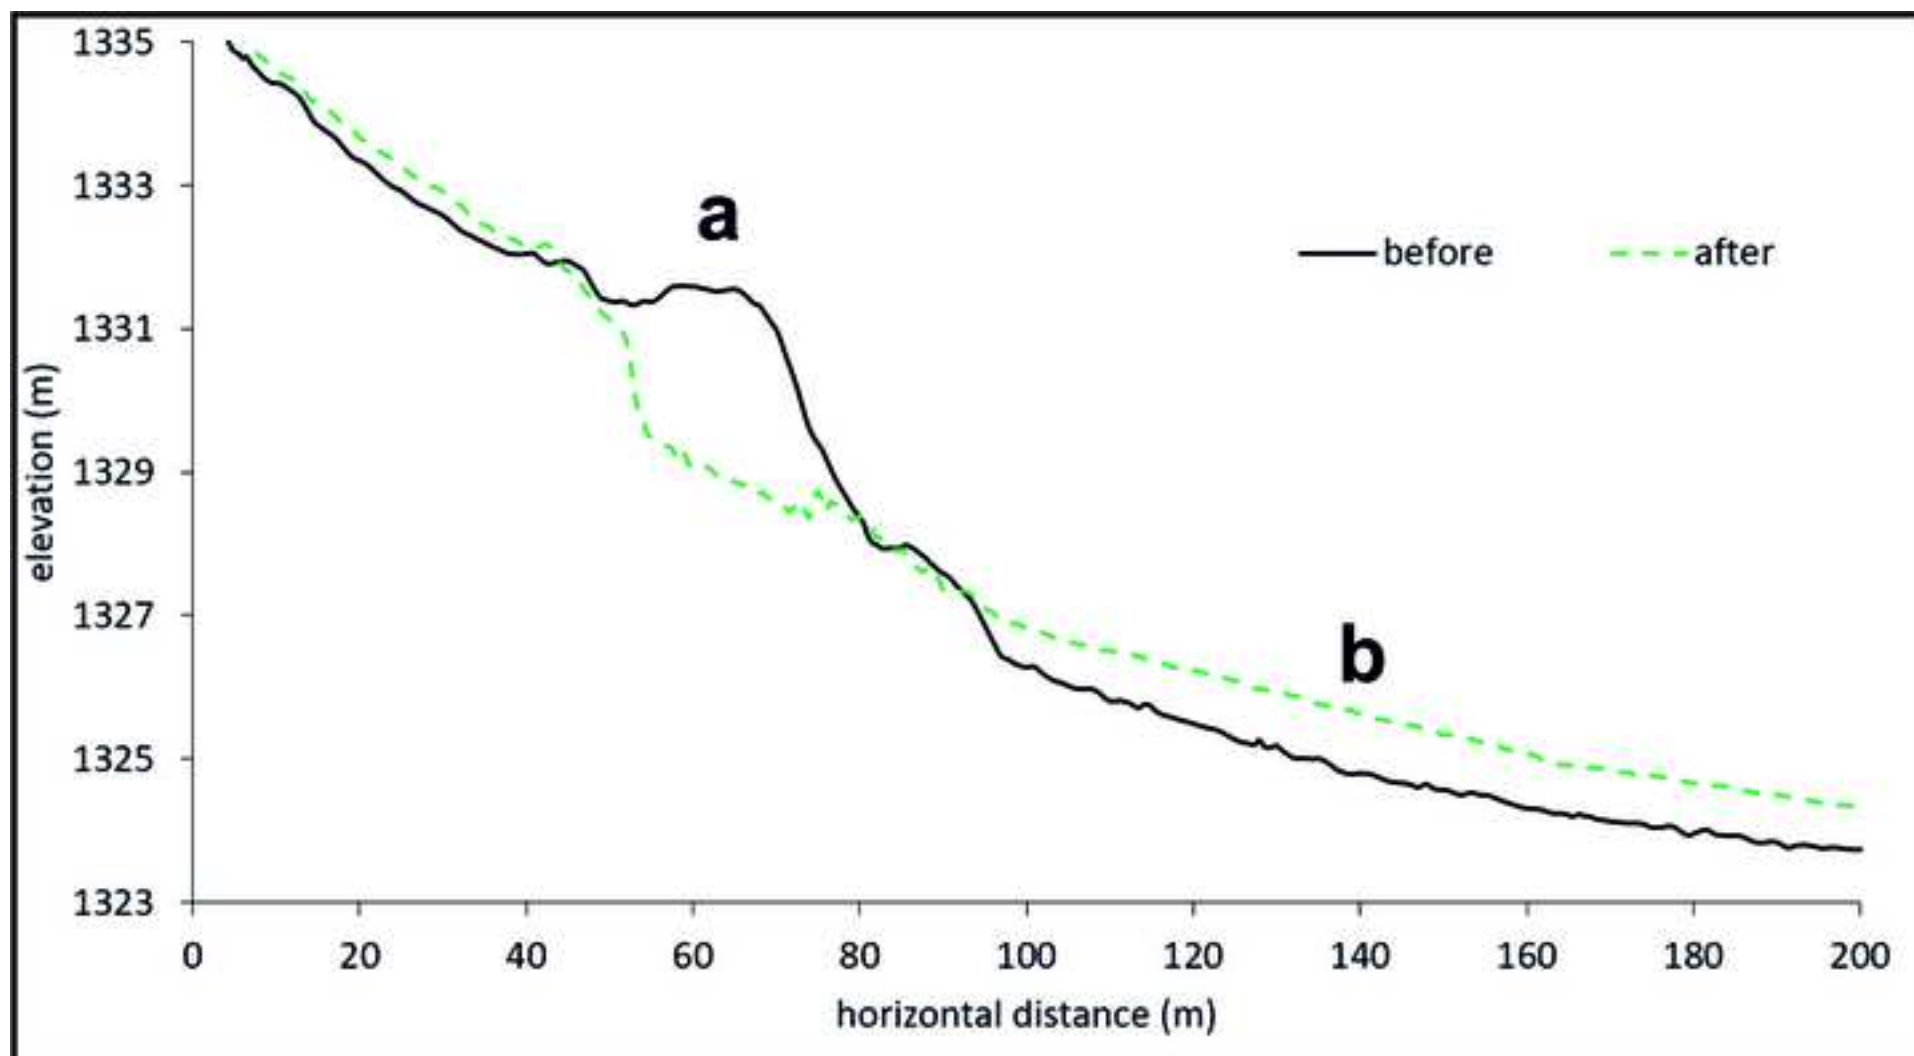
Figure 6

345
346 Figure 6. Profile of gully erosion (a) and deposition (b) in the unpaved road and ditch
347 (see Figure 4).

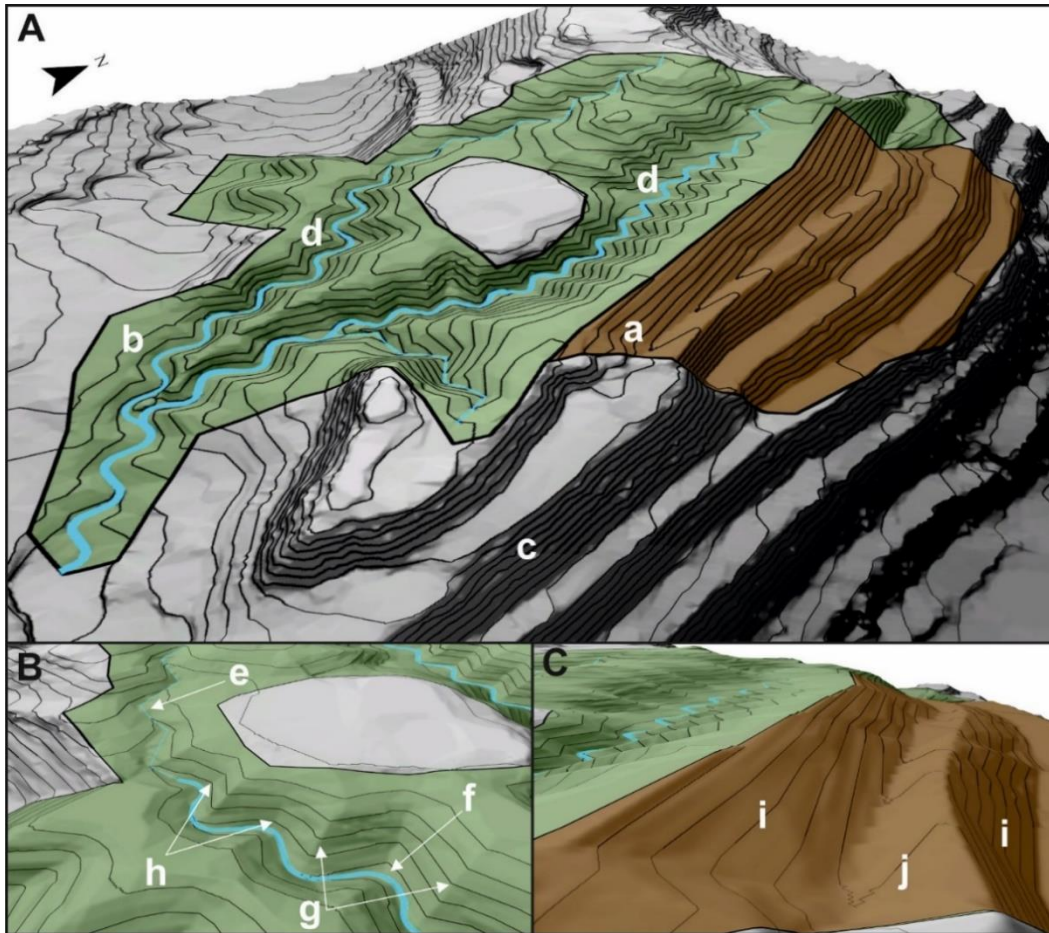
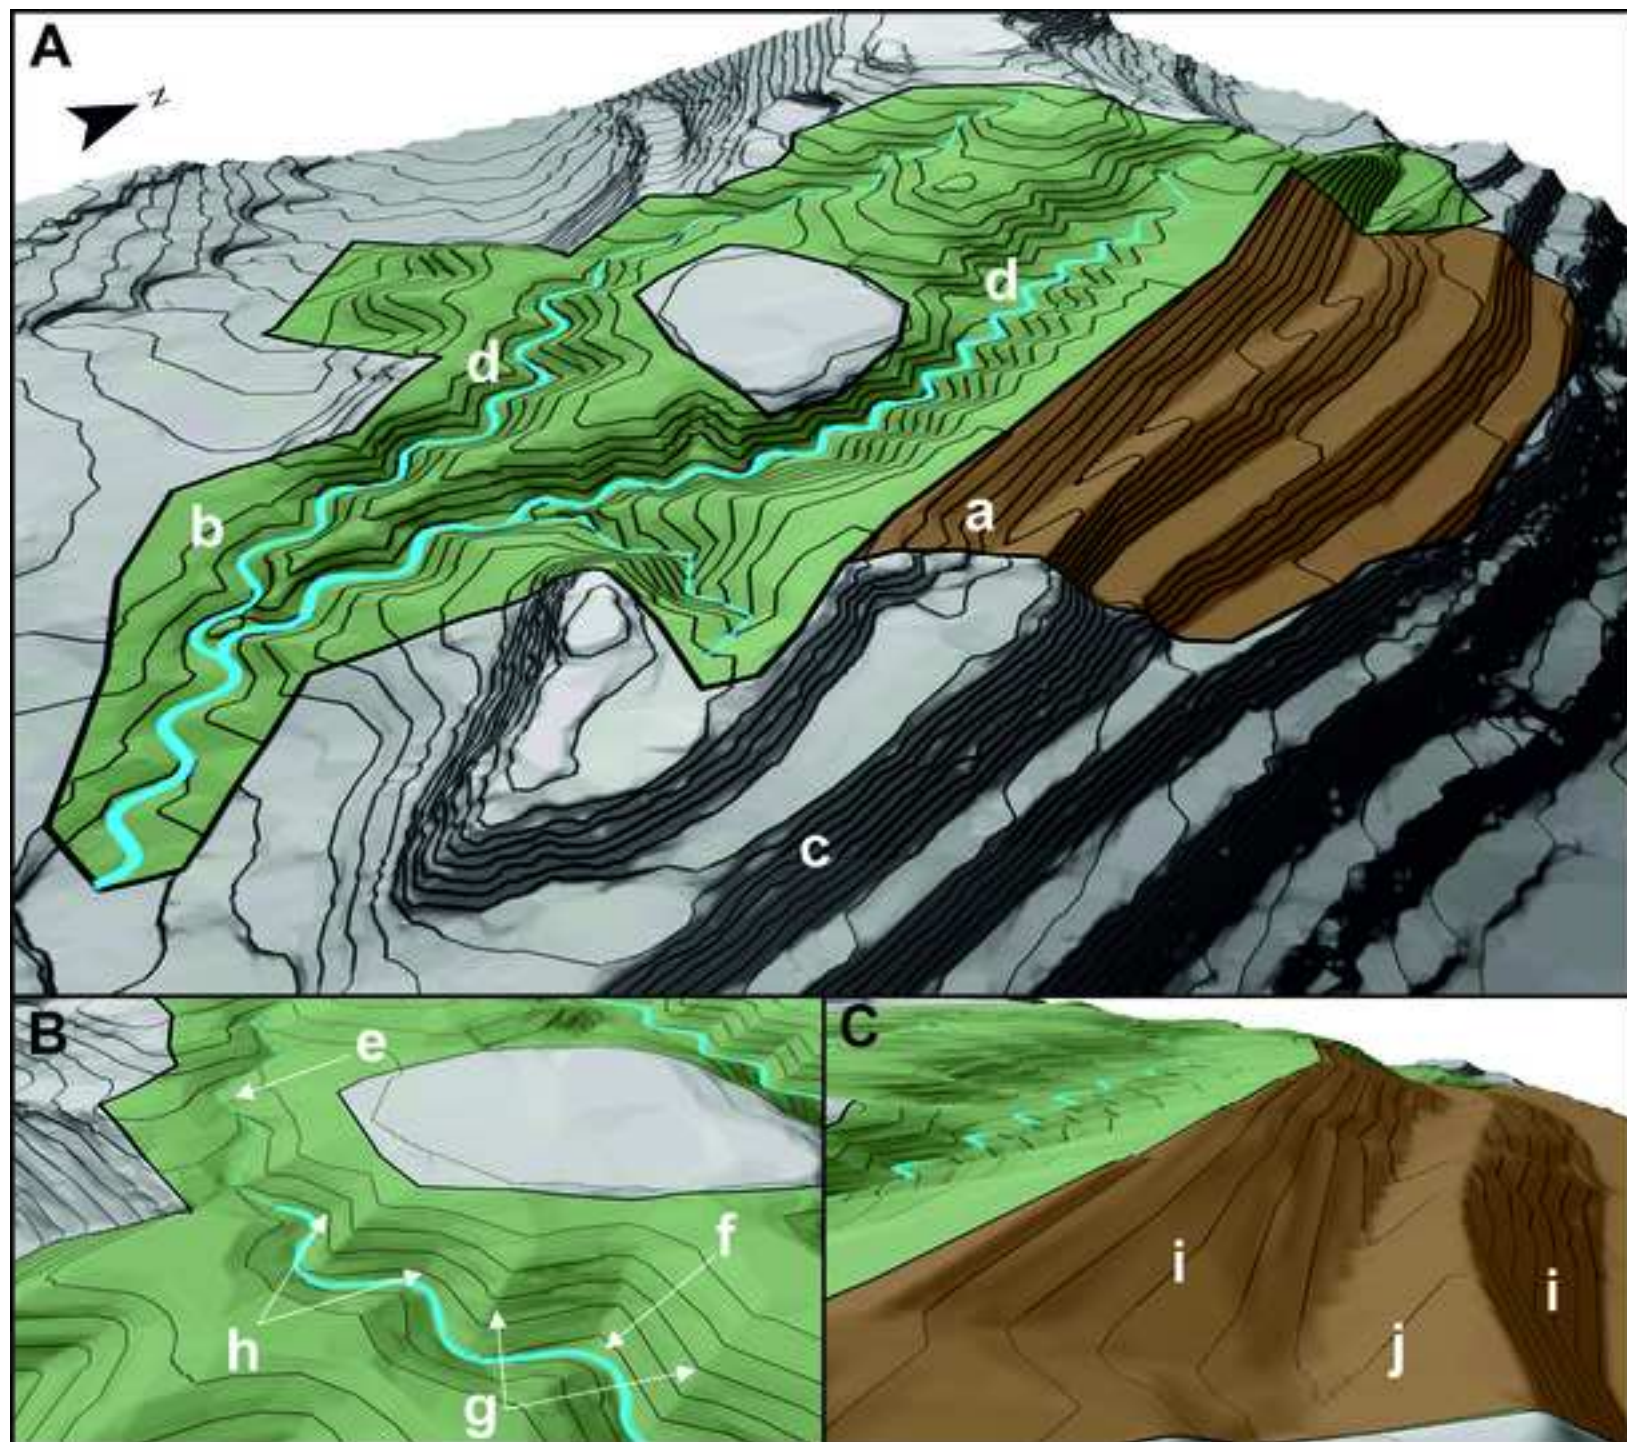
Figure 8

372 Figure 8. A series of 3D views of the geomorphic and terrace rehabilitation design for “a”
 373 waste dump in the Nuria mine: general (A) and details (B and C). (a) reclaimed area in
 374 terraces; (b) geomorphic rehabilitation; (c) original surrounding topography; (d) main
 375 channels with zig-zag (e) and meander (f) patterns; (g) convex-concave sub-ridges; (h)
 376 concave swales; (i) outslope; (j) berm with inverted gradient.

356 A detailed topography was surveyed using the SfM-UAV procedure (Fig. 7) to represent
357 the initial condition of the area. A geomorphic design was generated for the upper part
358 of the non-reclaimed area (Fig. 8) based on that topography and the parameters
359 measured in a local natural analogue. The channels have a zig-zag (slope > 4%) and
360 meander (slope < 4%) shapes; convex-concave hillslopes and concave swales were
361 added to the design. One channel is tributary to another, ending in a pond that operates

362 as base level. The channel slope varies (0 - 13 %); the entire reclaimed area has an
363 average 22% slope. The external terraces were also designed to be adapted to the
364 surrounding hillslopes (Fig. 7). The original terraces were very steep (50-60%), whereas
365 those designed are gentler (30-45%). Berm width varies in the range 7-13 m, having an
366 8% inverted gradient. This inverted gradient berm is a key issue for terrace preparation,
367 preventing water flowing from the next slope, thereby triggering rill and gully erosion.

377 The project area will be finalized by spreading a 1-m depth of carbonate colluvium and
 378 20 cm of topsoil. These thicknesses will be larger for the terraces, 2 m and 1 m
 379 respectively, owing to their higher gradient. The surface will be seeded with a mix of local
 380 herbaceous ground cover and shrubs. The rehabilitation started in the middle of 2018
 381 and currently the third terrace is almost finished. Once terrace construction ends, the
 382 final geomorphic design will be built with proper equipment (an excavator and a D6
 383 bulldozer). Altogether 190,000 m³ of waste material, 57,000 m³ of carbonate colluvium
 384 and 14,500 m³ of topsoil will be used in the rehabilitation.
