1 **Drainage network evolution and reconstruction in an open pit** 2 **kaolin mine at the edge of the Alto Tajo Natural Park**

26 **Abstract:** Landform instability of the abandoned Nuria kaolin mine, surrounding the Alto
27 Tajo Natural Park in Spain, has caused frequent and severe environmental impacts due
28 to deficient mining practices, environmental mismanagement and closure planning.
29 Geomorphic instability has caused widespread soil erosion and elevated sediment yields
30 with off-site effects. We quantified such land instability, the evolution of the resulting
31 drainage networks and catchments, and ensuing gully processes. High Resolution
32 Topography sources were compared with historic maps and photos. The current mine
33 rehabilitation practices are depicted based on a geomorphic approach that introduces a
34 sustainable drainage system designed to avoid detected risks. Our aim is reconstructing
35 fluvial channels and related hillslopes that mimic their natural counterparts adapted to a
36 rehabilitation of pre-existing gradient terraces. We demonstrate that: i) mining activity

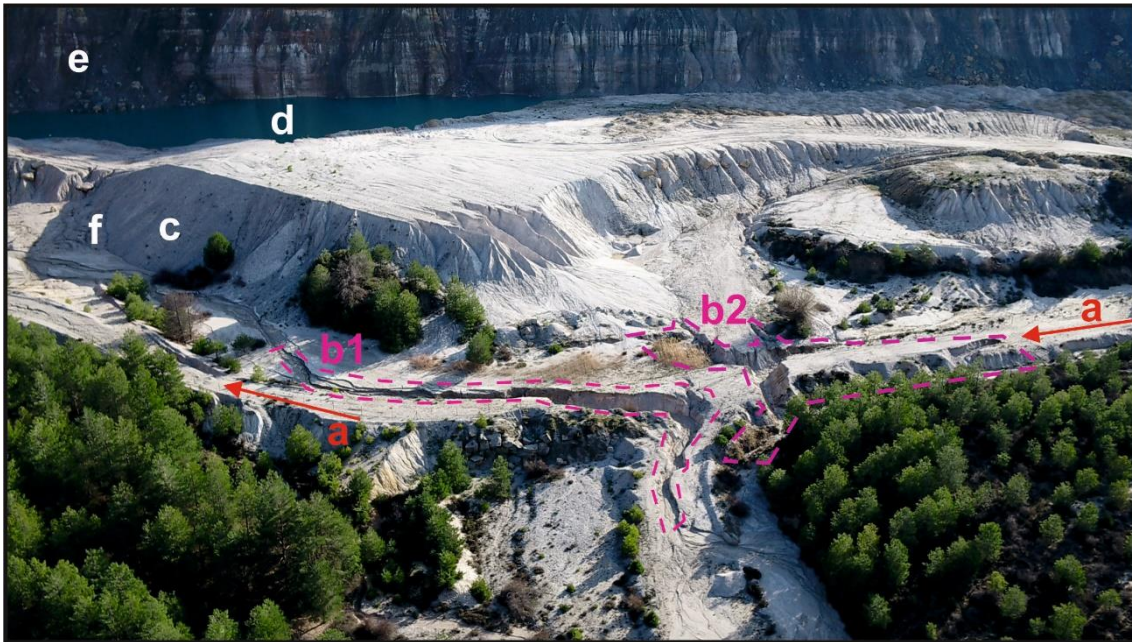
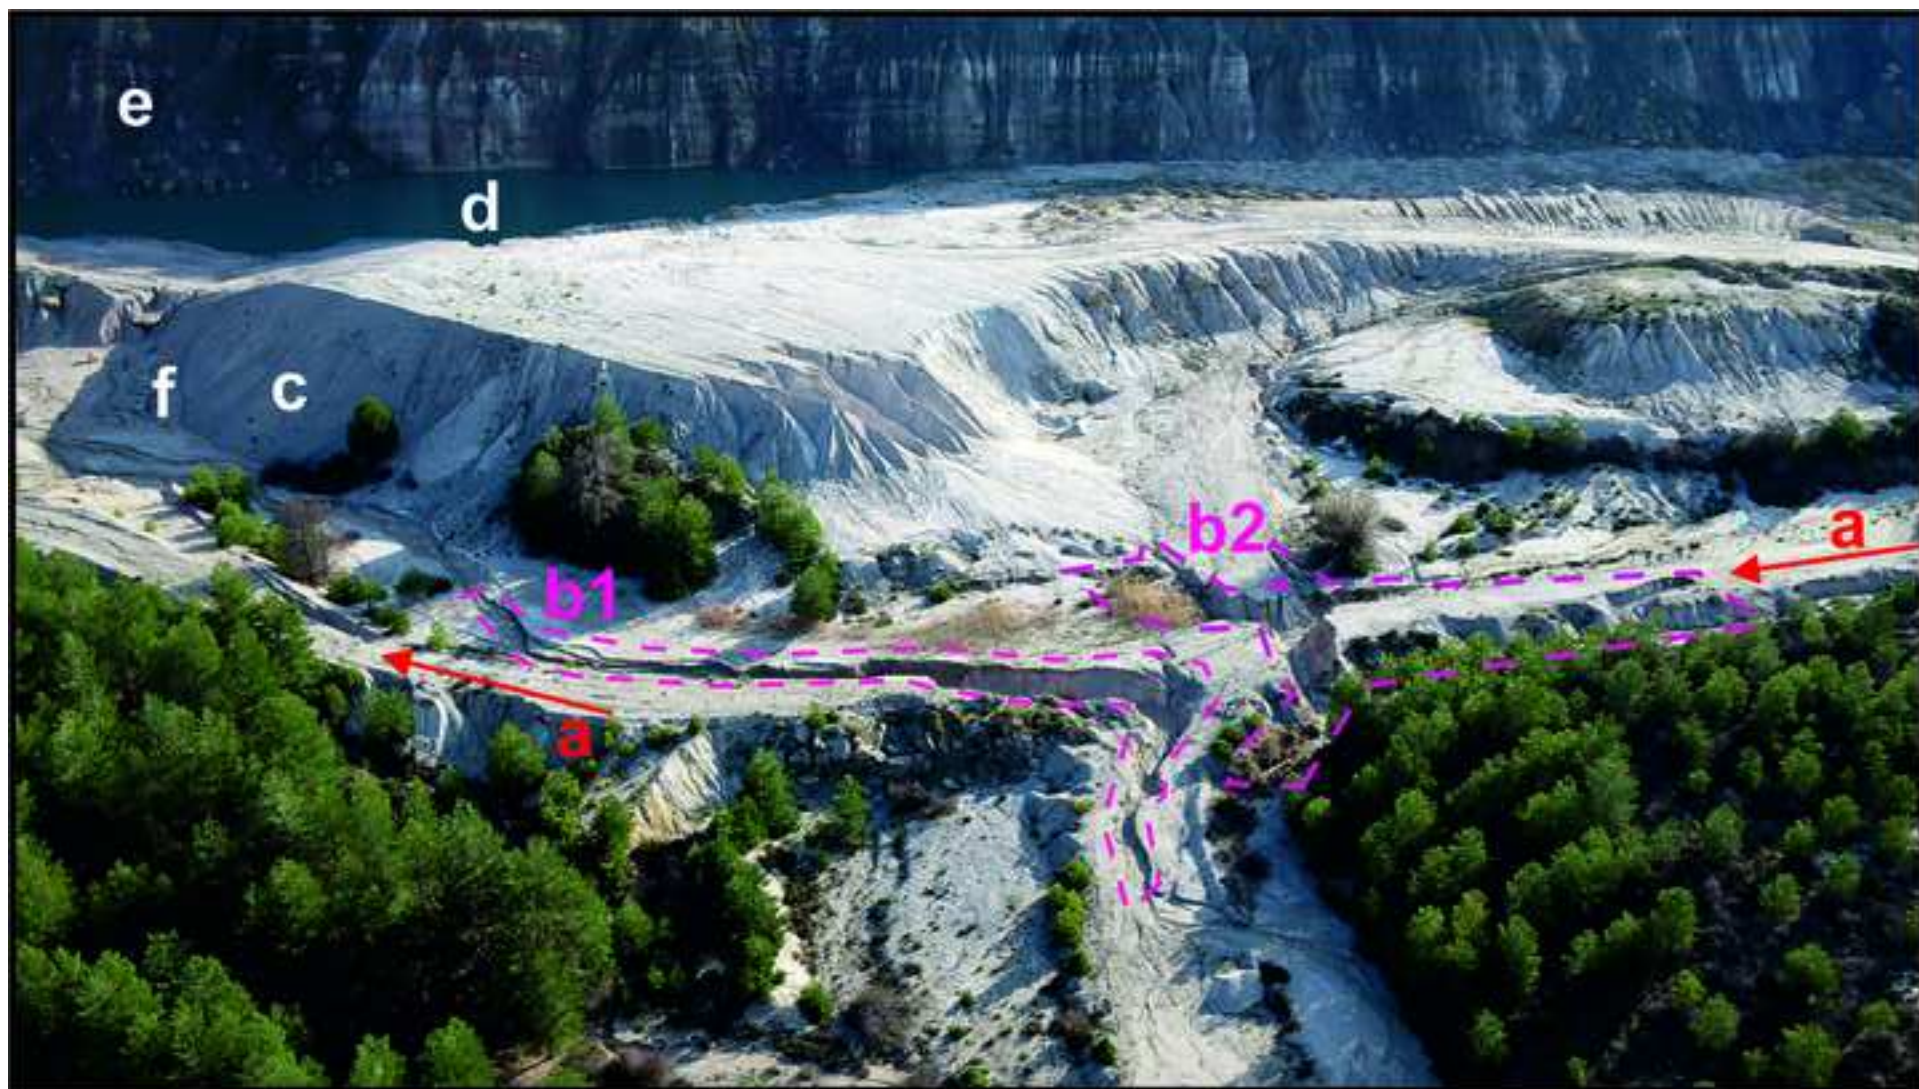
Figure 9

438
439 Figure 9. Oblique photo of the main active gully erosion in the Nuria mine threatening an
440 upstream pond (photographed on 26.03.2020). Road (a); left (b1) and right (b2)
441 headcutting gully erosion; earth —sand— dam (c) enclosing the pond (d); highwall (e);
442 weakest area in the earth —sand— dam (f). Photo by DGDRONE (2020).

443 This adverse gullying phenomenon is well-known (Collier et al., 1970) and occurs in the
444 absence of a proper drainage system. Fluvial erosion creates an intruding channel
445 network, leading to sediment yields that risk loading the natural fluvial system (Zapico et
446 al., 2017), and the destruction of sensitive structures such as roads or ponds. Additional
447 evidence of water reproducing natural fluvial processes in the mine is the main gully
448 profile becoming concave (Fig. 6). Gullies can also appear linked to other mining zones,
449 such as the edge of reclaimed filled valleys and downstream of retention cells, as is
450 typical of coal mines of central Appalachia (Reed and Kite, 2020). Our observations
451 demonstrate a rise in the number of gullies with increased drainage area. Gully
452 appearance due to drainage network removal is not exclusive to the mining industry, as
453 it also occurs due to other anthropogenic activities such as urbanization (de Albuquerque

494 The risks of the Nuria mine arose from the lack of a proper closure plan. The terraced
495 waste dumps occupying half of the mine have been or are being stabilized and restored.
496 However, the rest of the mine (“ α ” in Fig. 1) is experiencing severe erosion by an
497 unstable, interim drainage network, thereby threatening the long-term stability of the
498 mine. Not only is it increasing drainage density, but it is also shaping channels with
499 predominately concave profiles that can affect roads and ponds in the Nuria mine. If
500 erosion reaches a pond, a flash flood may be generated, moving to the two downstream
501 waste dumps, thereby potentially creating a catastrophic massive earth movement.
502 Hence, urgent measures are required to restore the “ α ” zone.
