Effect of conservation treatments on heritage stone. Characterisation of decay processes in a case study.

Preliminary studies are an imperative when determining the impact of conservation treatments on historical materials. The Romanesque apse on a church at Talamanca de Jarama, Madrid, Spain, whose dolostone was severely decayed by rainwater and salts, was treated in the past with substances that ravaged the restored area. Petrological techniques showed that salts leached out of the cement under the roof onto the stone cornice whose surface had been coated with synthetic resins. During evaporation, the salts precipitated in the stone and underneath the resin, inducing blistering, fissuring, flaking, scaling and detachment of part of the restored decorative elements.

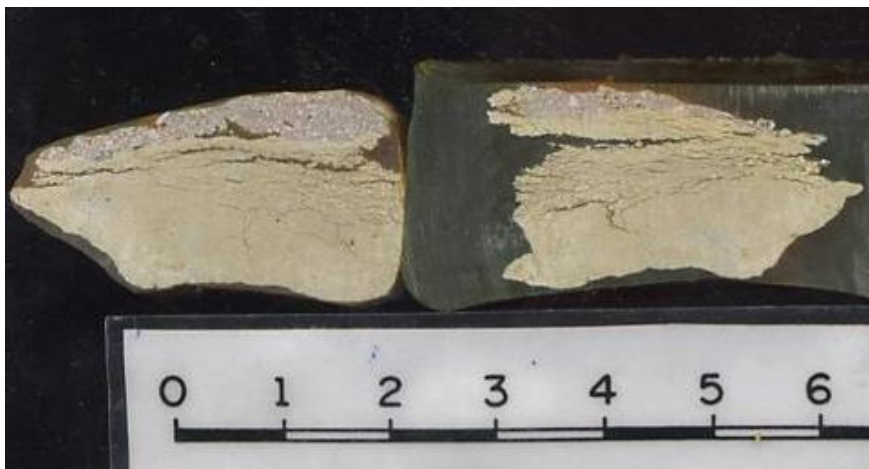
Fig. 5

346 acrylic resins) restoration mortar, scaling and surface detachment prevailed. Such types of decay
347 affected the restoration mortar, the gypsum layer and even part of the cracked dolostone, with the
348 total or partial loss of the restored ornament (Fig. 5).

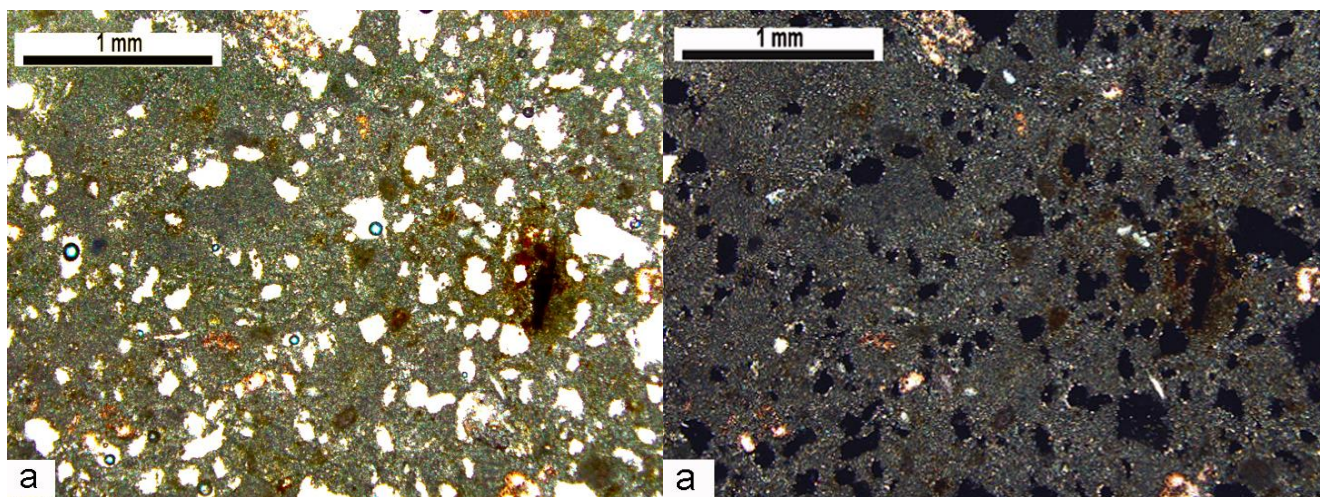
Fig. 6

217 A- The cornice has a 1 to 8-mm thick grey mortar rendering containing white particles that adapts
218 to the surface irregularities in the intensely cracked stone substrate (Fig. 6). This mortar bonded
219 apparently well to the stone, although not uniformly, for the non-filled millimetric pores found in
220 some areas may have facilitated detachment (Figs 6 and 8).

The main type of decay found in the *Piedra de Redueña* [2] dolostone forming the carved cornice on the Romanesque apse was intense inner cracking parallel to the surface, at depths of up to 1.5 cm (Figs 6 and 8). On the surface, this cracking translated into flaking and scaling liable to detachment.

526 Fig. 6. Cross-section of scale removed from cornice, showing three zones: upper grey layer with
527 white particles and varying depth (restoration mortar), middle layer where the stone substrate
528 exhibits cracks parallel to the surface and a few white spots, and lower layer where the yellow
529 substrate is compact

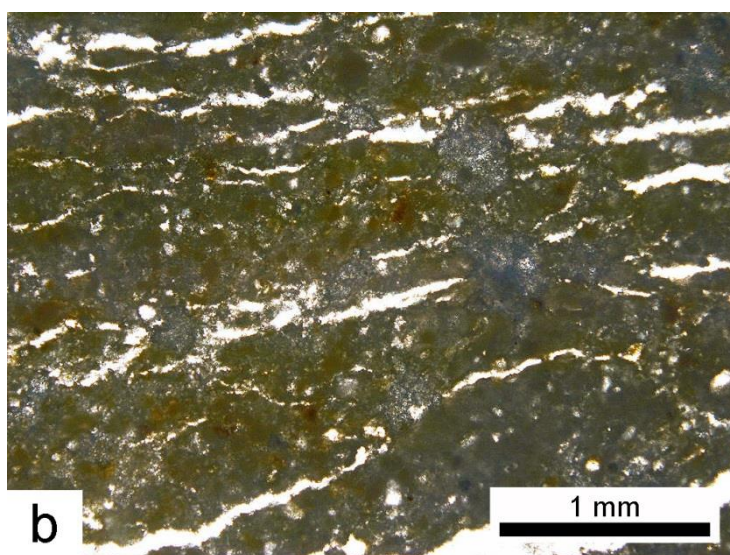
Fig. 7a

The PM study revealed that this massive dolostone is characterised by rhomboid micritic dolomite crystals measuring <10 µm on average and 20-25-% intercrystalline porosity (Figs 7a and 7b).

The intense cracking on the sample surfaces increased in the outward direction (Fig. 7b). These cracks, parallel and sub-parallel to one another and to the outer surface of the sample, were 75 µm thick on average and over 250 µm thick in the outer-most areas.

530 Fig. 7. PM images of yellow dolostone on the upper part of the apse: a) no decay but substantial
531 original porosity (left: parallel nicols; right: crossed nicols); and b) cracks and nodules indicative of
532 decay (parallel nicols)

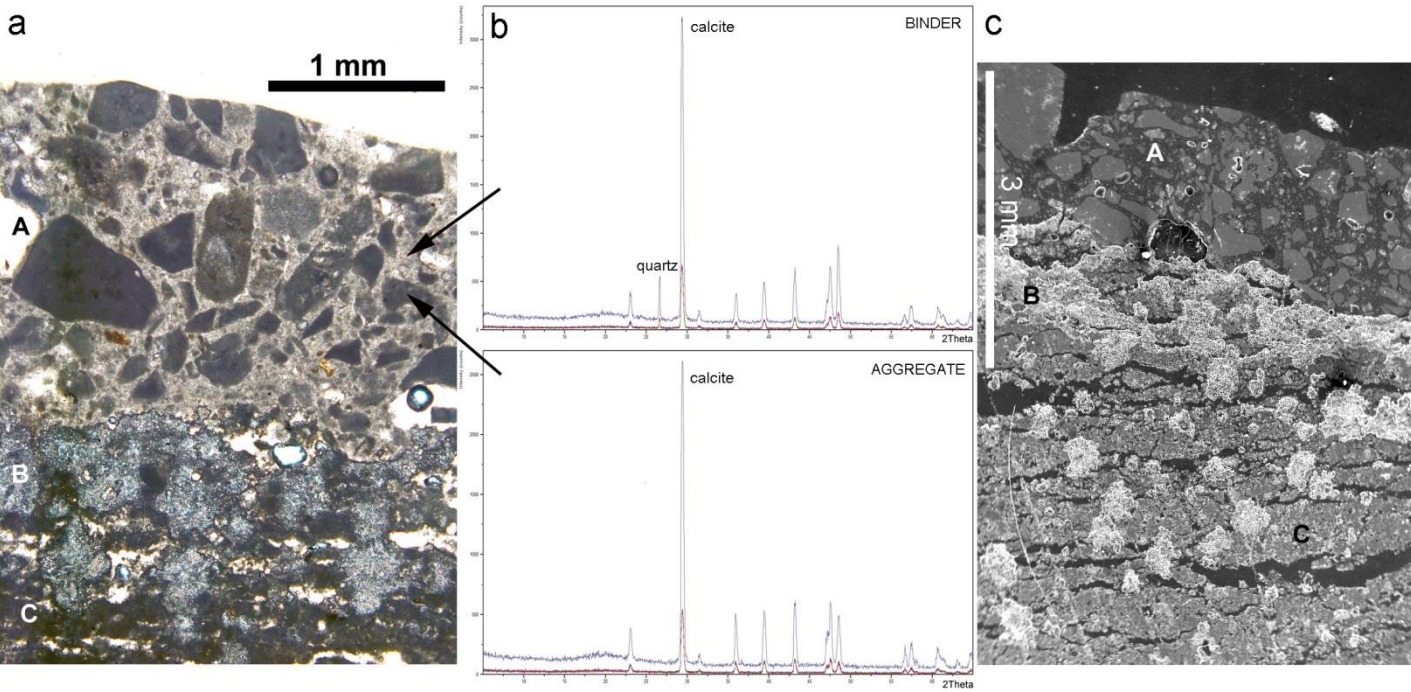
Fig. 8

During saline solution migration toward the stone surface, the salts precipitated, clustering under the surface treatments (restoration mortar or surface film) that they were unable to permeate (Figs 8, 13, 14a and 15). As a result, a layer of gypsum of varying thickness appeared between the surface treatments and the cracked-consolidated stone, especially where the bond between them was weak. The continuous crystallisation-induced stress of salts destabilised the restored ornament. These sub-efflorescent clusters underneath the coating film (acrylic resin) caused swelling, fissuring, flaking and detachment in both layers. When saline sub-efflorescence was located under the (epoxy and

535 Fig. 8. Scaling on cornice: a) PM image with parallel nicols; b) μ XRD diffractogram showing the
536 mineralogy of the two components of the restoration mortar; c) SEM-SE image of a thin section: A
537 - restoration mortar, B – gypsum layer, C - cracked stone substrate with gypsum nodules

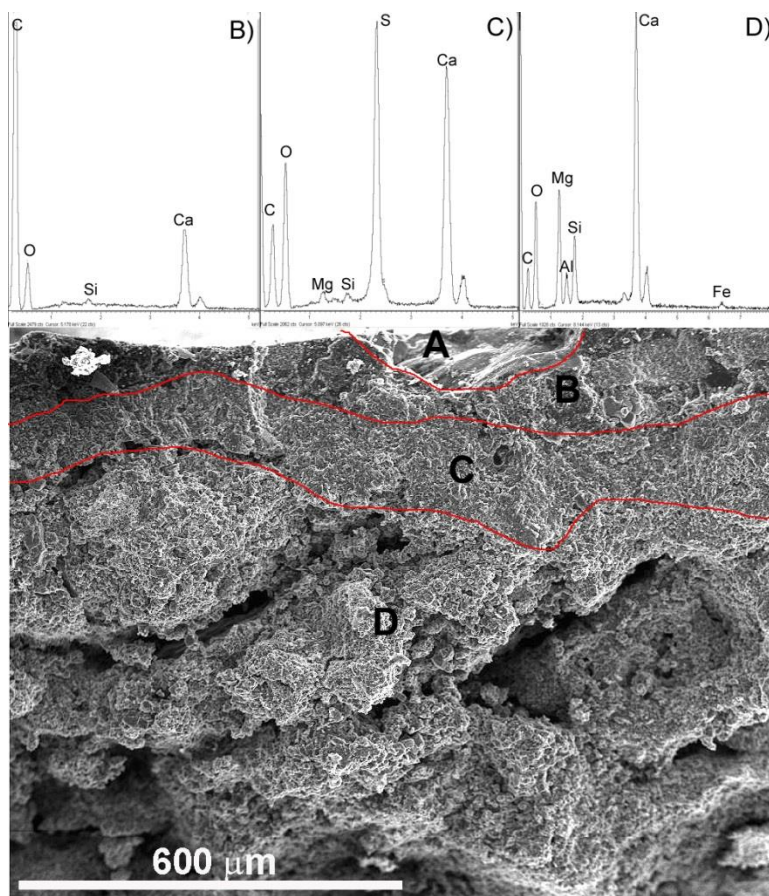
Fig. 13

C - In the cracked stone substrate (areas C in Fig. 8 and D in Fig. 13), the Ca-, Mg- and Fe-bearing dolomite crystals and the inter-crystalline and fracture porosity were covered with a thin film only detectable under SEM. Its main (EDS-analysed) chemical composition included Si and Al, while C was scanty present. PM observation (Figs 7 and 8) revealed the presence of this treatment indirectly, for the fracture porosity was not filled with the salts detected.

546 Fig. 13. SEM-SE image and EDS point chemical composition of a scaling fragment, showing: A -
547 surface treatment, B - restoration mortar, C - gypsum layer and D - cracked stone substrate
548 Fig. 14. PM (parallel nicols) images of: a) gypsum nodules inside the cracked dolostone; and b)
549 capillary connections.
550 Fig. 15. Mechanism governing post-1990 intervention decay in cornice and modillions: 1 - acrylic
551 surface treatment; 2 - synthetic restoration mortar; 3 - gypsum layer; 4 - cracked dolostone with
552 gypsum nodules; A - rainwater leakage; B - surface runoff.
