EFFECT OF MANUFACTURING METHODS ON THE DECAY OF CERAMIC MATERIALS: A CASE STUDY OF BRICKS IN MODERN ARCHITECTURE OF MADRID (SPAIN)

Elena Mercedes Perez-Monserrat^{a*}, Fernando Agua^b, Rafael Fort^a, Monica Alvarez de Buergo^a, Juan Felix Conde^b, Manuel Garcia-Heras^b

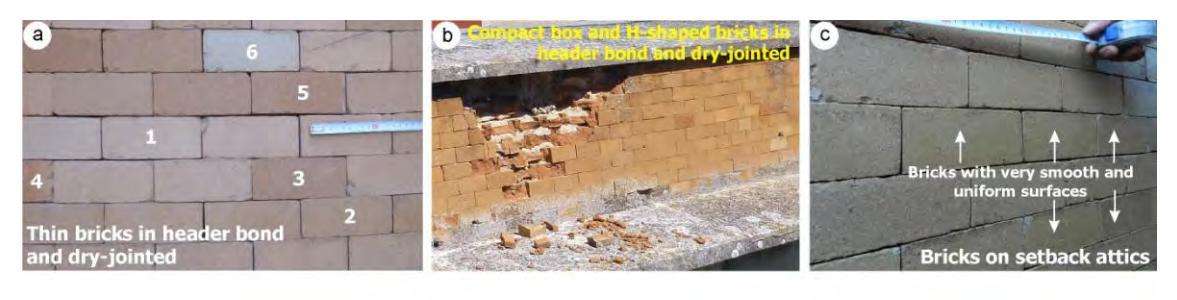
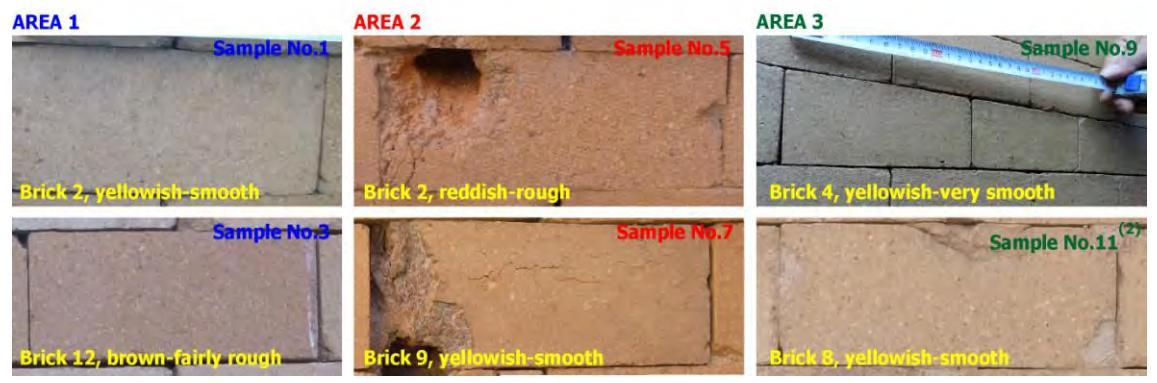
Figure 5. Brick bonds and appereance (colour and texture).

The bricks were found to exhibit two main hues, yellowish and brown, although the former predominated (Figure 5a). Examination showed that most of the yellow bricks had a smooth and uniform surface (1 in Figure 5a), although a few exhibited a rougher and less uniform surface, a darker colour and a profusion of aggregate inclusions (2 in Figure 5a). The brown bricks, distributed randomly on the façades, had rough surfaces in general as well as a profusion of aggregates (3 in Figure 5a). Many smooth yellowish bricks in particular but others also, were observed to have a reddish hue, although not across the entire exposed face (5 in Figure 5a). This gradient toward reddish hues was found in some of the rough brown bricks as well, although there the change in colour was less perceptible. An occasional smooth textured off-white or pale grey brick was also observed (6 in Figure 5a).

a) thin bricks in main body façade enclosures: (1) yellowish and smooth surfaces; (2) dark yellow and rough; (3) dark brown; (4) yellowish, partly reddish, smooth; (5) off-white or light grey and smooth surface.

b) brickwork on upper attic parapet: joint mortar pointing on the inside as well as the lower cantilevered cornice and the non-cantilevered capping can be shown.

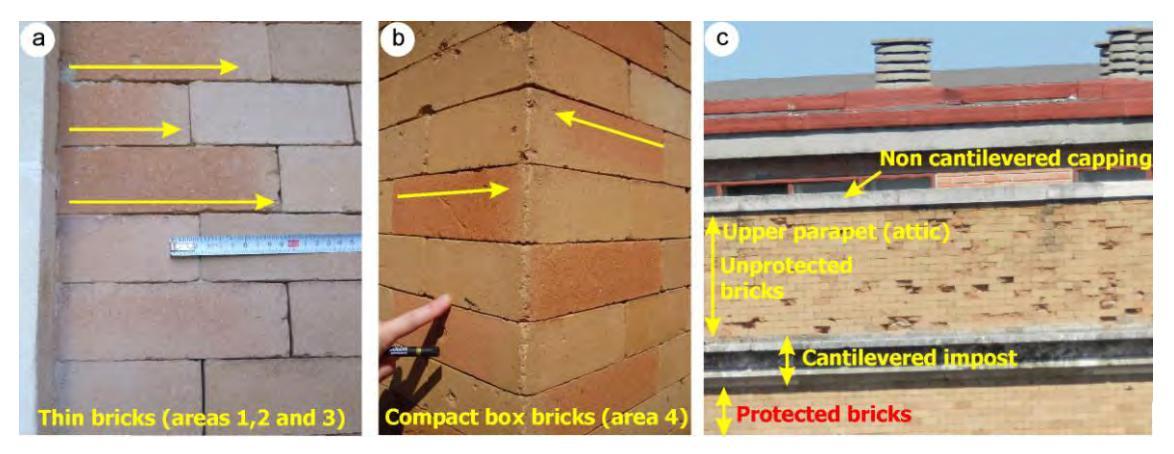
Figure 6. Main forms of decay observed in façade bricks.

Although most of the bricks were observed to exhibit a yellowish hue and uniform texture on the exposed face, two forms of generalised decay were also found in many. The first, surface colour change, particularly in units located at plane intersections or at the interface with the stone around openings (especially on stretchers), consists in a turn from yellowish to reddish hues (many fewer brown bricks had turned reddish) and was attendant upon a gradual change from a smooth, uniform surface to a rough uneven surface with aggregate inclusions (Figure 6a).

In the setback attic, the very smooth, uniform and yellowish bricks underneath the parapet, especially the ones in the lower courses, exhibited barely any colour or textural change (Figure 5c). The exception was the alternating stretchers at the corners (Figure 6b).

Many of the units on the parapet over the setback attics were found to exhibit surface roughness and cracks, often with scaling. In addition to the concomitant loss of material, this situation constituted a hazard due to possible fragment detachments. This decay was directly related to brick exposure to rainwater at this high elevation, for the scantly cantilevered capping and the absence of a dripstone (Figure 2b) leave the material essentially unprotected (Figure 6c). Fragment loss had also led to some degree of colour variation in this area of the setback attics, where the exposed bricks were darker and characterised by crumbling and powdering.

a) gradual colour change and increasing roughness in bricks that interface with the stone framing on openings.

On the grounds of the in-situ observations and measurements, the moisture concentrating at the interface between the bricks and the stone frames around openings and its diffusion across the entire brick can be said to induce the colour change in the exposed face, with the original yellowish hue gradually giving way to a reddish tone (Figure 6a). Attendant upon this process is a gradual rise in roughness, for as the smooth, uniform surface recedes, it exposes the inner body of the brick, which is not only reddish but contains numerous aggregate inclusions and therefore an uneven texture. Therefore, the yellower and consequently smoother surface bricks were less decayed. At plane intersections, either between the panels and the openings lacking stone moulding (area 3, setback attic) or at corners, brick decay was attributable to the same process, although in these areas moisture diffuses primarily from the joint with the adjacent bricks (Figure 6b).

The parapet crowning the façades is in need of repair, following on a visual inspection of the surfaces of all the bricks to stabilise any at risk of detachment. Where detachment is deemed to be most significant, the inner parapet brickwork should be inspected to determine the possible existence of construction factors that may be favouring the concentration of moisture.

If new bricks are manufactured to replace material in the upper parapet, the existing surfaces should first be cleaned and repaired and the new bricks fired at temperatures of over 900°C. The new units should exhibit a yellowish hue similar to the colour of most of the bricks in this area to minimise possible façade colour changes. To that end, colour coordinate a* values should range from 10 to 12.5 and b* values from 22 to 28. Similarly, the L* value should lie between 57 and 63 and the C* value between 24 and 30.

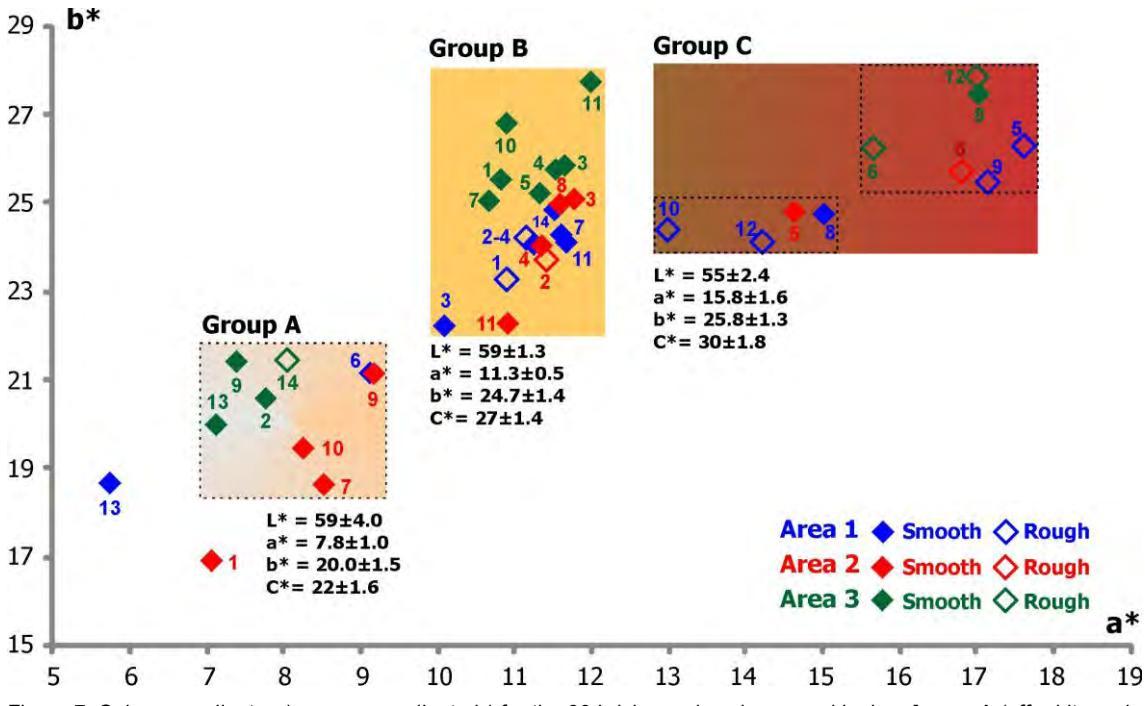
The mean a^{*} values are plotted against the mean b^{*} values for each brick and the data points are clustered by group A, B or C in Figure 7. Generally speaking, nearly half of the bricks were observed to lie in group B (yellowish) and the bricks in the setback attic (area 3) exhibited higher b^{*} values and a narrower scatter. Group A varied more widely in hue, with off-white to light grey tones, and two bricks were excluded. The a^{*} values (approximately 10-12) ranged more narrowly than the b^{*} values (22-28) in the group B (yellowish) bricks. The group C units exhibited substantial a^{*} value variation, leading to a subdivision into $12 < a^* < 15 // 10$

25<b*<28 (brown hues) and 15<a*<17 // 25<b*<28 (reddish hues, which further to the in-situ observations were found in originally yellowish bricks). Group C (brown and reddish) had more rough than smooth surface bricks, especially in the units with higher a* values, i.e., bricks with a more reddish hue.

Figure 7 also displays the mean L*, a*, b* and C* values and standard deviations for each group of bricks. Lightness (L*) was greatest and saturation (C*) lowest in the group A bricks (hence their lighter hue) and vice-versa in the group C bricks. The group B bricks followed an intermediate pattern.

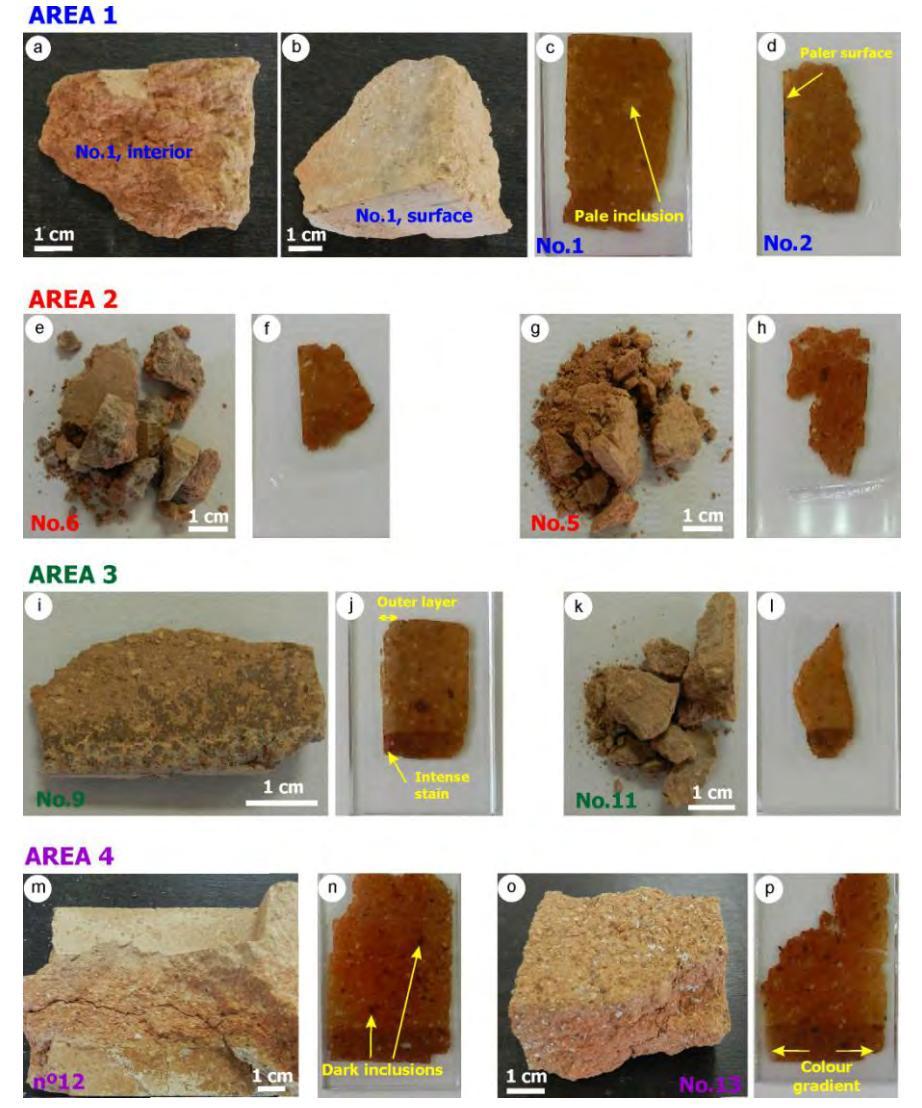
Figure 8. Samples from four areas on the façades and respective thin sections.

The brick fragments collected were reddish-brown and somewhat yellower on the surface (Figure 8). The setback attic samples (area 3) were somewhat yellower (Figures 8i and 8k), whereas in the area 4 fragments had a yellowish outer region that could be clearly distinguished from a visibly disaggregated/cracked reddish inner region, generating a more perceptible colour gradient (Figures 8m and 8o). Macroscopic examination of the thin sections revealed sample non-uniformity in terms of the distribution, type and size of aggregate inclusions, particularly visible in samples of the area 4 (Figures 8n and 8p), while the area 3 pieces were more uniform (Figures 8j and 8l). Inclusions of up to 2 mm were observed, some pale and sub-round (Figures 8c and 8d) and others darker and with elongated morphologies. The latter abounded in the area 4 bricks in particular (Figures 8n and 8p). The intense reddish tone in the stained clay matrix in the area 3 pieces (Figures 8j and 8l) denoted the presence of calcium carbonate. The area 4 bricks exhibited the aforementioned colour gradient (Figures 8n and 8p). Besides the lighter coloration to the surface observed in many samples, No.9 sample had a paler surface than interior, but its thin section featured a unique surface layer around 3 mm thick on average that acquired an intense reddish colour when stained (Figure 8j).

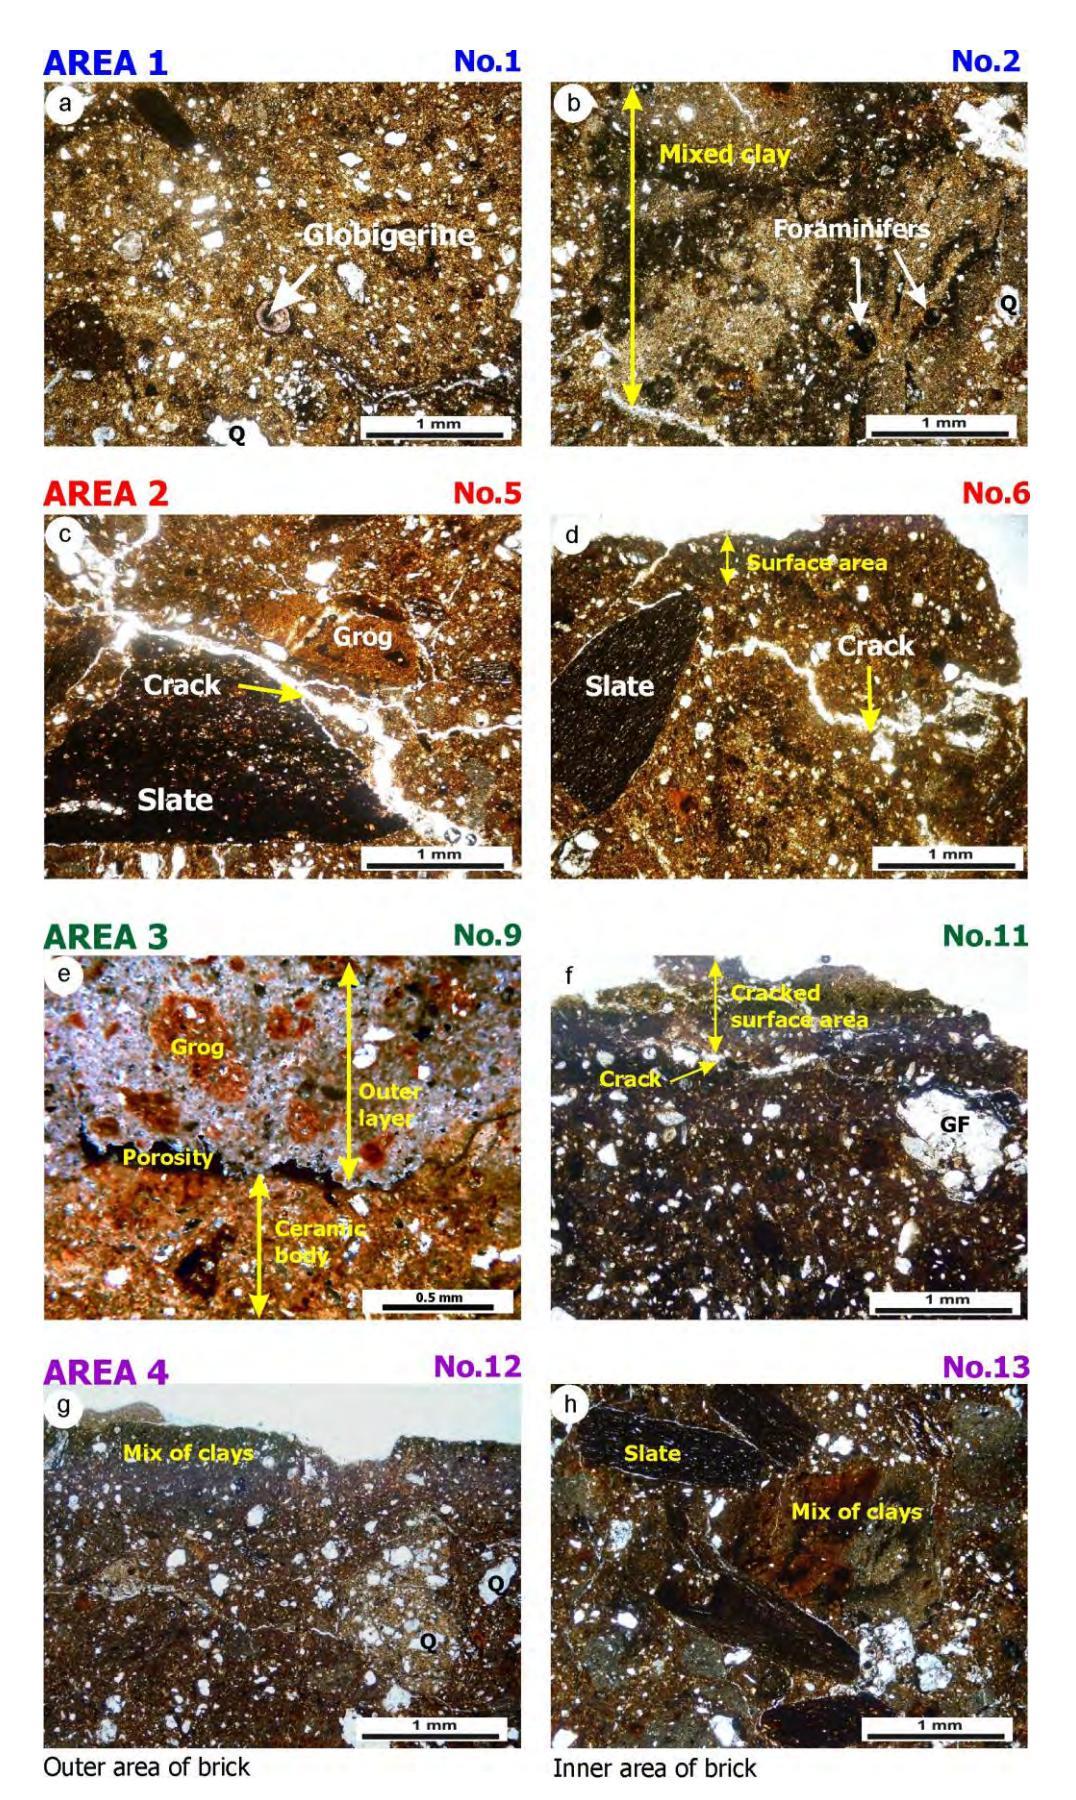
Figure 9. Polarised optical micrographs of the bricks studied. Crossed nicols in 9e, parallel nicols in rest; Q = quartz; GF = granite fragment.

The POM observation of the samples (Figure 9) revealed a profusion of aggregate inclusions in the clay matrix, at a visually estimated aggregate-matrix ratio of 3:1. These aggregate inclusions mainly comprised mono-mineral and sharp-edged quartz grains, perhaps denoting the deliberate inclusion of aggregate additions rather than their natural presence in the clay sediment used. Feldspars, granite and sandstone fragments, as well as foraminifers, primarily globigerines, were likewise observed (Figure 9a). A carbonate-high clay that also contained foraminifers was found in the irregular sub-rounded and pale colour inclusions (Figure 9b). The darker and elongated inclusions were identified to be slate fragments around which shrinking cracks formed, so brick cracking was favoured (Figure 9c and 9d).

Brick surfaces were more uniform and paler in colour than the clay matrix and much smaller inclusions can be observed (Figures 9d, 9f and 9g). Cracking was sometimes observed in the surface (Figure 9f). Quartz aggregate inclusions were occasionally observed to protrude on the surface. A greyish matrix with numerous reddish inclusions, possibly grog or chamotte (Cuomo di Caprio et al., 1993), formed the outer layer observed in sample No.9 (Figure 8j). This layer differed from the surfaces of all the other samples studied and was separated from the underlying clay matrix by a very distinct crack (Figure 9e).

In the area 4 bricks, uniform surfaces prevailed with a lighter colour and smaller sized inclusions than in the underlying material. The clay in this inner part of the bricks was darker and had larger cracks. Slate fragments and possibly grog (Cuomo di Caprio et al., 1993) were identified, surrounded by shrinkage cracks (compare the outer region in Figure 9g to the inner in 9h).

The aforementioned petrographic findings suggest that the bricks may have been made with a mix of clays: a yellow, perhaps a Miocene marl clay containing foraminifers, and a red Triassic clay containing slate fragments. The presence of globigerines in the samples analysed may allow allocating the constituent clay identified as Miocene marl clays extracted at Bailén. Besides, the use of other bricks, initially also selected for the works, can be ruled out, inasmuch as they were manufactured in other areas of Spain where the geological substrate lacks such marine microfossils. Lastly, related to the brick surfaces, the samples collected in areas 1, 2 and 4 had a paler surface and smaller inclusions than the body clay matrix, whereas the surface observed in sample No.9 (area 3) did not appear to consist in a ceramic material.

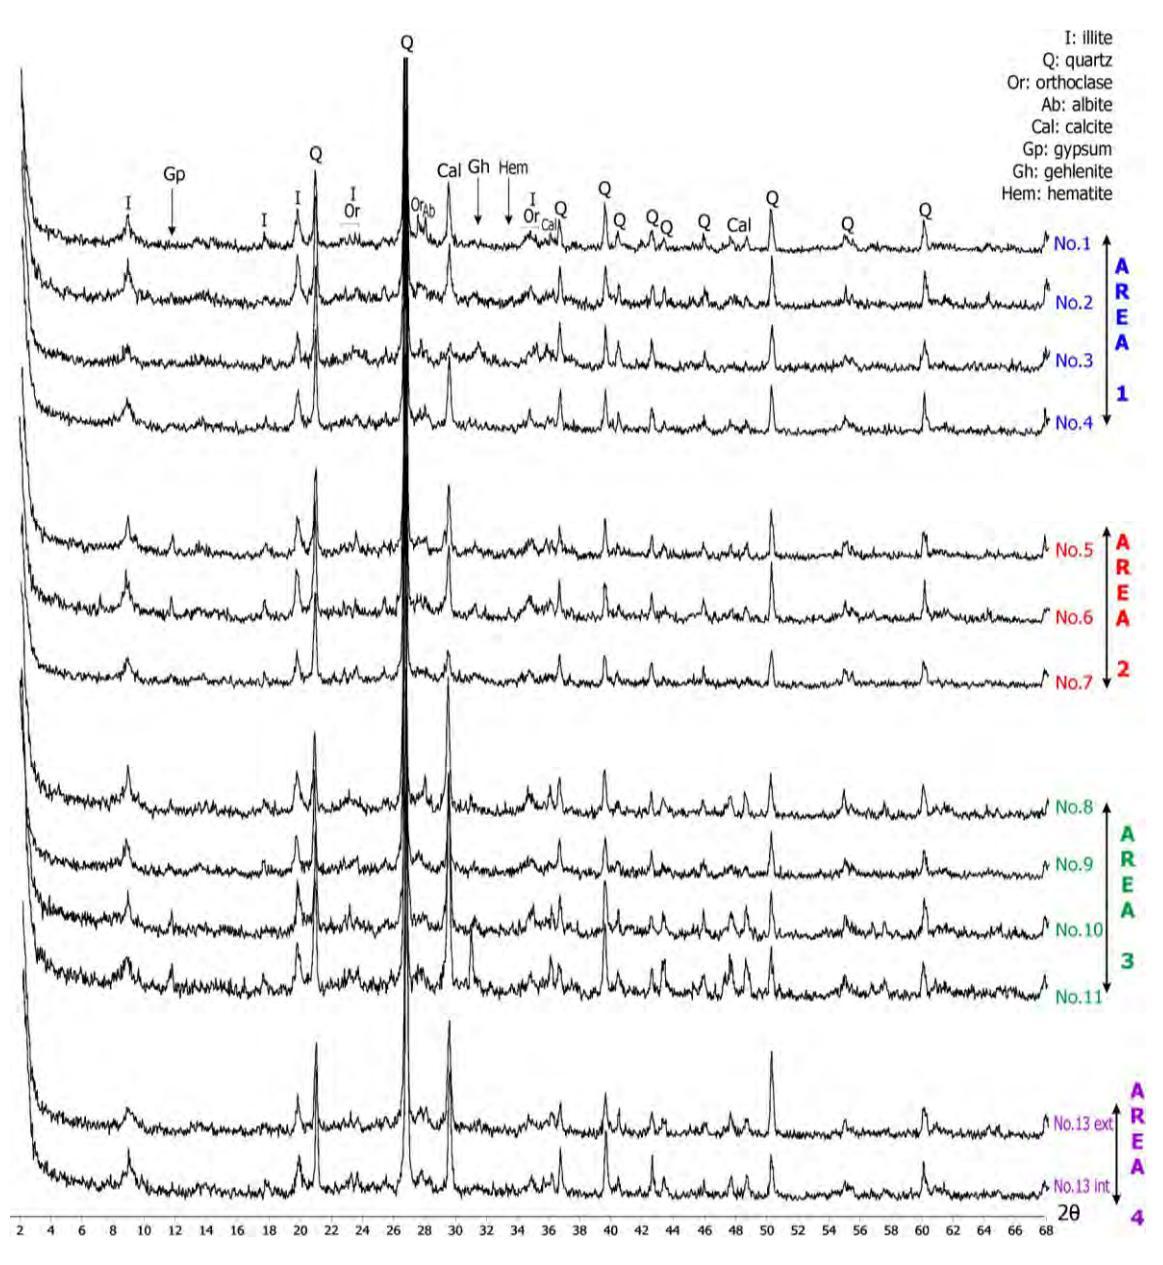
Figure 10. Diffractograms derived from the samples analysed.

The XRD analysis showed that the brick samples studied were mineralogically similar (Figure 10). They were made with similar raw materials and fired at similar temperatures. The main phases identified were quartz, feldspars (orthoclase, albite or both), calcite and illite. Quartz and feldspars were primarly present in the aggregate inclusions observed in the thin sections, whilst the calcite and illite mainly formed part of the clay matrix. Other mineral phases detected included gypsum and hematites. Gehlenite was also identified, with a very faint diffraction line in nearly all the samples and a significant presence in sample No.11 only (Figure 10, area 3). An analysis of sample No.13 (Figure 10, area 4) revealed less intense illite reflections in the outer than in the inner region, a possible indication that the firing temperature was higher on the surface or that during brick extrusion a smaller particle size was chosen for the outer clay, which would contain more illite. As illite has high iron oxide content, the difference in concentration in the two regions would explain the colour gradient observed (Figures 8m to 8p).

The detection of hematites, which appear from 700°C in oxidising conditions (Maniatis et al. 1981; Nodari et al. 2007), would in all likelihood be due to the use of iron-rich illitic clay. Although air pollution is low in the area where the Faculty of Medicine is located, the gypsum identified in some of the samples may be related to slight atmospheric SO₂-induced sulfation on the brick surface (Cultrone et al., 2007).

Since most of the bricks may have been extruded, finer particle clay would have been chosen for the surface, so greater sintering has been favoured and as a result less porosity and a higher surface gloss (Kingery, 1976). The bricks were fired at a temperature of 800-850°C. While not especially high, such temperatures sufficed to sinter non-structural brick apt for cladding and lowered production costs considerably.

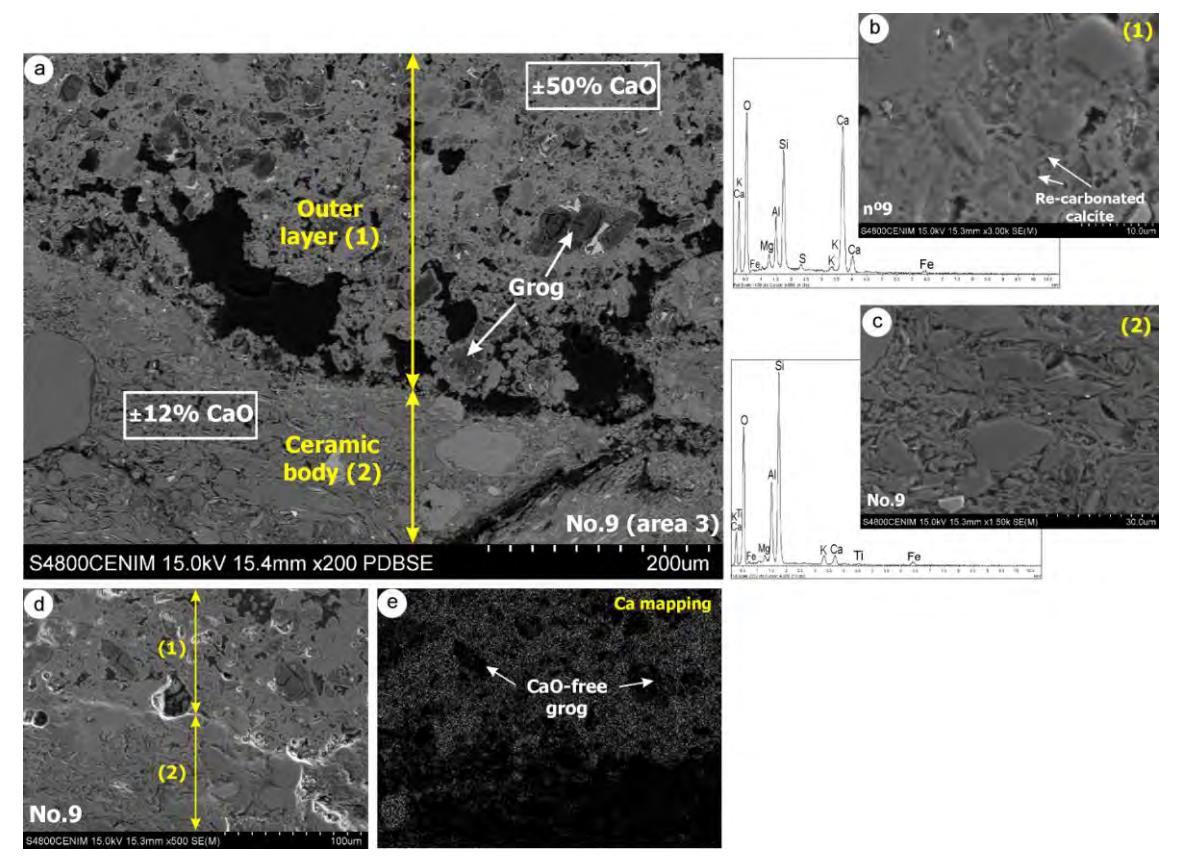
Figure 11. FESEM-EDS microstructure, microtexture and elemental composition of sample No.9 from area 3 (setback attic): a) BSE images; b), c) and d) SE images.

oxide contents in this layer. The microstructure of the underlying ceramic body, in contrast, was characteristic of sintered, non-vitrified ceramic material (Figure 11c), which is consistent with a firing temperature of 800-850°C. The ceramic body exhibited a higher relative silicon and aluminium oxide content and a lower concentration of calcium oxide (~12 wt%) than the outer layer (Figure 11d). Calcium element mapping confirmed its higher concentration in the surface layer and the presence of grog, which contains barely any calcium (Figure 11e).

The FESEM-EDS data showed, then, that this surface layer comprised a lime-based material to which brick grog was added as an aggregate, and that neither the microstructure nor the chemical composition of this layer was the same as found for the ceramic material in the body of the brick.
