Geomechanical Characterization of Unwelded Volcanic Bimrock Materials for Sustainable Slopes: Application to Road Instability Problems in the Western Cordillera of Ecuador

This paper presents a geomechanical characterization for unwelded volcanic bimrock materials. Bimrocks are geological materials consisting of blocks of rock of different sizes embedded in a finer matrix. Many volcanic deposits and outcrops can be classified as bimrocks, and some of them correspond to unwelded bimrocks, i.e., with the absence of strong bonds between blocks of rock and matrix. The geomechanical characterization proposed is oriented towards bimrocks slopes, their stability and landslide hazard occurrence. It consists of five steps which includes the material description, the volcanic deposit classification, the definition of block size range, the computation of the volumetric block percentage, the geotechnical characterization of the blocks of rock, and the geological and geotechnical analysis of the matrix that surrounds the blocks. The geomechanical characterization proposed is applied to four slopes at the Western Cordillera of Ecuador, where slopes instabilities are common. Results show that th

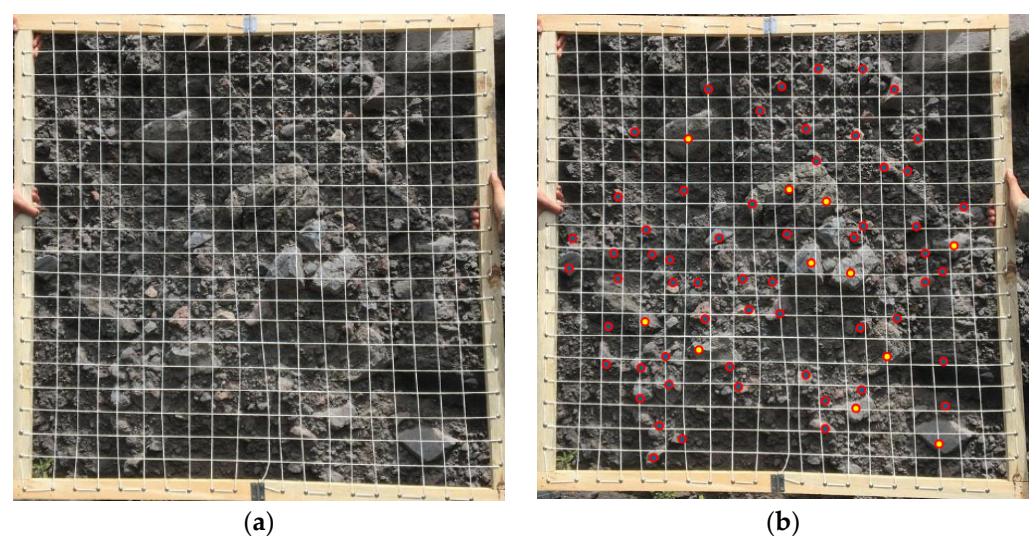
Figure 2. Block count for the determination of VBP, taking into account the scale effect: (a) $1 \text{ m} \times 1 \text{ m}$ mesh; (b) block count of those particles inside the block size range defined by the interval $(0.05 \cdot L_c, 0.75 \cdot L_c)$.

Although the literature contains different techniques for computing the VBP, this work proposes (Figure 2) using a manual block count performed by a mesh grid with a scale of $1 \times 1 \text{ m}^2$, following the method of Ettinger et al. [41]. This approach allows for the estimation of the VBP by measuring block diameters relative to matrix diameters, thereby defining the corresponding block and matrix volume percentages. It is interesting to note that this broader scale offers a more comprehensive assessment of the block proportion in the field, in contrast to the linear scanline method proposed by Nikolaidis and Saroglou [20]. In addition, the selected technique is much simpler to apply in the field than fractal techniques [19], and by collecting graphic data of the outcrop, including frontal and lateral photographs, image processing techniques [11] can be used to easily and accurately compute the VBP.

To improve the representativeness of the outcrop and enhance the accuracy of the scale-dependent analysis, the mesh can be expanded to a $2 \times 2 \text{ m}^2$ grid or even more. Having a greater mesh size may improve the representativeness of the estimation of VBP when blocks of rock are of high dimension, as is the case with debris flows. However, in other volcanic deposits, like pyroclastic flows, a mesh size of great dimension may lead to a poor estimation of VBP due to the existence of small blocks of rock, thin layers and/or the natural high heterogeneity of such deposits. In volcanic outcrops with very small or very large blocks, the choice of mesh size must balance statistical representativeness with practical feasibility.

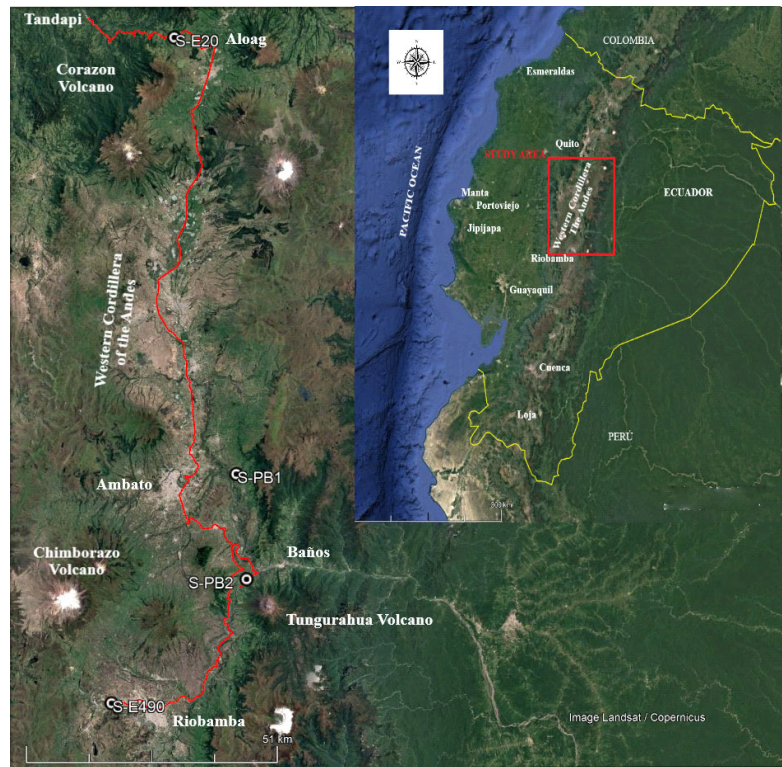
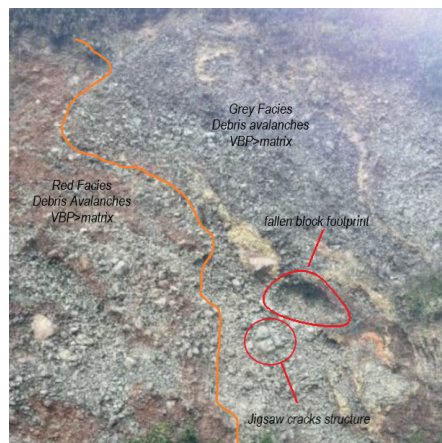
Figure 6. Road slopes in the Western Cordillera of Ecuador where the geomechanical characterization proposed is applied: (a) General location of the four slopes. (b) Slope S-PB1. (c) Slope S-PB, A, B, C, and D refers to four pyroclastic flow events identified; (d) Slope S-E490. (e) Slope S-E20, from the five levels identified (A to F); levels B and C correspond to bimrock materials.

In this context, the proposed geomechanical characterization was applied to four slopes (Figure 6) with exposed volcanic bimrock deposits found in the Western Cordillera of Ecuador:

All slopes had an inclination equal to or greater than 65° . Slope S-PB1 had a total height of 17 m, and the whole slope was formed by a volcanic bimrock deposit. The outcrop corresponded to a typical structure of clasts and debris avalanche, where the clasts produced by their transport are fractured and angular. Jigsaw crack structures, typical of avalanches, were observed. The deposit presented several levels of color, with chaotic, heterogeneous, and heterometric blocks, also with different directions of their arrangement. Thus, this slope was classified as debris avalanche.

Finally, slope S-E20 had a total height of 47 m and consisted of andesite clasts with a silty sand matrix. Heterometric blocks of more than 1 m in diameter were observed. The blocks had gray to brown colors, a product of alteration and iron oxides. The matrix had clasts whose sizes varied from 0.1 cm to approximately 16 cm. The base of the outcrop had gray clasts in a humid granular matrix. Different events were observed that indicate its Quaternary history with different epiclastic deposits, products of its transport on the top of a sequence of ash with fall material with pumice horizons. This slope was also classified as a debris avalanche, and, from the different materials found, 17 m were considered bimrocks affecting the slope stability (see Figure 6e).

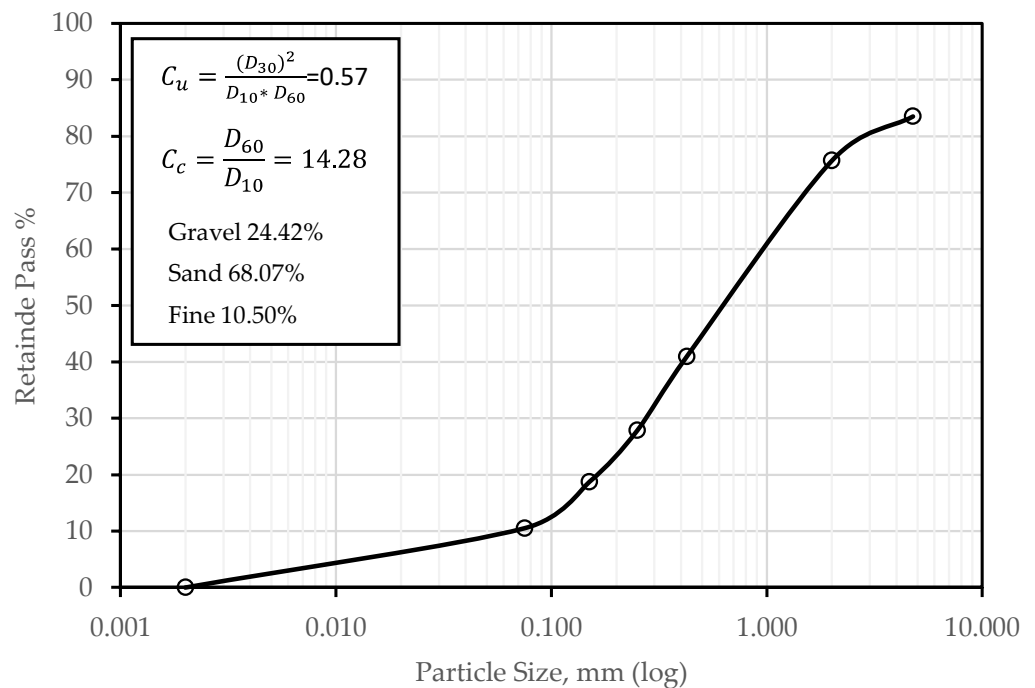
Figure 9. Gradation curve for a matrix sample taken at S-E490 slope.

Figure 9 presents the matrix gradation curve for that slope (24.42% gravel, 68.05% sand, and 10.50% fines). A uniformity coefficient larger than 6 suggests that the bimrock matrix exhibits a certain degree of particle size diversity, resulting in a good strength and stability of the matrix; however, a coefficient of curvature lower than 1 suggests the potential presence of voids or gaps between particles. Thus, the matrix exhibits poor sorting of its granular components, which may lead to low consistency and susceptibility to deformation and failure, thus affecting slope stability. In terms of plasticity, Atterberg’s Plastic Limit [46] could not be performed, proving the silty nature of the matrix fines, already evidenced by the XRD analysis (where only 11% were clay minerals). According to the USCS [47], the matrix was classified as SP-SM, indicating high permeability and low moisture retention.
