# Crushing effects on the durability of rocky aggregates used on road surfaces subjected to winter maintenance and extreme climate conditions

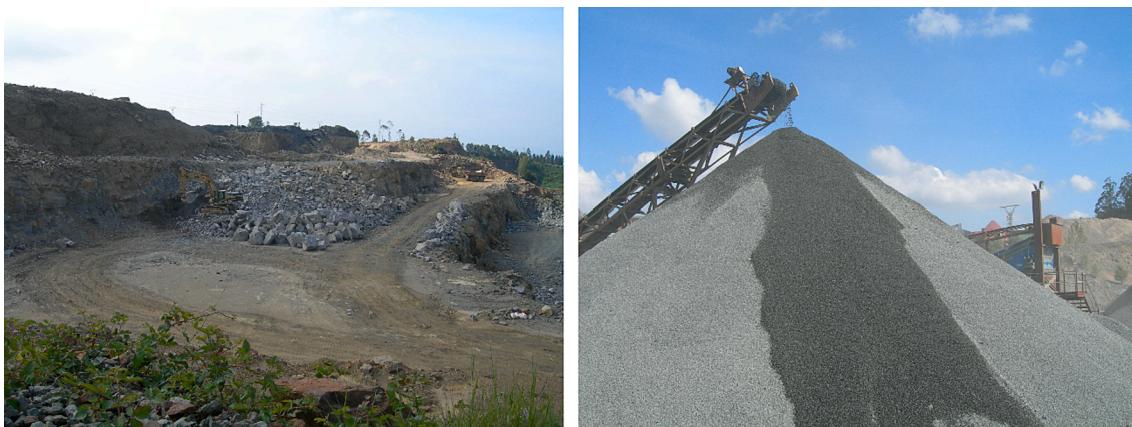
Fig. 2. Sampling working face on the left and stockpile on the right of the studied quarry.

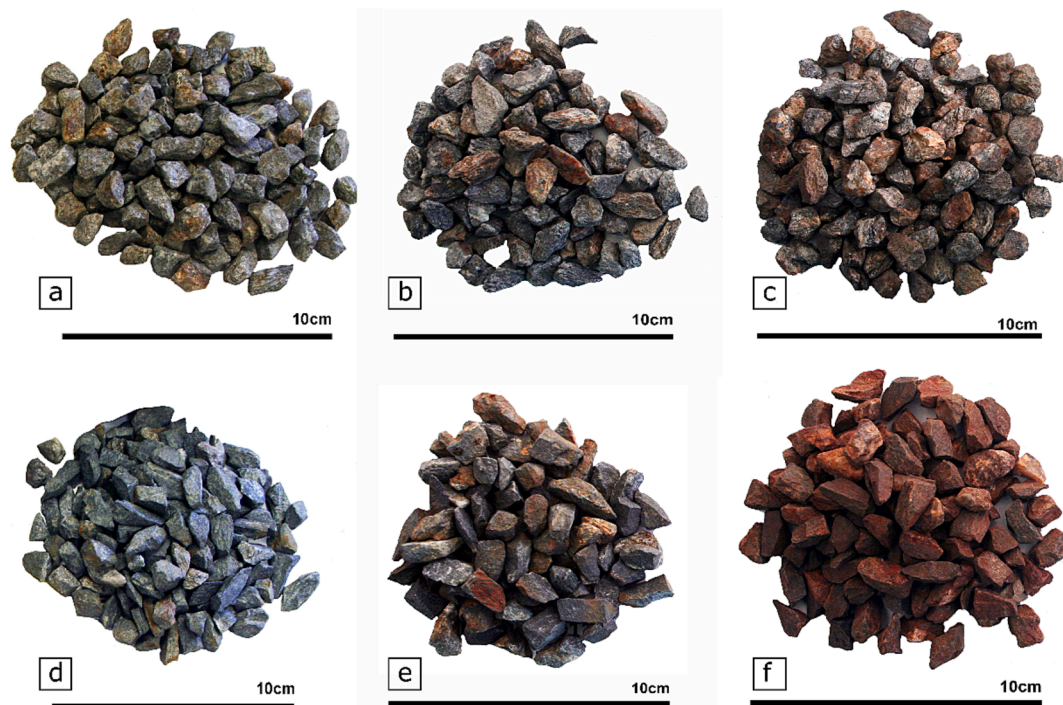
**Fig. 5.** Examples of schist 6/12 aggregate (a–c) and amphibolite 6/12 aggregate (d–f), before (a and d) and after the freeze-thaw (b and e) and thermal stress (c and f) tests [50].

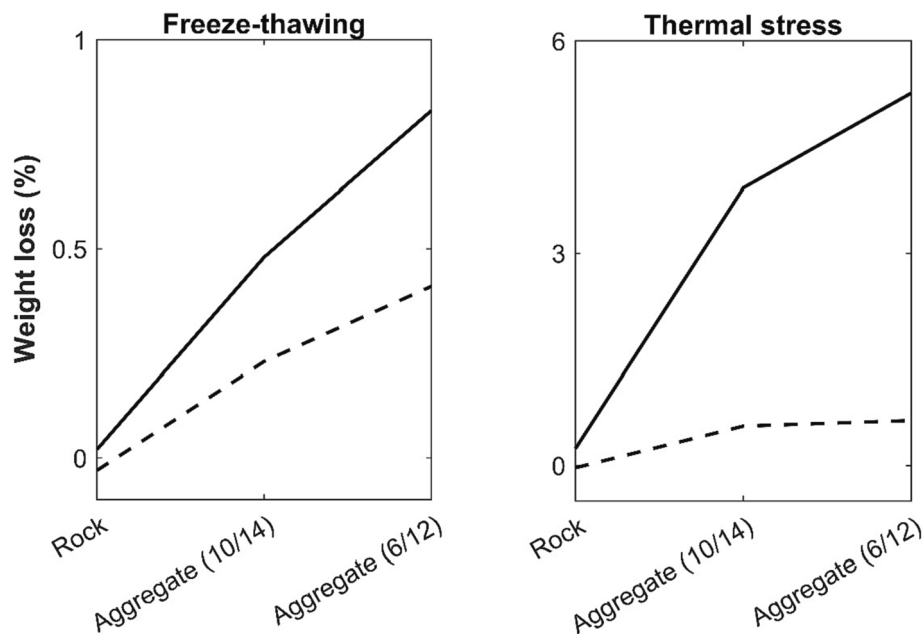
**Fig. 6.** Representation of the average weight loss of both lithologies subjected to the durability tests regarding samples processing in the quarry. Samples with particle size distribution bigger to 6/12 (10/14) has been added to evaluate the evolution of the materials also regarding their size.

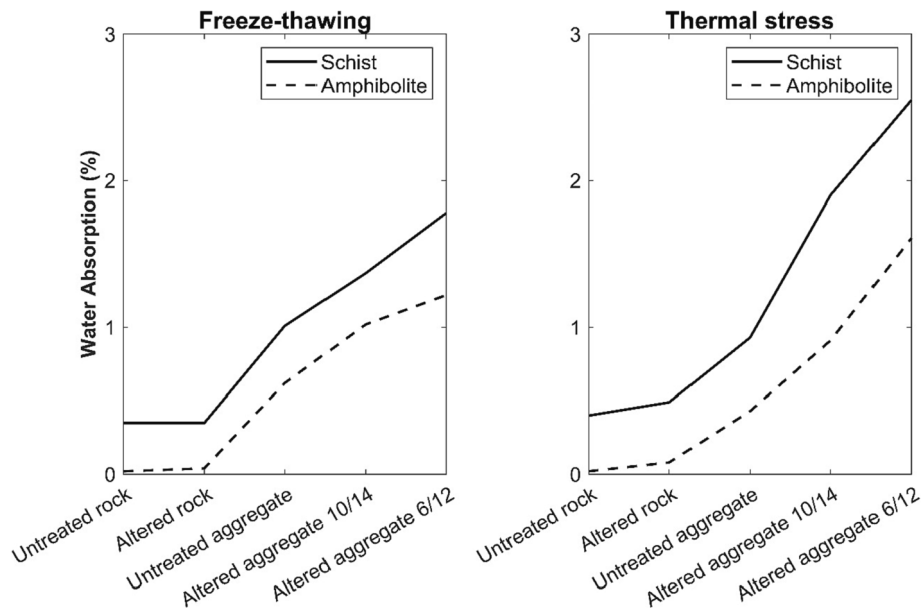
**Fig. 7.** Representation of the average water absorption coefficient of both lithologies subjected to freeze–thaw and thermal stress tests, regarding their processing in the quarry. Samples with particle size distribution bigger to 6/12 (10/14) have been added to evaluate the evolution of the materials also regarding their size.

In Table 4, it can be observed that the water absorption coefficient, and then, the open porosity to water of both lithologies increase after crushing processes in the quarry. Therefore, aggregates, which have a greater porosity than the rock, are more affected by the durability tests. This evolution in the water absorption coefficient regarding samples processing, particle size distribution, and environmental conditions is shown in Fig. 6. In this figure, it also can be observed that both lithologies follow similar trends, although schist is the material most affected by durability tests, especially thermal stress. After the freeze-thaw test, the water absorption coefficient of schist and amphibolite increases in a similar manner. After this test, the water absorption coefficient of schist and amphibolite rises to approximately 1.4–2 times its value (Table 4, Fig. 6). Equally, after the thermal stress test, the water absorption coefficient similarly increases in both lithologies. After this test, the water absorption coefficient can reach 1.5–2.6 times its value (up to 4 for the rock, Table 4, Fig. 6).
