Article

Sustainable Management of Landslides in Ecuador: Leveraging Geophysical Surveys for Effective Risk Reduction

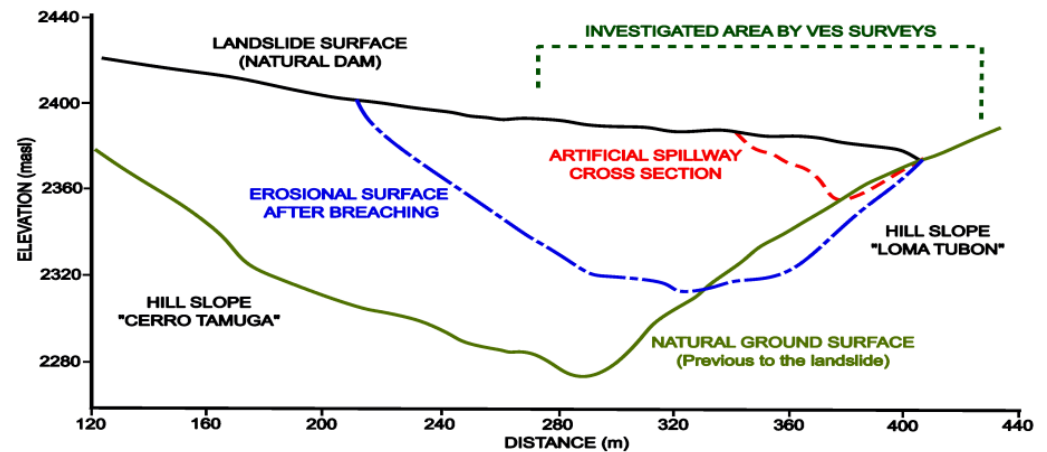
Figure 5. The Paute River valley's cross-section shows the height of the natural dam after the La Josefina landslide. The artificial spillway and the erosional surface sections after the failure are shown. Also, we indicate where the 12 VES were applied to study how the flooded water could be freed (modified from Plaza et al. [35]).

The urgent need to reduce the height of the material blocking the river course (the level of the flooded areas increased quickly and threatened major cities) led to the removal of the fallen sediments by the digging of an artificial spillway. The INECEL government institution performed 12 VES (and probably seismic refraction profiles, not confirmed) over the natural dam to analyze the characteristics of materials (Figure 5), but the obtained results were scarcely used, and some people considered them to be unreliable [36].

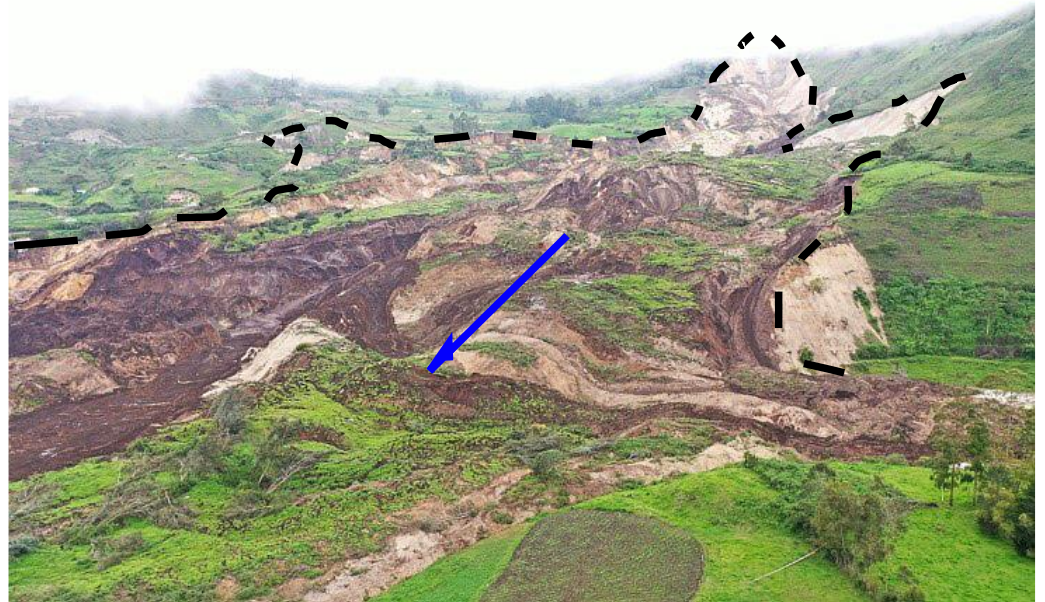
Figure 6. A general view of the Chunchi landslide (La Armenia sector). The direction (blue arrow) and delimitation of the landslide's head and the affected area are indicated as a black dashed line (modified from <https://municipiochunchi.gob.ec/wp-content/uploads/2024/05/01-1.jpg>, accessed on 21 September 2024).

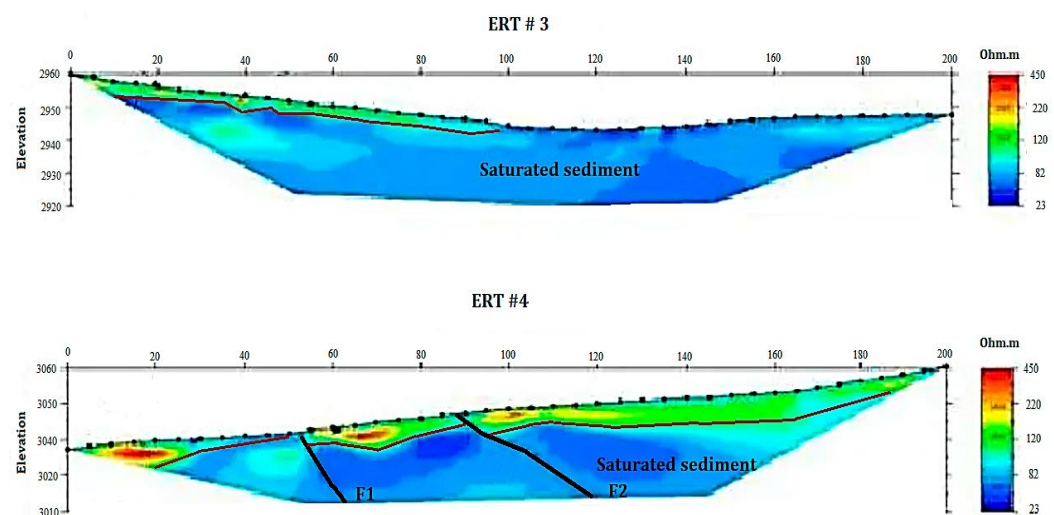
Figure 7. ERT geophysical interpretation of #3 and #4 resistivity profiles applied over the Chunchi landslide. Dotted lines show the electrode positions, and red lines delimit the shallow sediments, unsaturated, from saturated sediments. It also indicated faults that were obtained in the geophysical interpretation (F1 and F2) (modified from SNGRE [38]).

characteristics of the materials involved in the soon-to-happen landslide were performed from the application of electrical tomography surveys. In the area, six ERT profiles were performed by IIGE and SNGRE institutions (Figure 7 shows two examples) and they put in evidence the high water content, reaching the saturation at deep levels. This saturation corresponds with an aquifer with low mobility in the water (aquiclude) and faults (F1 and F2 in Figure 7) inside the body of the mobilized materials as part of the compartmentation of the landslide [38].

The ERT geophysical technique applied here is a source of information, including the stratigraphy and 2D or even 3D geometric distribution of materials, water content, satura-

tion state, and geological structures (faults and discontinuities). This kind of information can also be used to define the landslide failure surface if the depth of the data reaches it [39].

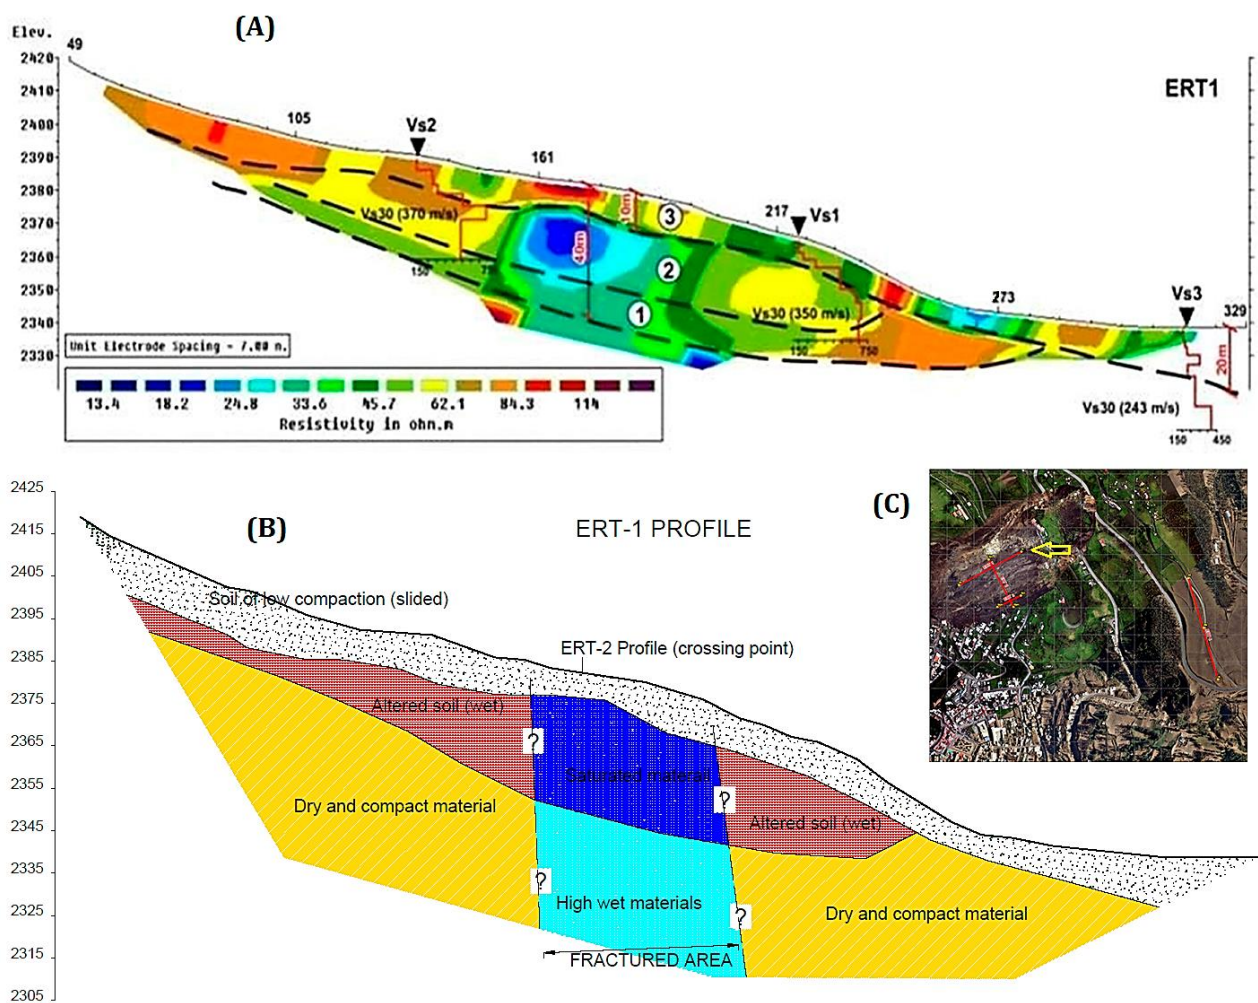
Figure 9. ERT-1 profile performed along the longitudinal section of the Alausi landslide: (A) original interpretation of resistivity geophysical data included in the SNGRE (2023) inform, where MASW survey results are superimposed in the section (Vs. 1 to Vs. 3 positions marked by inverted black triangles) V_{s30} values are indicated at every surveyed point, and numbers indicated the defined geophysical levels; (B) new geological interpretation made in the present work of the previous ERT profile to clarify the geophysical results (vertical scale doubled); (C) location of this profile (red line pointed by a yellow arrow) on an aerial view of the 2023 Alausi landslide where three more profiles location are indicated (red lines) ((A,C) pictures were modified from SNGRE and IIGE [44]).

The investigation of the landslide area before and after the event was performed by the Geological and Energy Research Institute (IIGE) and SNGRE [44]. Two electric tomography profiles were applied before the failure, and six more were applied afterward. The MASW seismic technique was also used to separate the mobilized material from the static one (Figure 9A). The geophysical results provided information about the sediment layer deposited (up to 45 m thick) and the characteristics of the soil resistivity of the bottom along the longitudinal ERT-1 profile (Figure 9A). A reinterpretation of the geophysical data is made in the present work by the authors (Figure 9B), also delineating the altered layer of soil (in situ saprolite) and the probable presence of a fault with saturation.

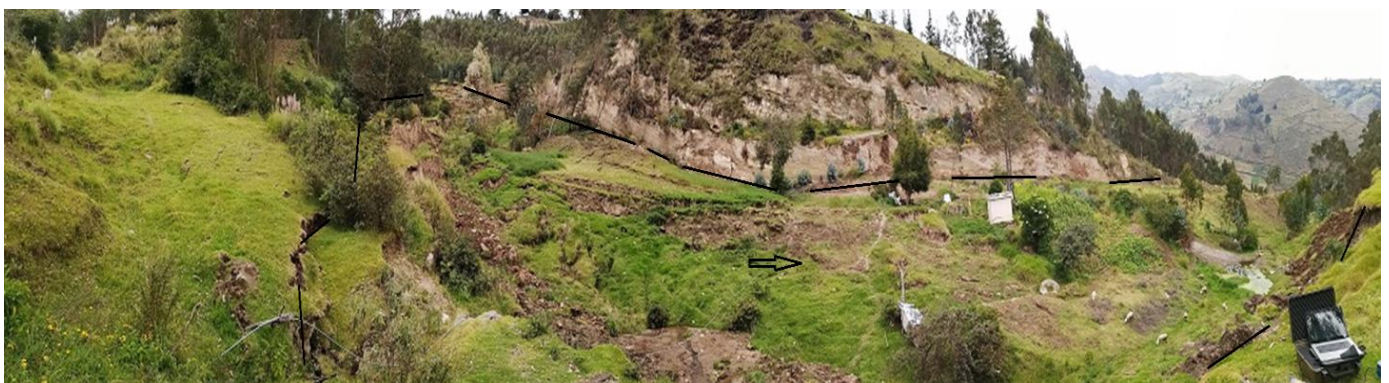
Figure 12. A panoramic lateral view of the Pujilí landslide taken from the right flank shows the scarp failure at the center of the picture (movement from left to right, arrow). In the bottom-right corner of the picture, the HVSR geophysical equipment is placed for survey.

Near Cachi Alto village, over a small landslide located inside a big one (Figure 12), partially stable, the authors performed an investigation using natural vibration of the ground measured by HVSR surveys as a first technique [47]. More than 80 single stations were performed to delimitate the mobilized materials from the static ones. The soft sediment thickness was computed from the ground natural frequency (f_0) and the sediment's shear-wave velocity, averaged over the whole sedimentary soft material above the static materials considered as the basement, by applying the formulation shown in Nakamura [45]. The shear-wave velocity was obtained using the MASW seismic technique, which can be applied to every measured HVSR point (Figure 13A). In this case study, the failure surface was obtained from three methodologies based on the geophysical surveys performed. The differences between them were established as minimum values (Figure 13B).
