32 **Keywords:** internal erosion, embankment dam, paleochannels, seepages, concrete cut-
33 off wall.

94 The Negratín Dam (southern Spain) presents a determined number of leakages
95 throughout the mountain ridge forming the left abutment of the reservoir. These leaks
96 appear when the water level exceeds the 622 m above sea level (a.s.l.) by the presence
97 of paleochannels embedded in the substratum. These infiltrations not drags particles
98 although they can derive in piping and/or internal erosion in the near future.

99 Concerning to the above exposed problems, this study aims to detect preferential
100 leakage routes and the initiation of internal erosion in the Negratín Dam, close to the left
101 abutment, by measuring electrical resistivity and induced polarization along a profile.
102 This case is quite unusual due to where leakages have been detected is not an
103 embankment dam or its foundation, but a natural mountain ridge between two parallel
104 ravines close to the left abutment of the dam. In addition, ERT and IP combined have
105 not been used to detect this kind of infiltrations in such contexts.

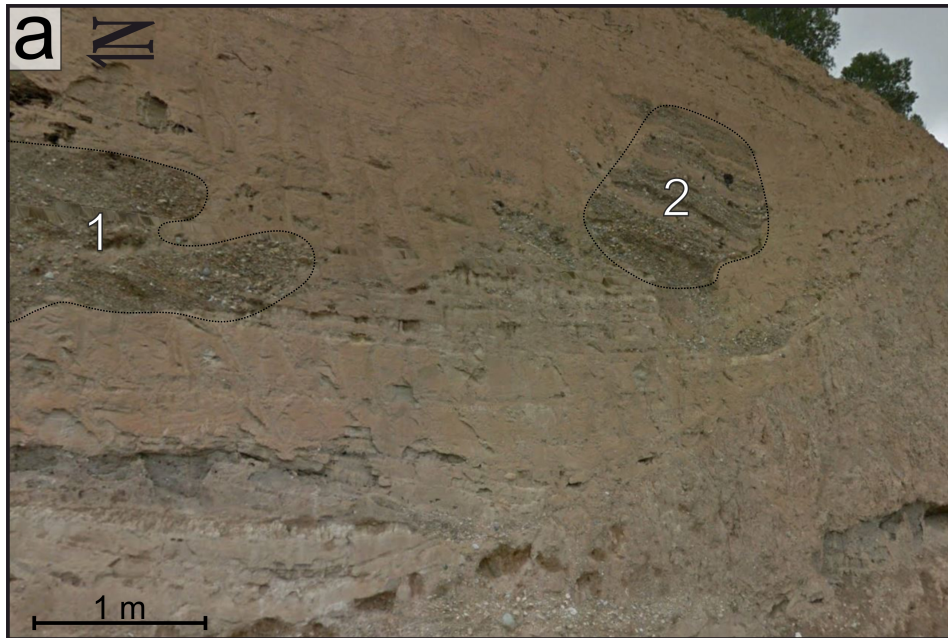
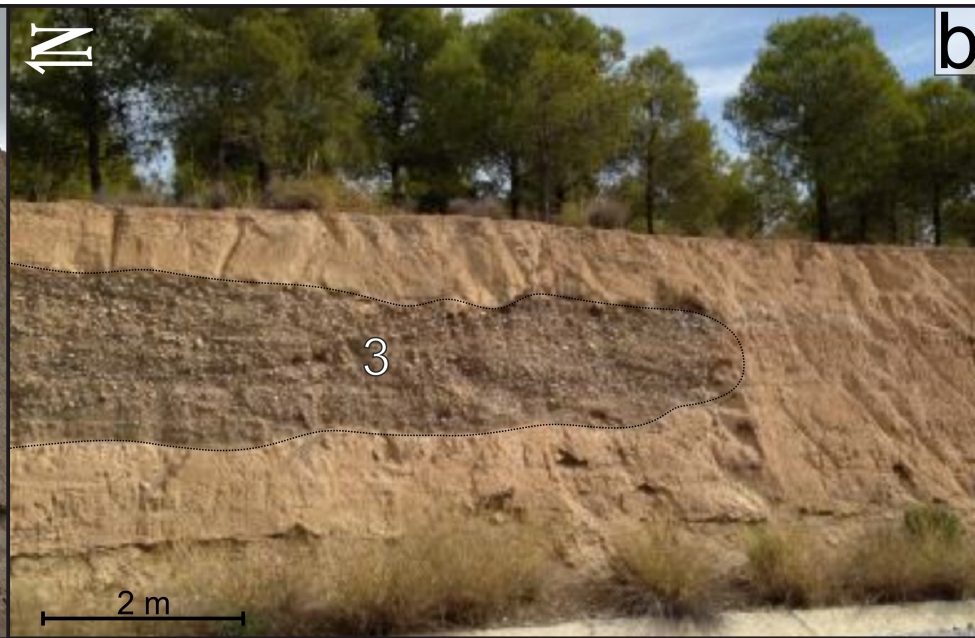
361 *Figure 2:* Paleochannels observed in road slopes at the mountain ridge where the
362 leakages were detected. They have with different sizes: (a) metric scale and (b)
363 decametric scale. Location is marked in Fig. 1.
