Article

Monitoring Soil Sealing in Guadarrama River Basin, Spain, and Its Potential Impact in Agricultural Areas

Keywords: soil sealing; impact; remote sensing; Madrid

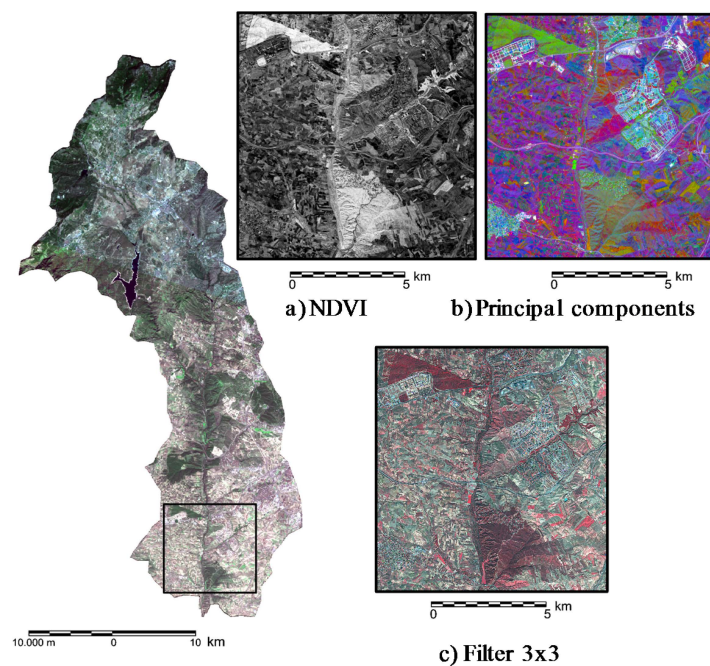
Figure 2. Digital analysis of Spot image.

To detect and measure soil loss in 2011, the Spot image spatial resolution was improved by merging the panchromatic and multispectral images. Figure 2 shows the false-Spot image of the Guadarrama Basin and, in detail, the main digital image processing used to highlight sealed soil. In Figure 2 the NDVI highlights natural and cultivated vegetation in very light shades. The NDVI image was very useful in the digital processing of the areas sealed in 2011, as it allowed areas of open urban development to be differentiated from more compact areas, as this index differentiates different vegetation patterns (woodland, pastureland, wasteland, urban parkland, gardens, *etc.*). This index facilitates visual differentiation of urban areas because of their regular spatial pattern, and also digital

differentiation as it obtains intermediate values between bare soil and vegetation mass. Urban parks are also well represented in the NDVI on account of their clearly marked limits and high values.

Road infrastructure and different urban typologies are clearly shown in the principal components image (Figure 2b), and non-sealed surfaces are clearly differentiated, even in the Sierra. This digital processing enables the clear identification of urban core and new buildings in blue shades.

The image obtained using filters facilitates the detection of linear features (motorways, roads and streets) which are also included in measurements of sealed soil. Soil loss from road infrastructure is not normally included when sealing is measured, as these linear features are not usually measured as areas.

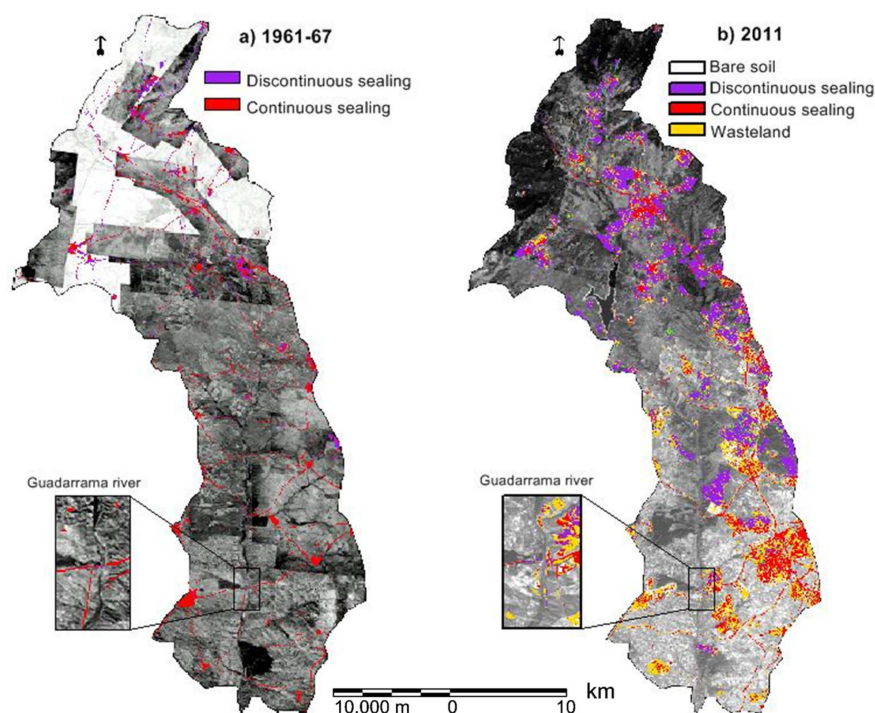
Figure 3. (a) Soils sealed in 1961–1967; (b) Soils sealed in 2011.

The estimated surface affected by sealing over the last 50 years is shown in Table 2 and Figure 3a,b.

It is interesting to note here the significant increase in sealing in the Guadarrama Basin, from 4% to 9% in 50 years (125%), especially on the left bank, which is closer to the city of Madrid. Soil sealing is similar to other European and Asiatic cities. Regions such as the Mediterranean coastal areas underwent a 10% increase in soil sealing during the 1990s [2]. In the Urban Agglomeration around Hangzhou Bay (UAHB), China, the percentage of sealed soils increased from 2.7% in 1994 to 4.7% in 2003 and to 8.7% in 2009 [25]. As indicated by Kasanko *et al.*, 2006, urban development in Europe is a result of various factors, and when it occurs along a river it creates a very different type of development from other locations [26]. This also occurs in the area analyzed here, as the plots are highly fragmented and include areas with trees, pastureland and/or wasteland and riverbank vegetation. Construction is limited by the flood plain and the sandy materials with significant gully formation.

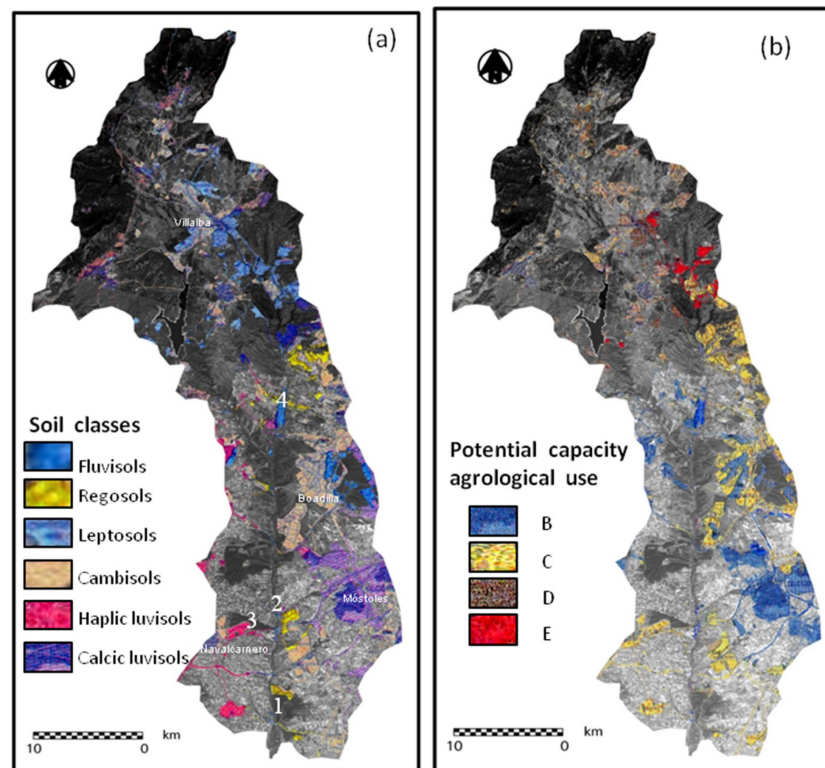
Figure 4. (a) Soil associations sealed in 2011 and sample location; (b) Sealing in 2011 classified by potential capacity for agricultural use.

Four soil profiles were analyzed (Table 3 and Figure 4): the texture is sandy loam. These soils are poor in clay and organic matter so that their structure is unstable, favoring erosion processes. These soils are permeable, neutral or slightly acid, with few carbonates and very few salts. Although these soils are not particularly fertile, they are the most productive in the area analyzed. Their loss also implies reduced water infiltration, increasing surface run-off. The destruction of the vegetation cover accelerates this erosion. The loss of highly productive agricultural soils due to soil sealing is an indicator for assessing land degradation in Spain [27].

A contrast can be observed between the two banks of the river in terms of the types and classes of sealed soils. On the right bank, the sealing mostly affects haplic luvisols. On the left bank, the sealing affects calcic luvisols, calcareous regosols, eutric and dystic cambisols and some eutric fluvisols. The medium and coarse texture soils over the tertiary sands and arkoses are highly permeable, and pose a moderate erosion risk, which is higher in the regosols. The fluvisols and some luvisols generated on the flood plain present hydromorphic problems. The impact is much lower in the northern half of the basin for those soils over Paleozoic materials and soils characterized by associations of leptosols and dystic cambisols.

When the sealed soil polygons are superimposed on the map of agrologic classes, it can be seen that in the Guadarrama Basin there are no Class A soils with maximum potential for agricultural use. However, there are considerable areas with highly fertile Class B soils which have been subjected to significant sealing. On the arkose deposits Class C soils have also been sealed. On the Paleozoic materials the sealing is less extensive and corresponds to less fertile soils (Class D and E). Therefore, the most intense degradation process in the basin has taken place on the most fertile Class B soils.
