# The Diezma landslide (A-92 motorway, Southern Spain): history and potential for future reactivation

**Abstract** A complete failure analysis of a complex landslide located in Southern Spain (the Diezma landslide) has been undertaken using geotechnical, geophysical and geological data. The triggering factors were a high groundwater level and the reduction in the shear strength parameters of the high-plasticity clay. The 2010 reactivation of the landslide was related to the poor performance of the first line of deep drainage wells, although the second and third line of wells and the anchored pile barrier were effective in preventing the landslide reaching the A-92 motorway. Analysis indicates that further reactivation of the Diezma landslide could take place following a period of heavy rain if the drainage wells are not properly maintained, or if an earthquake of  $M_w$  4.0–5.0 occurs within 25 km of the site.

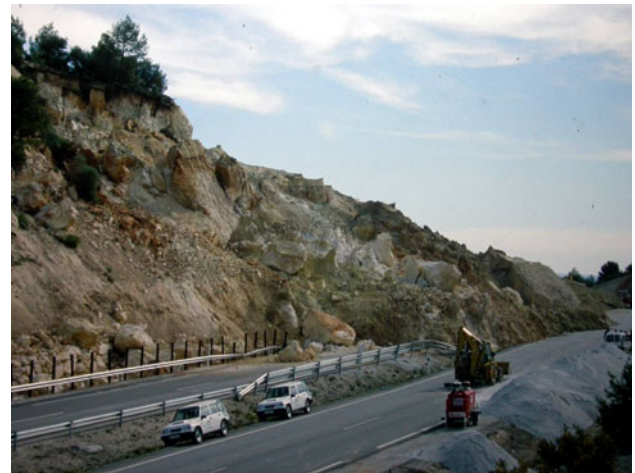
**Fig. 3** Panoramic view of the toe of the Diezma landslide during the 2001 collapse over the A-92 motorway, which was closed for several days

The Diezma landslide took place on 18 March 2001 following a period of high precipitation and caused significant damage on the Sevilla–Almería motorway (A-92), which was closed for several days as the cutting slope failed completely/collapsed (Fig. 3). The stabilisation of the Diezma landslide began immediately and involved re-grading the slope and installing additional surface drainage systems and deep drainage wells, as well as the construction of a barrier of anchored piles (Oteo Mazo 2001, 2003). Despite these measures, the Diezma landslide was partially reactivated as a result of the heavy

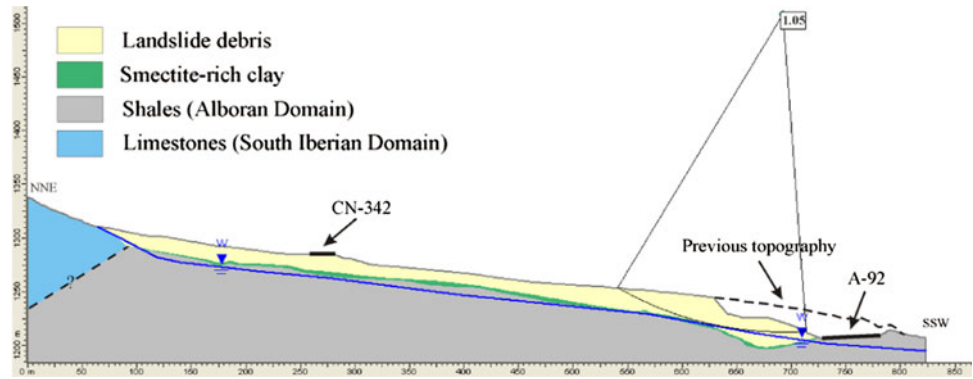
**Fig. 5** Longitudinal cross section of the Diezma landslide after the construction of the A-92 motorway considering a deep water table (blue line) and residual shear strength parameters

The construction of the A-92 motorway in 1993 substantially modified the geometry of the natural slope at the toe. The projected talus had a 1:1.5 ( $\sim 35^\circ$ ) profile including one intermediate berm (Fig. 5). Even after this significant modification of the topography, the slope remained stable. According to the analysis, the  $SF$  for peak shear strength parameters and a deep water table (18–20 m) is still very high ( $SF = 2.12$ ), while considering residual shear strength values the slope is just stable ( $SF = 1.05$ ). This situation fits very well with the occurrence of the small, shallow landslide, which took place in May 2000 at the toe of the slope—the first sign of instability of the Diezma landslide area after the A-92 motorway construction.

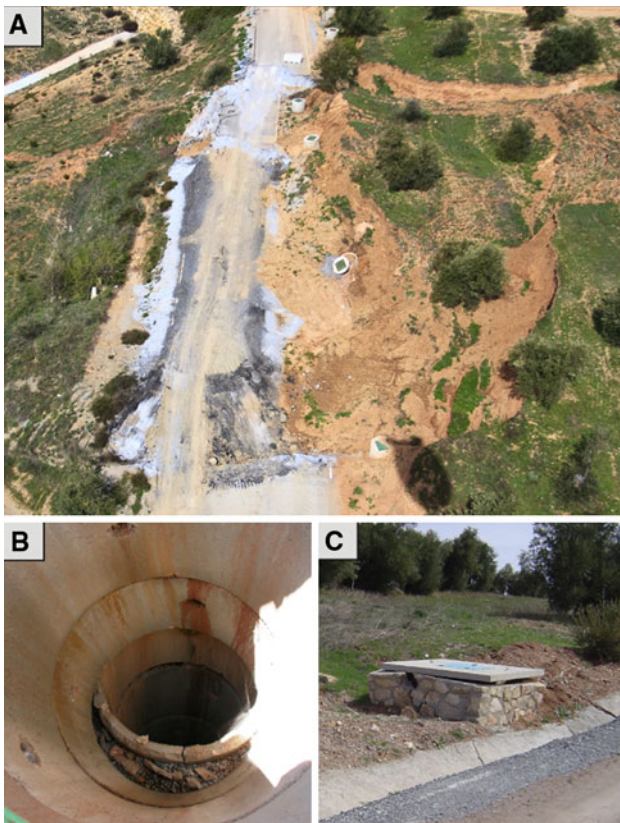
**Fig. 8** **a** Aerial view of the first line of deep drainage wells and the old CN-342 road, which collapsed/moved during the 2010 landslide reactivation. **b** Broken well of the first line of drainage wells. **c** A damaged well in the second line of drainage wells

The Diezma landslide remained stable for a further 9 years until 2010 when it was reactivated, again coinciding with a period of high cumulative precipitation. The main cause of the reactivation was the inadequate performance of the first line of deep drainage wells, which were known to have been working inadequately since at least 2005, due to the small movement at the head of the landslide.

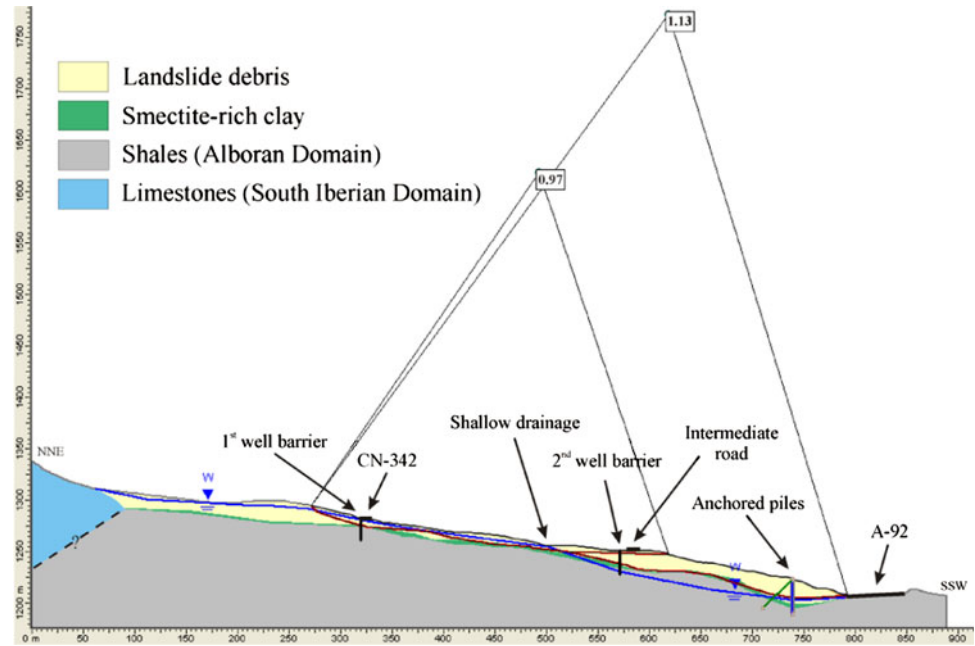
**Fig. 9** Longitudinal cross section of the Diezma landslide after the 2010 reactivation considering a shallow water table (blue line) at the head zone and residual shear strength parameters. Failure surfaces are shown by red lines

The reactivation of the Diezma landslide took place following the winter of December 2009–February 2010. The cumulative rainfall at the date of the landslide (361 mm) was higher than the average cumulative value for 2010 based on the previous 10 years (141 mm); see Fig. 6b. The main scarp extended over the old CN-342 road, which failed and moved downhill. The first and second lines of drainage wells and the first shallow drainage system were also broken and moved by the landslide (Fig. 8). However, the retaining wall of anchored piles prevented the landslide reaching the A-92 motorway. A safety factor of 1.13 was calculated for the whole slope; considering only the part of the slope which moved, the safety factor was 0.97 (Fig. 9).
