Cleaning methods assessment for the limestone façades of the formerly Workers Hospital of Madrid, Spain

Keywords: limestone, cleaning methods, assessment, chromatic parameters, SEM-EDS

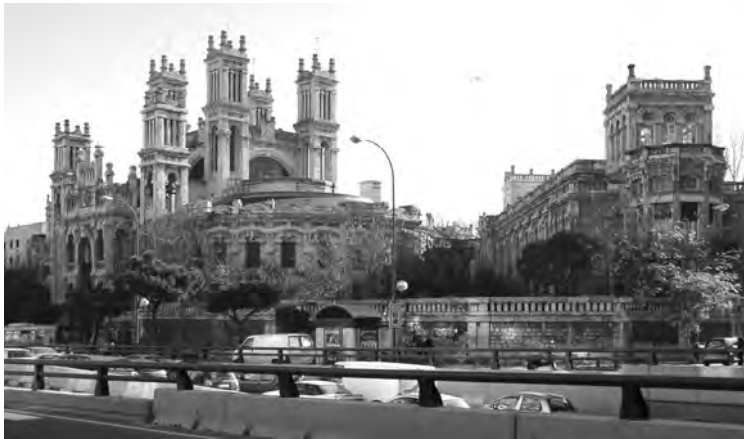
Figure 1.

The former Workers' Hospital, designed by architect Antonio Palacios, was built between 1909 and 1916, primarily of limestone. Also used on the surrounding wall (Figure 1), the stone is from the *Caliza del Páramo* geological formation located in the east and southeast of the Community of Madrid. Several stone varieties are found in this formation, all of which have been widely used in the built heritage of the region since the 18th century [1,2]. The building was used as a hospital until the early nineteen seventies, when it closed chiefly for want of financial support [3], and remained vacant for 15 years. In 1979 it was listed as a national artistic and historic monument. The regional Government of Madrid purchased the property in 1984 as the headquarters for the regional Department of Housing and Transport. In the comprehensive restoration and rehabilitation works performed between 1984 and 1986, one of the main tasks was to clean and protect the stone facades.

Twenty years after they were last cleaned (1986), the stone facades were severely soiled, due primarily to the building's location in a polluted urban area (Figure 1), one of the busiest in the city where vehicle traffic is especially heavy. The flyover that stood on the street bordering the building for 35 years (1969-2005) supported traffic on the order of 80 000 vehicles over top and 70 000 underneath per day. The vehicle entry to the present underpass built in 2005 to replace the flyover is just opposite the

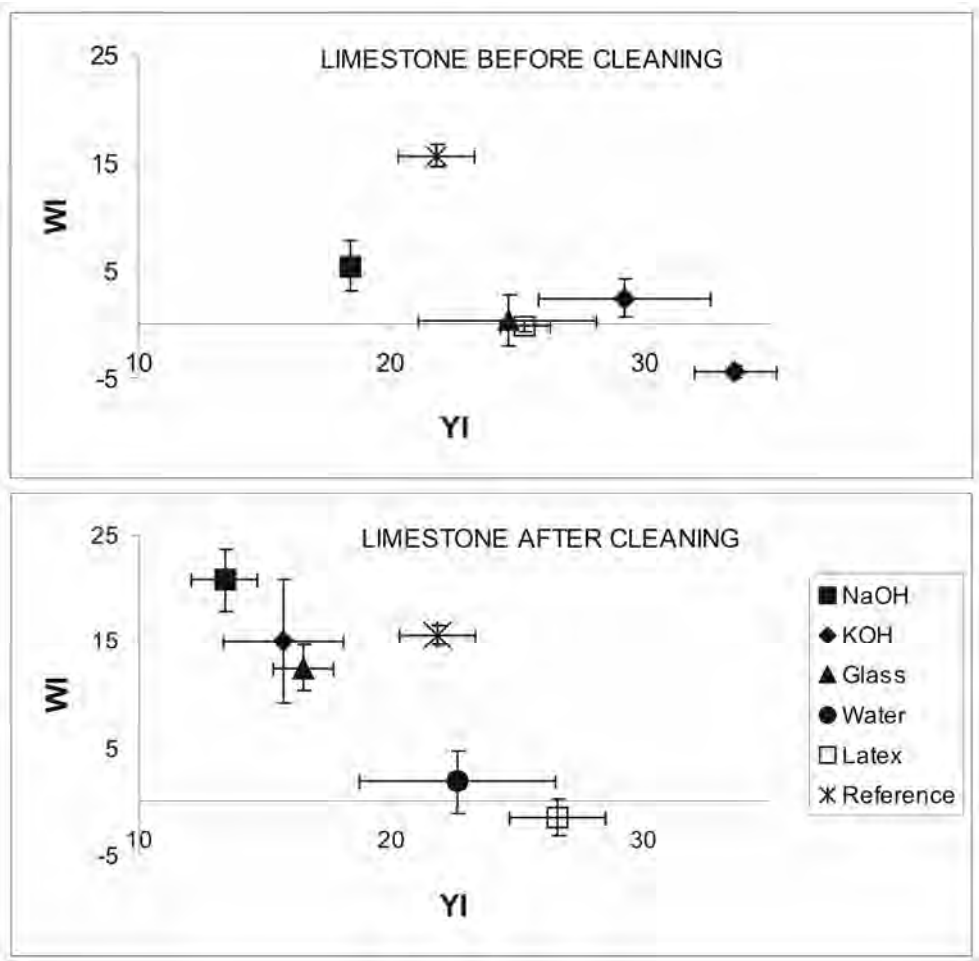
Figure 10.

A comparison of the white and yellow indices of the samples cleaned with the various systems to the rain-washed reference showed that the glass bead and alkaline gel methods were the most effective in this regard, as they yielded the smallest chromatic differences (Figure 10).

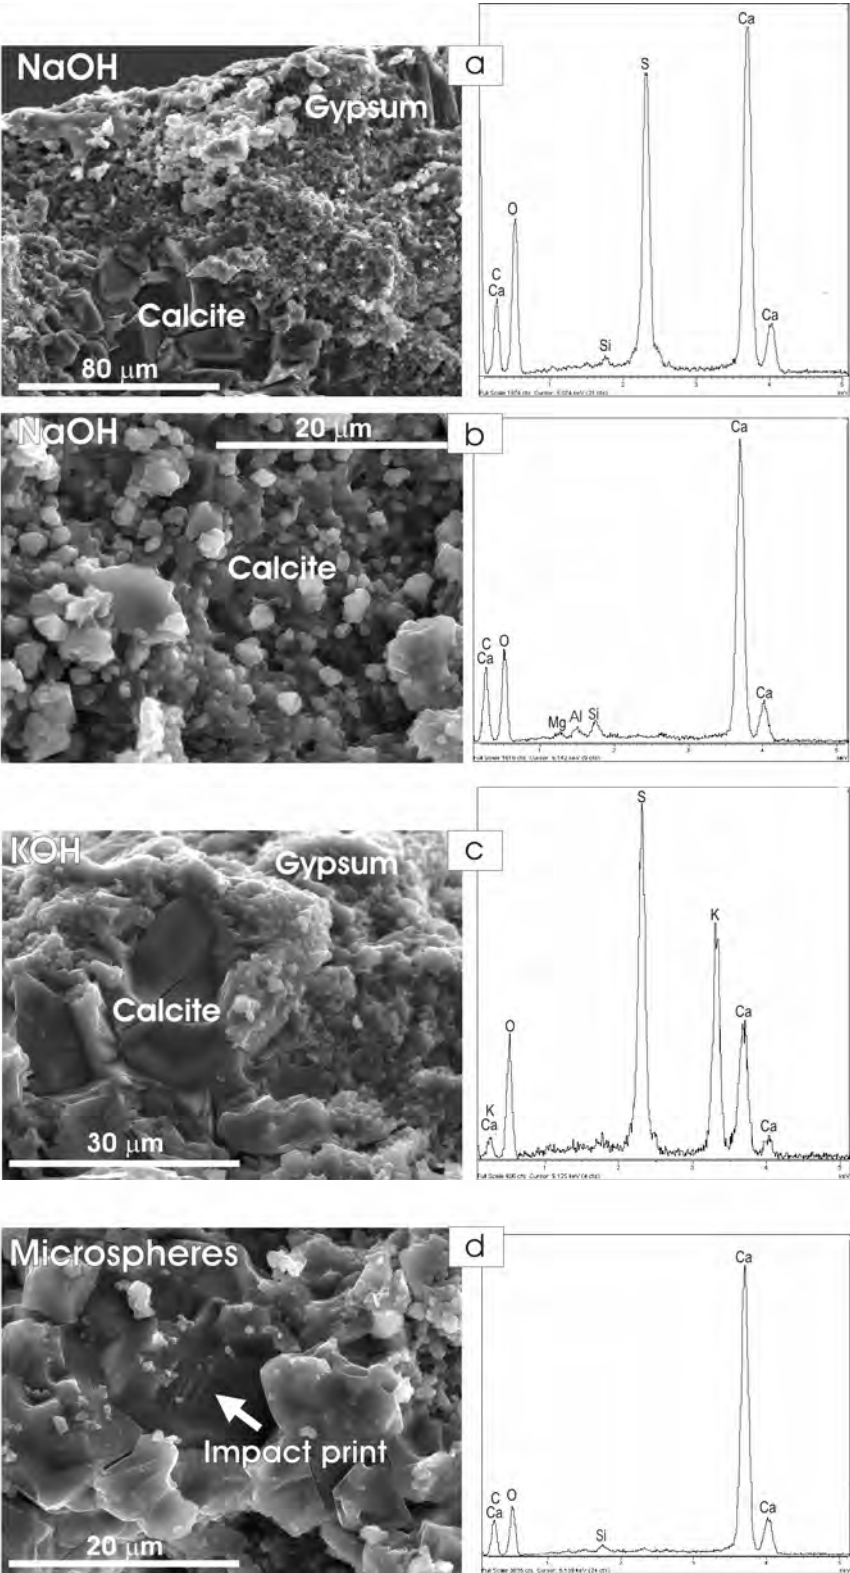
cleaned with a sodium hydroxide-based gel (Figure 11a). Moreover, some of the calcite crystals in the area where the black crust was eliminated were slightly dissolved (Figure 11b), an outcome of the fairly aggressive nature of this product.

The KOH gel thinned the black crust but did not remove it entirely. In addition, the high potassium content may have induced salt formation (as already suggested by [35] and with it the whitish postcleaning veil observed on the stone surface (Figure 11b). Glass bead blasting was the most effective method, for it removed the black crust completely, i.e., both soiling and the gypsum crystals. In addition, bead impact left only faint marks on only a few of the calcite crystals (Figure 11c).

Figure 11. SEM photomicrographs, in secondary electrons mode), and the corresponding EDS area analysis on the cleaned stone for the three more effective cleaning methods tested. (a, b) NaOH; (c) KOH; (d) Microspheres. All of the images are cross sections of the cleaned stone (stone surface on the top of the image), except b), which corresponds to a view of the stone surface.
