# The Somolinos quarry full history: from historic and recent land degradation to sensitive geomorphic-ecological restoration and its monitoring

# **The Somolinos quarry full history: from historic and recent land degradation to sensitive geomorphic-ecological restoration and its monitoring**

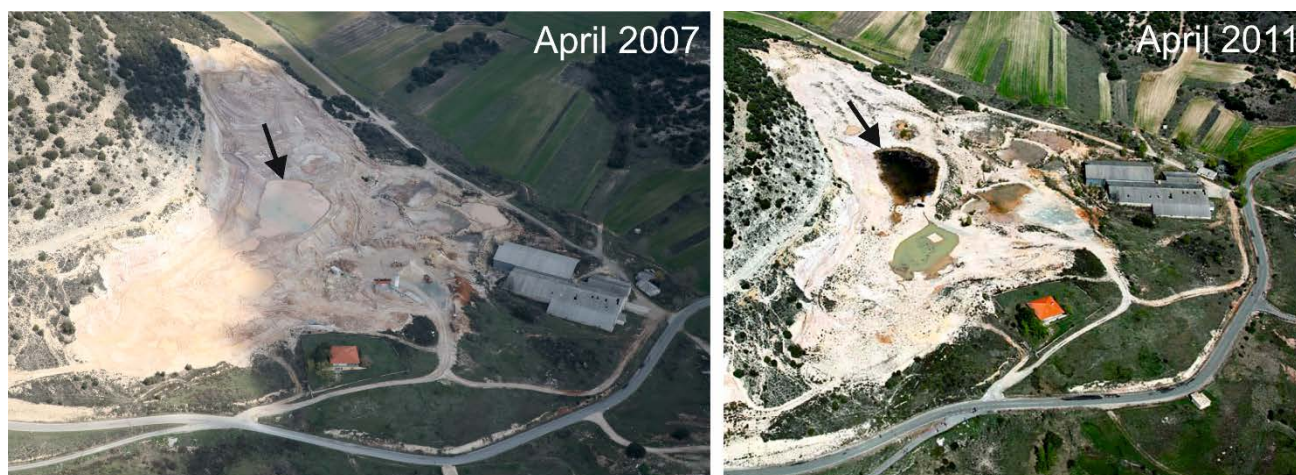
*Figure 3. The 2007 image shows the quarry closure and stabilization works, regrading platforms and sediment ponds construction (the black arrow points to the main one, which is the one visible at Figure 2F). As it can be seen in the 2011 image, four years later, the surface had not recovered any soils or vegetation.*

The conventional rehabilitation of the Somolinos quarry was performed in 2007 with a low budget of the bond guarantee. The action was a basic risk reduction approach consisting of broad stepped platforms linked by short rectilinear slopes. Different ponds within the platforms acted as sediment traps. No topsoil could be applied upon the regraded surfaces, leaving the loose sands exposed followed by tree and shrub plantings, intended to control erosion. By 2011 the platforms and the rectilinear slopes showed severe erosion, the pools presented signs of accelerated filling by sediments, and the planted vegetation was totally ineffective at controlling erosion (see Fig. 3). The most positive outcome was the pools acted as sediment traps. However, the erosion from the rest of the surface was sporadically released to the surroundings as suspended sediment, impacting the downstream fluvial network (Fig. 4).

The existing spoils at the quarry, regraded into broad platforms and ponds at the 2007 risk-mitigation intervention (see Fig. 3), were the only materials that could be cost-effectively used to accomplish the described geomorphic design. The construction had to be conducted without importing or exporting materials. These spoils were dominantly sand and clay. The geomorphic-based ecological restoration plan had to be complemented with subsequent specific measurements about replacement of soils and re-vegetation. For topsoil dressing, the only available material at the surroundings of the quarry was the carbonatic colluvium which draped the extracted mined material, and was chaotically disposed at the edge of the derelict area; no true soil was present. Carbonatic colluvium has been successfully used as subsoil restoring similar scenarios (Martín Duque et al., 1998; 2010). The spreading of this carbonatic colluvium on the geomorphically regraded mine spoils would replicate the surficial deposits of the original (natural) slopes, and it has therefore a sound ecological basis. Chemical analysis of the colluvium would reveal the need or not of organic amendments. The main aim of the selection of the plant species to be used in the revegetation process was protecting the soil against erosion.

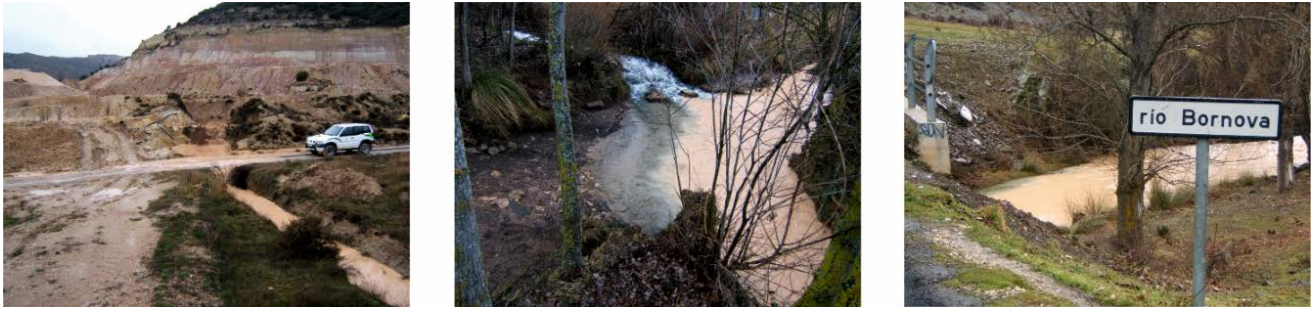
Figure 4. Left, suspended sediment releases from the Somolinos quarry to the fluvial system. Center, confluence of the Tejo stream with the Bornova River. Right, high turbidity at the Bornova River. See Fig. 1 for locations. Photos by local Environmental Rangers, as of February 23, 2007.

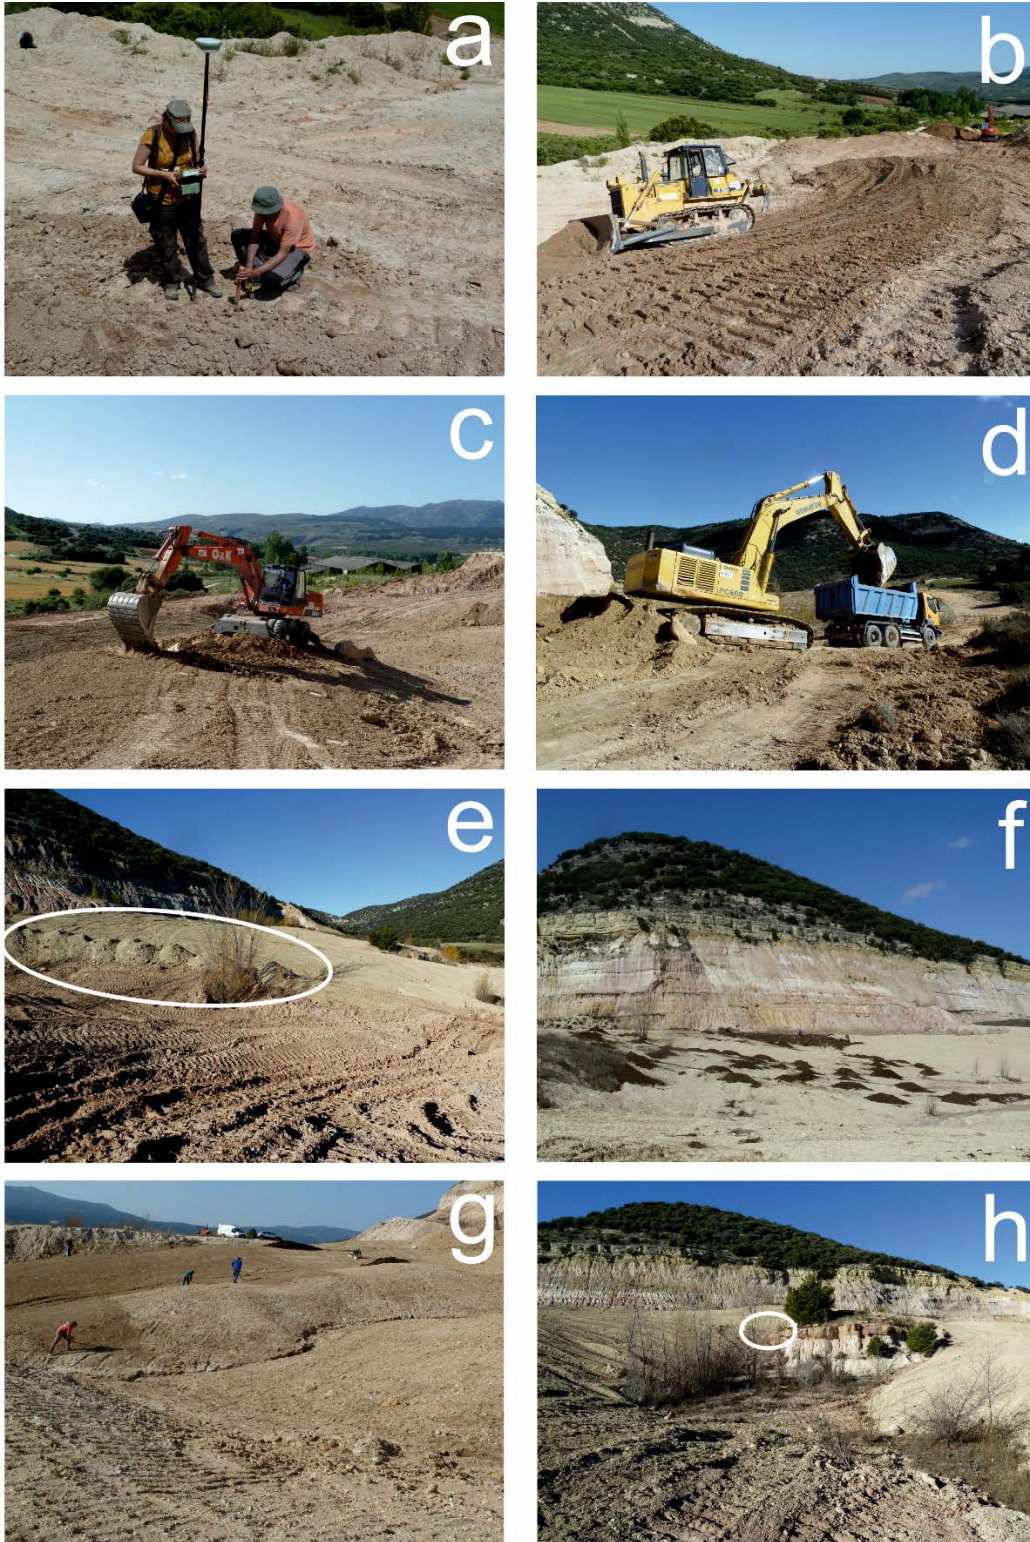
*Figure 6. (a) Staking out the geomorphic design with DGPS; (b) D6 bulldozer regrading a scalloped hillslope; (c) excavator building a rock outcrop at the top of a ridge, to add geomorphic landscaping features; (d) excavator loading carbonatic colluvium to be used as subsoil; (e) mounds of carbonatic colluvium (white ellipse) being spread at the regraded surface; (f) mounds of organic matter (local sheep manure); (g) manual seeding and raking; (h) the white ellipse shows a local base level located at a stable sandstone ledge, visible at its right. This outcrop was also maintained, retaining geodiversity.*

The planned restoration was executed in two phases, following the budget availability by the funding administration. The respective earth movements were carried out during June of 2011 (one hectare) and October of 2013 (five hectares), with subsequent soil and revegetation works. Figure 6 shows a set of images compiling all the execution phases of the restoration. The design could not be totally completed at the former main sediment pond (see Figure 5), due to water saturation of its sediments. The restoration of this persistently wet area was updated as a wetland habitat, although drained from a certain elevation to avoid mudflow risks.

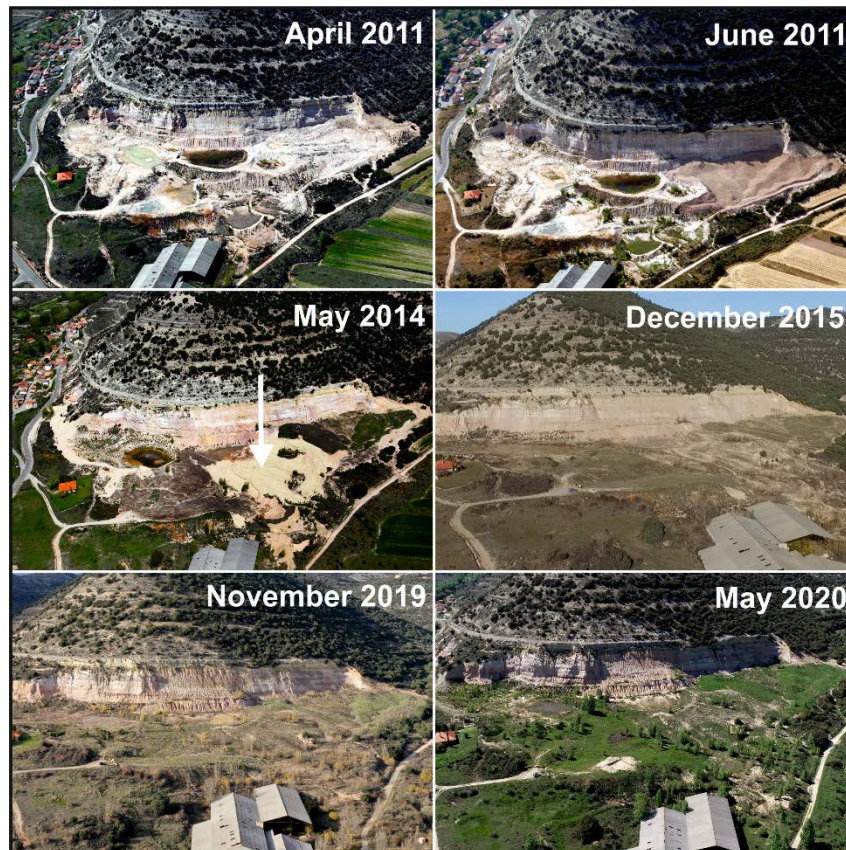
Figure 7. Comparison of oblique aerial photos of the Somolinos quarry from April 2011 (before restoration) to May 2020. Notice the 1-ha surface restored in June 2011. At the May 2014 photo, the lighter colours (white arrow) are the central area left without manure amendment. Photos by Paisajes Españoles (2011, 2014), David Gutiérrez (DGDRONE, 2015, 2020) and Javier Melero (2019).

Figure 7 is a time-lapse sequence of several oblique aerial photos of the Somolinos quarry, showing its visual landscape evolution.

The landscape evolution has been monitored from 2011 to 2020 through time-lapse sequences of several oblique aerial photos. The first three (April 2011, June 2011 and May 2014) were obtained using aviator plane flights and the three latter (December 2015, November 2019 and May 2020) through unmanned aerial vehicle (drone) photographs. During the observation period, drone technology replaced human on-board procedures for data collection.

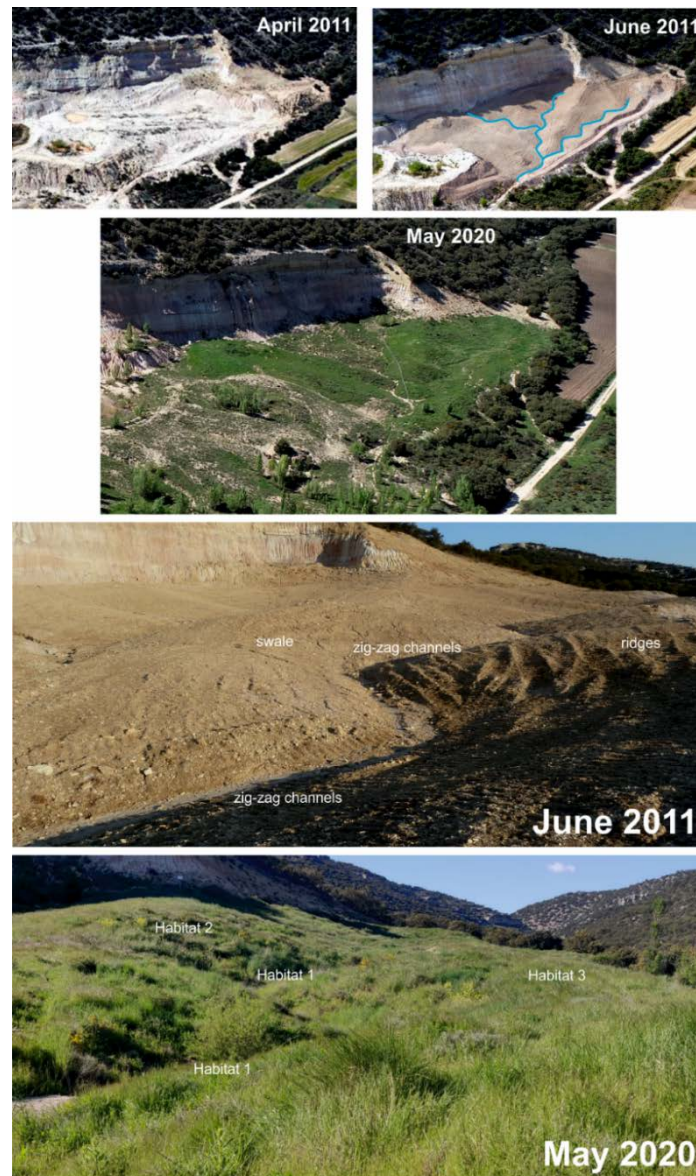
*Figure 8. Nine years of landscape and vegetation evolution at the Somolinos quarry. The three upper images show progression from April 2011 (pre-restoration), to June 2011 (after first phase of geomorphic restoration, with the GeoFluv channels highlighted), to May 2020. The two lower images show vegetation evolution after an homogeneous (seeding) revegetation, with a divergence in community composition and structure among habitats ruled by the environmental heterogeneity provided by the geomorphic design (see text for explanation). Credits of aerial photos at Fig. 7 caption.*

Figure 8 shows the result of nine years of vegetation cover development from the designated seed mix. Field surveys confirmed the hypothesized organization of habitat 1 (*Salix spp.*, *Fraxinus spp.*,...) developed on fluvial bottom channels; habitat 2 (*Rubus spp.*, *Rosa spp.*, *Crataegus spp.*,...) established at sub-watershed swales; and habitat 3 (*Genista spp.*, *Thymus spp.*, *Santolina ssp.*, *Lavandula spp.*...) associated to the rolling uplands (ridges and subridges). In this case, plant cover was higher on manure-fertilised surfaces, where *Agropyron sp.*, *Medicago sativa* and *Onobrychis viciifolia* were dominant. However spontaneous colonization was less active than in non-fertilized zones, because of the well-known competitive process of seeded and spontaneous plants in reclaimed-mining ecosystems (Vidal-Macua et al., 2020).

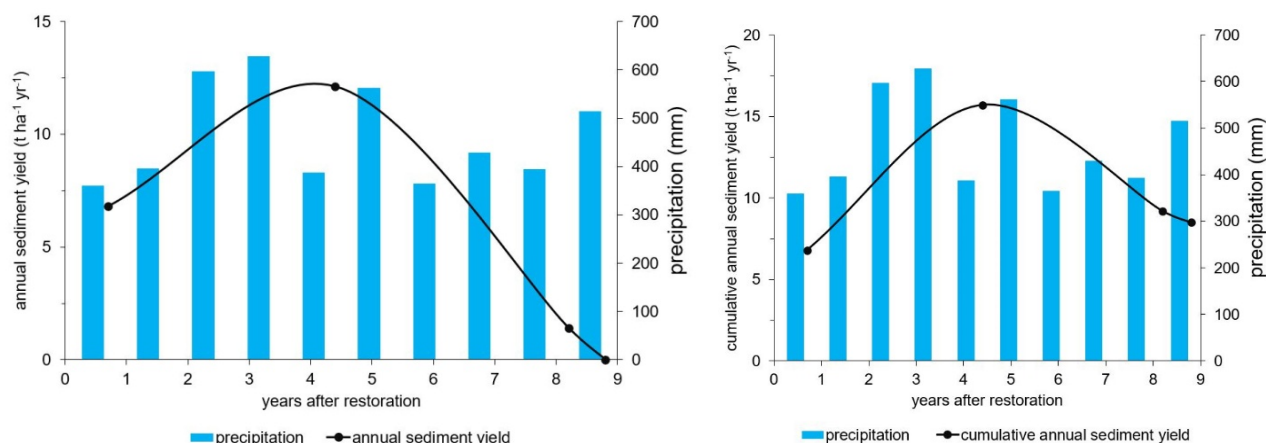
Figure 11. Left, evolution of the annual sediment yield of the Somolinos quarry with time. Right, cumulative sediment yield for the Somolinos quarry. Precipitation values are included for informative purposes (see discussion on precipitation at 3.3.4 section).

Figure 11 shows the limited erosion zones sediment yield evolution at the Somolinos quarry with time. In terms of erosion rates, annual sediment yield of the monitored area oscillated from 12.11 t ha<sup>-1</sup> yr<sup>-1</sup> (15.69 t ha<sup>-1</sup> yr<sup>-1</sup> cumulative) at the end of 2015 (half of the monitored period) to 0 t ha<sup>-1</sup> yr<sup>-1</sup> (8.55 t ha<sup>-1</sup> yr<sup>-1</sup> cumulative) for May 2020 (end of the monitoring period).

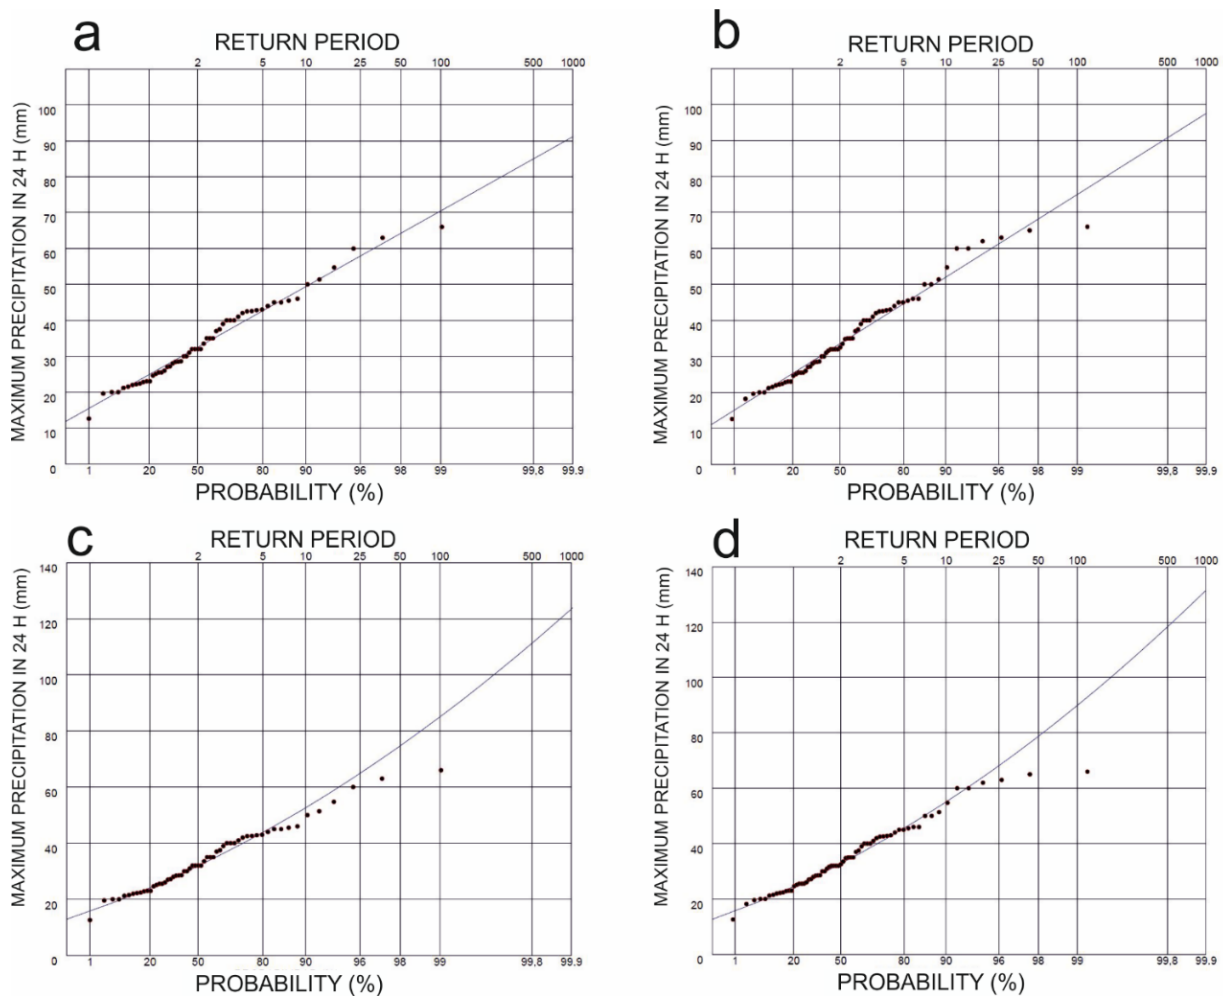
Figure 14. Magnitude and frequency curves of Maximum Precipitation in 24-hours for the Riba de Escalote weather station. (a) Gumbel function, MOM method, 1954-2010; (b) Gumbel function, MOM method, 1954-2020; (c) SQRT ETMax function, ML method, 1954-2010; (d) SQRT ETMax function, ML method, 1954-2020. See text and Table 4 for interpretation.

Regarding intensity, an analysis of the annual series, for the same period of 1954-2020, of maximum precipitation in 24-hours duration shows, for two statistical models (SQRT-ETmax + ML y Gumbel + MOM), the different precipitation quantiles are slightly higher for the series 1954-2020 than for the series 1954-2010 (see Table 4 and Figure 14). This means that the maximum precipitation in 24-hours has increased for the decade 2011-2020. In addition, those percentages increase with the return period, between 3.1% (T=2 years) and 6.3%
