Title: Non-destructive testing for the assessment of granite decay in heritage structures compared to quarry stone

TITLE: Non-destructive testing for the assessment of granite decay in heritage structures compared to quarry stone

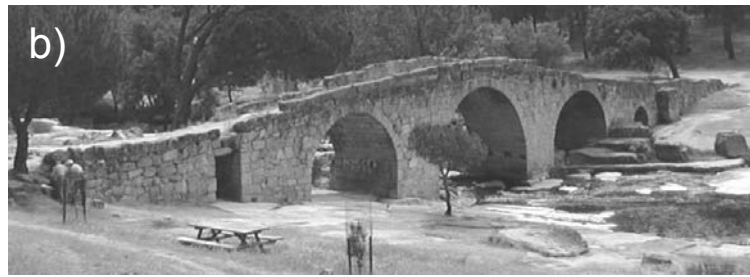
Figure 2

Fig. 2. a) Church The Assumption of Our Lady, Valdemorillo, Madrid. b) "Roman" bridge, Valdemaqueda, Madrid

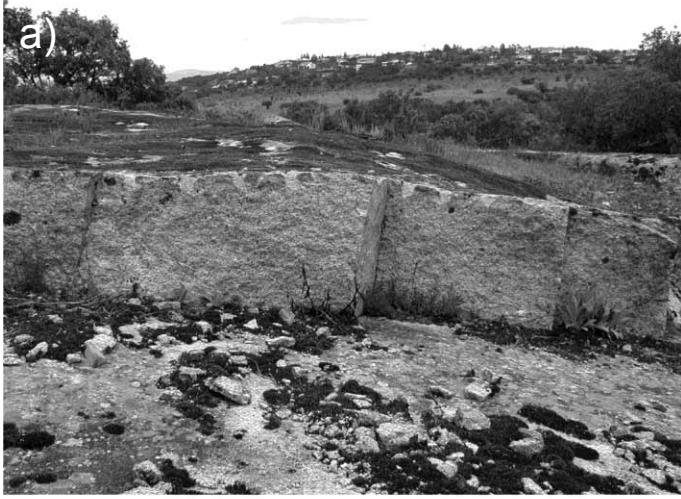
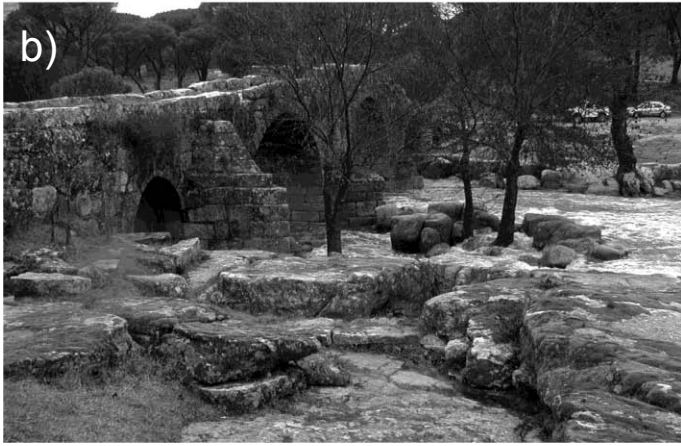
Figure 3

Fig. 3. Images of some of the quarries that supplied stone for the monuments construction. a) Valdemorillo, b) Valdemaqueda

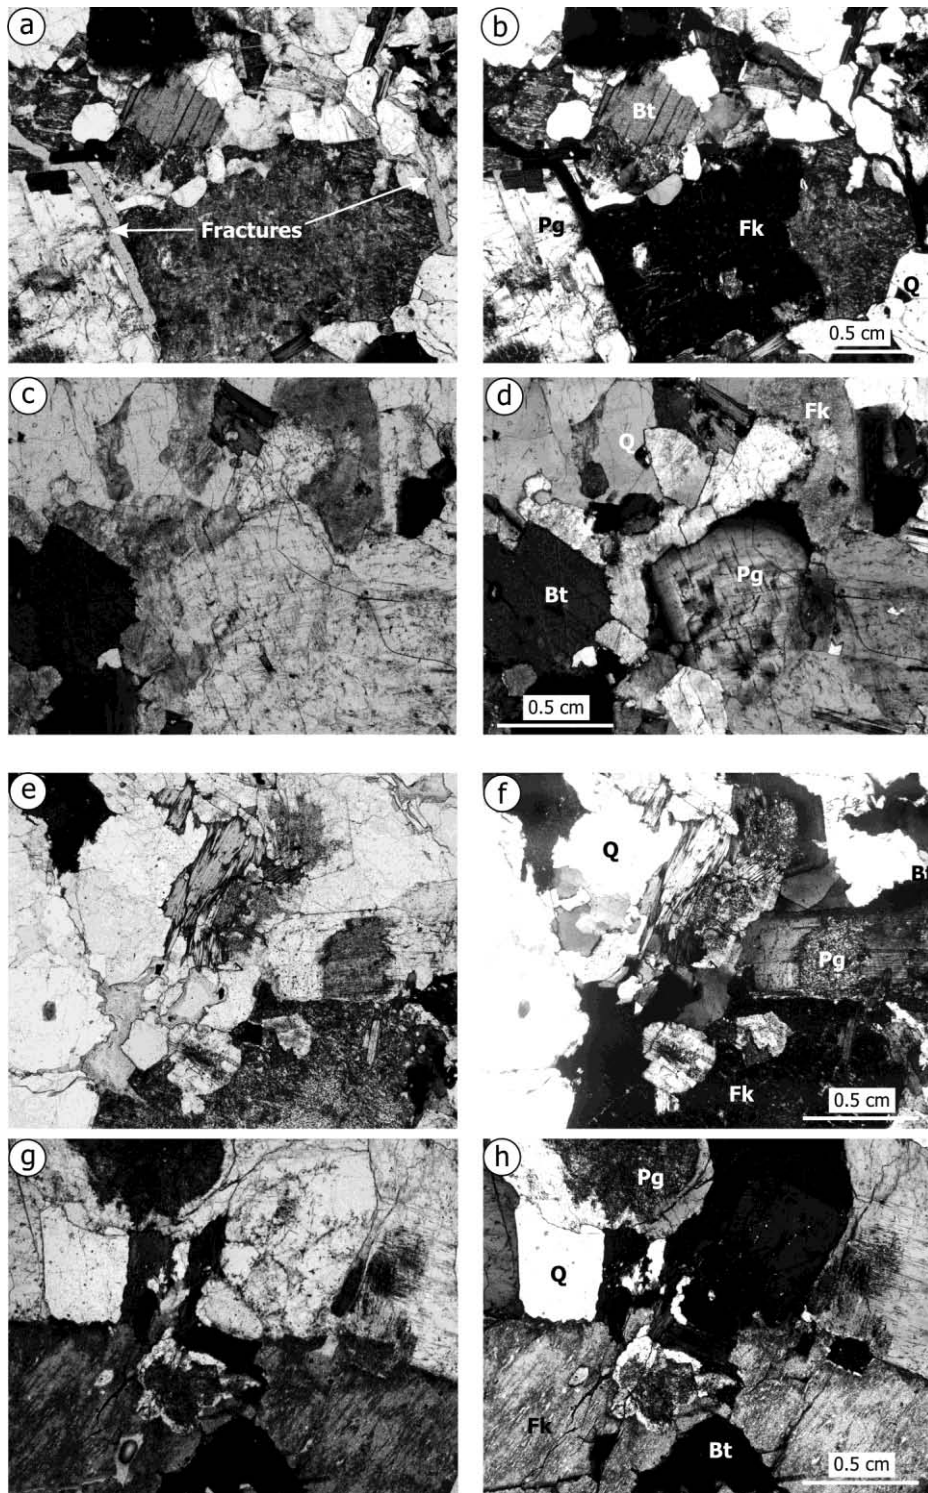
Figure 4

Fig. 4. Images of the sampled granites under the polarizing optical microscope. Left images, plane polarized light; right images, crossed polars. a, b, e and f correspond to ashlar; c, d, g and h to quarries. Church granitic ashlar (a and b) show more fissures and alteration of the potassium feldspar than granite quarried (c and d), both homogeneous monzogranite. The bridge granitic ashlar (e and f) and corresponding granite quarried (g and h), both porphyritic monzogranite, display intense plagioclase sericitization. Q: quartz, FK: potassium feldspar, Bt: biotite, Pg: plagioclase.

Both mineralogical and textural petrographic differences were observed between the church and quarry monzogranite. As a result of its alteration close to the surface, the potassium feldspar (orthoclase) in the ashlar appeared to be more soiled than in the quarry material, while the conversion of plagioclase to sericite was also slightly more intense in the former. Finally, a much larger proportion of fractured crystals were found in the building than in the uncut stone (Figures 4a, b, c and d).

As a result of mineralogical alteration processes in the granite, the plagioclase was intensively transformed into sericite, primarily in the crystal nucleus, where the coarsest epidote-clinozoisitic group crystals were observed. The surface biotite shows alteration, with few crystals converted to chlorite. Barely any significant mineralogical or textural differences were detected between the bridge and quarry stones (Figures 4e, f, g and h).

From a petrological standpoint substantial differences were found between the granite on the historic structures, especially the church monzogranite, and the rock in the quarries (Figure 4). These differences were mainly related to physical decay, with an increase of cracks both inside the minerals and in between their (inter and intra-crystalline) contacts. Cracking led to much higher porosity, which in turn favoured granite ashlar deterioration. The mineralogical differences between monumental and quarry granite included a slightly greater degree of conversion of plagioclase to sericite in the former, and the potassium feldspar in the monumental granite appeared to be more soiled than the mineral in the quarry rock.
