DOI: 10.1038/ncomms8963

# Exceptional river gorge formation from unexceptional floods

L. Anton<sup>1</sup>, A.E. Mather<sup>2</sup>, M. Stokes<sup>2</sup>, A. Muñoz-Martin<sup>3</sup> & G. De Vicente<sup>3</sup>

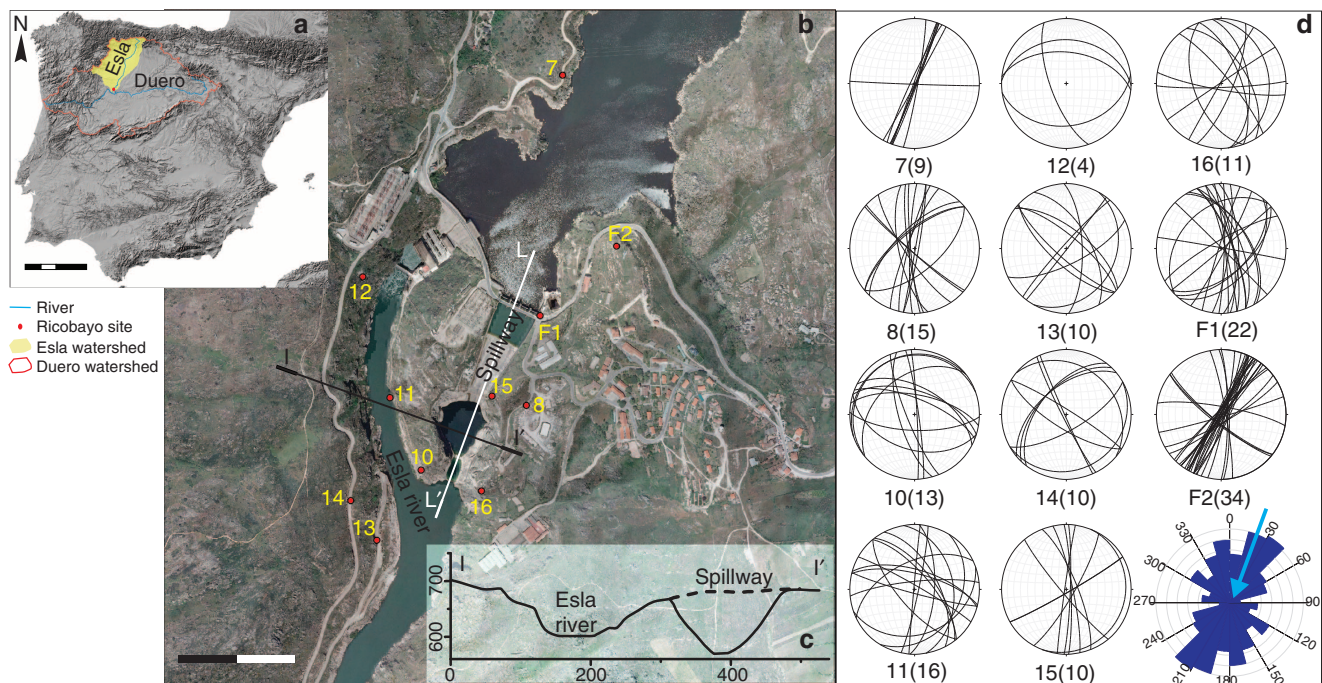
**Figure 1 | Field area and fracture pattern.** (a) The Río Esla and Duero watersheds and the study area location. Scale bar, 200-km long; (b) the Ricobayo dam, its spillway and sites of measurements and sampling (orthophotograph, IGN, 2011). Location of longitudinal profile shown in Fig. 3i is indicated by L-L'; I-I' indicates the section shown in c; scale bar, 250-m long (bottom left corner); (c) cross-section showing pre-scour (dashed line) and present topography. (d) Stereoplots of fracture orientations (numbers = location, in brackets the number of fractures plotted). Rose diagram of the whole-fracture population (class interval 15°, maximum percentage 14.6, percentage interval 2%). Arrow shows flow direction of spillway.

jointed/fractured. The top edge of the granite spillway coincides with a regional low-relief surface  $\sim 100$  m above the modern Río Esla channel (Fig. 1c).

**Bedrock discontinuities.** Systematic measurements of fractures (joints and faults, see Methods) revealed a pattern in the Ricobayo area dominated by NNE–SSW striking fractures (Fig. 1d). This included a primary NNE left-lateral strike-slip fault system concordant with previous field-based regional structural geological analyses<sup>34,35</sup>. This primary pattern exerts a significant control on drainage network orientation, as observed in the lower Río Esla reach (Supplementary Fig. 1). Secondary fracture sets oriented NNW–SSE and ESE–WNW are encountered and are significant at outcrop scale (Figs 1d and 4). Most fractures were vertical or near-vertical, although minor subhorizontal unloading joints were also present. Fracture spacing was locally in a 0.3–3 m range (Supplementary Table 1) and fracture length is typically more than several tens of metres, with a vertical persistence along the whole outcrop (Fig. 4). Exposures of discontinuity surfaces revealed a dominance of fresh, tight and unweathered planes. Fracture plots suggest that the primary fracture sets influence river incision and the progression of erosion in the spillway. Vertical and sub-vertical NNW to NNE trending structures determine the bedrock river and spillway gorge orientation (for example, site 15 in Figs 1 and 4a). ESE trending fractures are orthogonal to flow direction in the spillway with sets dipping both against and towards the flow (Figs 1d and 4).

**Fracture population analysis.** Field survey was undertaken to identify the bedrock fracture pattern. Orientation (trend and dip) of 151 fracture (fault and joint) planes were measured at 11 sites in the Ricobayo area (Fig. 1d). This task was preceded by field reconnaissance to select representative outcrops that encapsulated all of the fracture types and patterns. Stereoplots, histograms, rose diagrams and density plots were used to analyse the data. The fracture pattern is dominated by NNE–SSW striking structures, while secondary fracture sets oriented NNW–SSE and ESE–WNW take weight at outcrop scale (Fig. 1d). Together with the statistical analysis, the dominant trends were identified from aerial and field imagery and then compared with published regional fault patterns<sup>34</sup> (Supplementary Fig. 1). Due to the relevance of dip and dip direction of the orthogonal to flow fracture sets in the erosional process<sup>36,57</sup> and based on field experience (Fig. 4a–d), ESE trending sets were analysed separately. Planes striking within  $\text{N}85^\circ \text{ E}$  and  $\text{N}140^\circ \text{ E}$  were extracted from the whole population and represented by a stereoplot and density diagram (Fig. 4h).

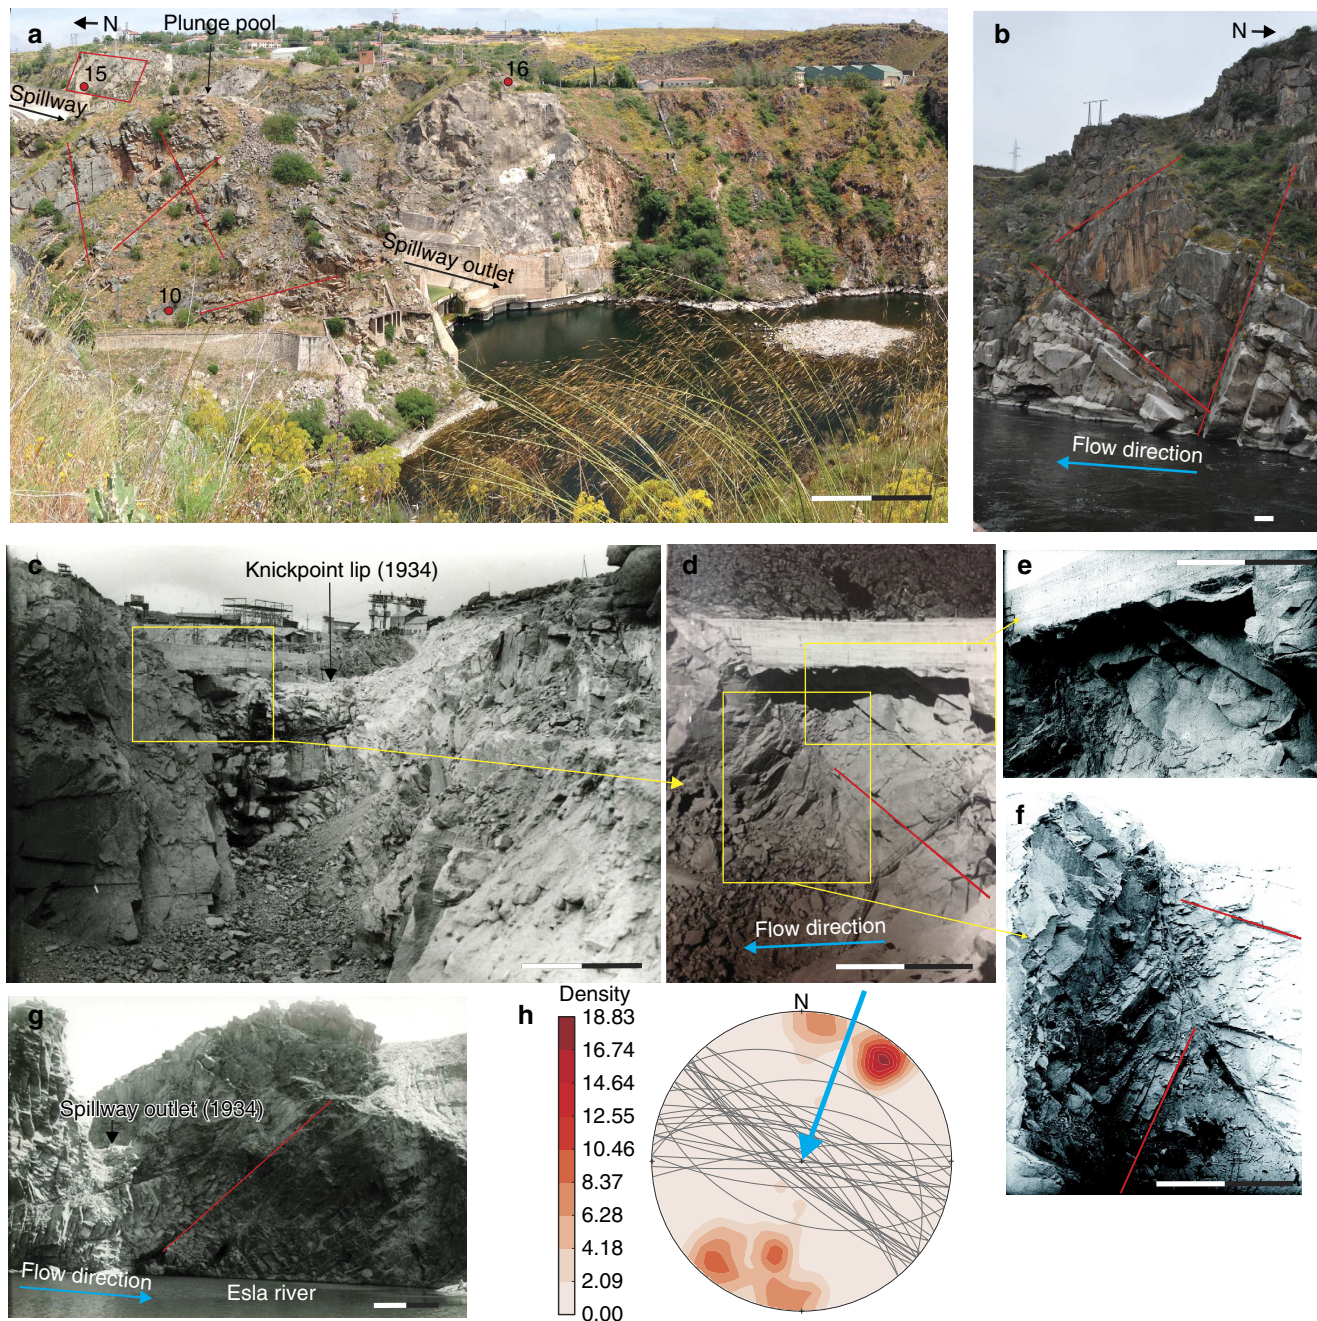
**Figure 4 | Field photographs illustrating fracture geometry at the spillway site and Río Eslla.** (a) Present spillway outlet and fracture pattern. Red dots indicate measurement sites (Fig. 1), red lines indicate fracture planes. Red box at site 15 represents a ~N-S fault plane outcrop, parallel to the spillway gorge orientation. Scale bar, ~50-m long. (b) Western side of the Río Eslla in front of site 11 (Fig. 1b). Fracture set dipping against and toward the flow. Scale bar, ~1-m long. (c) Spillway lip and gorge formed during 1933-1934 hydrologic year (scours 1-3; Fig. 3); scale bar, ~50-m long, (credit Iberdrola). Yellow box indicates location of photograph d. (d) Fracture pattern at the knickpoint lip by summer 1934 when retreat had significantly slowed (credit Iberdrola). Scale bar, ~25-m long; Yellow boxes indicate location of photographs (e,f). (e) Detail of fracture orientation (dipping against the flow) at the knickpoint lip. Scale bar, ~25-m long. (f) Detail of fracture orientation (dipping predominantly toward the flow) downstream of the knickpoint lip. Scale bar, ~25-m long; (g) Fracture sets dipping predominantly against the flow at the ~30-m height knickpoint formed at the spillway outlet (confluence with the Río Eslla) by March 1934. This knickpoint disappeared during the fourth main scour (Fig. 3d,e) in March 1935. Scale bar, 25 m. (h) Orthogonal to flow fracture planes dipping towards and against the flow. Stereoplot and density plot of ESE trending fractures, measured at the Ricobayo sites (see Methods).

patterns are found in the regional geological context. However, discontinuity patterns through fracture density and orientation interactions play an important role in the gorge development<sup>12,20,36</sup>. The existence of several fracture sets with different orientations resulted in the formation of bedrock blocks that were susceptible to removal by plucking and probable block topple

(Fig. 4). Similar (m-scale) blocks can be found elsewhere in the natural reaches of the Río Eslla suggesting this is not just localized to the spillway area. The NNW to NNE structures regionally determines channel orientation patterns. Furthermore, although they are quantitatively less represented, the orthogonal to flow fracture sets within these channels play a key role in the gorge

progression. This structural pattern (Fig. 4) enhances headward erosion when the fractures dipped towards flow and favoured incision when fractures dipped predominantly against flow<sup>20,36</sup>.

by anti-flow oriented fracture sets, implying that that structural differences along the gorge, with local predominance of fracture sets dipping against the flow, became significant in suppressing the retreat progression<sup>30</sup> (Fig. 4d-g).

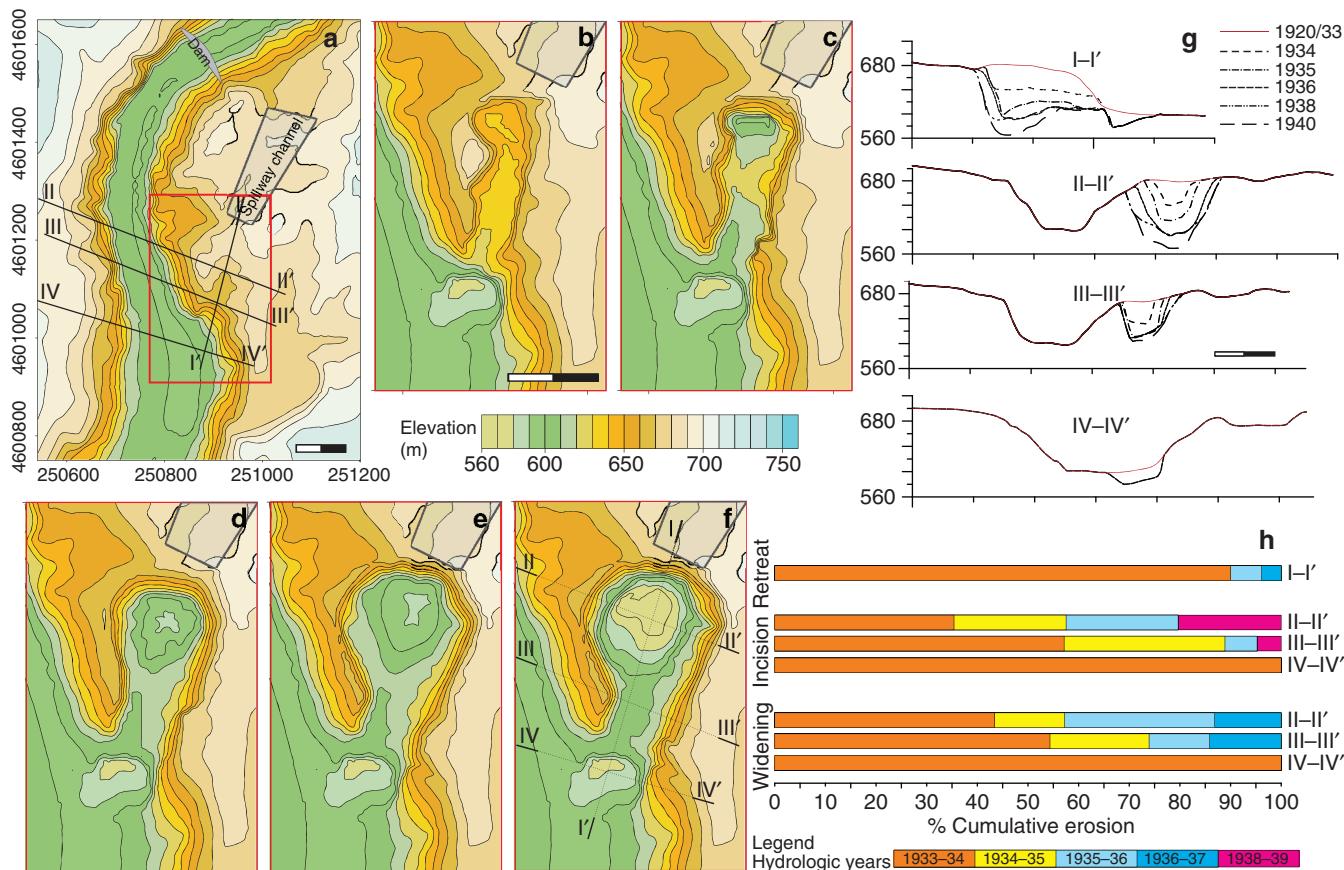
**Figure 5 | Contour maps of the spillway topography showing the erosion sequence.** Contour lines = 10-m intervals. Map dates: (a) 1920; box = area represented in b-f; Dam and present location of the spillway channel represented. (b) 1934 (after scour events 1-3); (c) 1935 (after scour event 4); (d) 1936 (after scour event 5); (e) 1938; (f) 1940; (g) sections of spillway site in successive years (see a for location). Scale bar, 100-m long. (h) Plot of cumulative percentage of retreat, incision and widening along different gorge sections. Upper reach (II-II'), middle reach (III-III') and lower reach (IV-IV').

during the erosion events (1934–1940) was performed through analysis of historic topographic maps<sup>28,29</sup> (Methods). Digital elevation model (DEM) generation illustrates the former topography of the spillway site and how the bedrock erosion proceeded (Fig. 5). Comparison of successive DEMs enabled spatial and temporal erosion patterns to be quantified for successive stages and allows the calculation of erosion rates (incision, widening, retreat and eroded volume; Fig. 6).

Before the erosion events dam workers established a low gradient (<1°) unlined rock spillway channel. The channel, 400-m long, was inset ~20 m into the bedrock on a topographic high (~70 m above the riverbed; Figs 3i and 5a). The downstream boundary of the spillway was formed by a high angle (~30°) knickpoint lip perpendicular to flow that had been artificially created in the spillway mouth (Figs 3 and 5a,g).

depth increased in the plunge pool with successive outflow discharges and progressive scour formation, the water jet energy focused on the developing plunge pool water body<sup>41,42</sup>. Over this time bedrock scours occurred predominately at the base of the plunge pool and incision in the middle reach was minimal (Figs 5g,h and 6). Subsequently, as the channel was deepened and enlarged, the rim of the headwall and the gorge sides became unstable and the canyon began widening. Thus, while headwall retreat moved as a wave of erosion upstream creating the canyon, the slowdown in retreat rate promoted a persistent vertical headwall, allowing incision and widening to progress (Fig. 7) and eventually forming the present amphitheatre-headed valley with a 40 m water depth plunge pool (Figs 5 and 6).
