AN OVERVIEW OF NON-DESTRUCTIVE AND MINIMALLY INVASIVE TECHNIQUES FOR MOISTURE CONTROL IN THE CULTURAL HERITAGE

This article describes the use of non- or minimally destructive methods to study damp in San Juan Bautista Church at Talamanca de Jarama in the Spanish province of Madrid. The combination of ground penetrating radar (GPR), electrical resistivity tomography (ERT) and wireless sensor network (WSN) techniques provided sub-surface information, while data on wall surfaces were collected with contact hygrometry and infrared thermography. The respective findings and ranges of observation were inter-related to identify the decay associated with the damp and determine the advantages and drawbacks of each instrumental method.

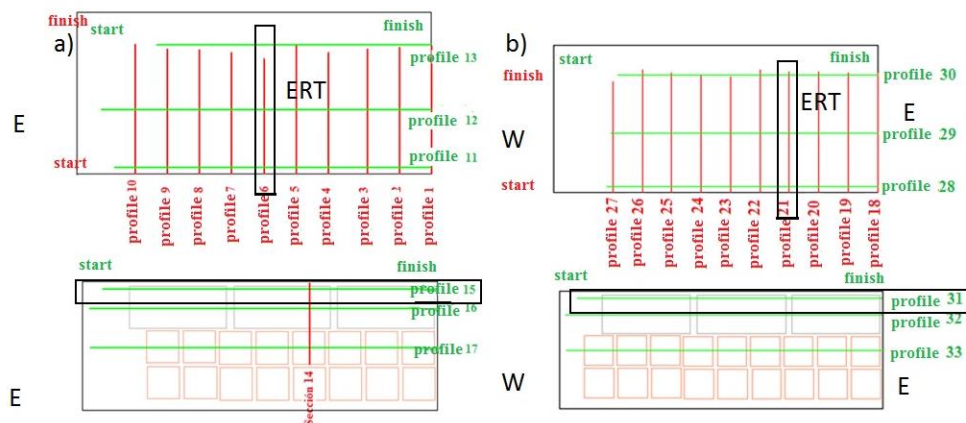
Figure 4. GPR survey profiles in a) south-side wall (above, elevation view) and floor (below, plan view); b) north-side wall (above, elevation view) and floor (below, plan view); solid black outline: profiles where ERT was also performed

The radargram for survey profile 1 revealed the presence of moisture in some points around the confessional, most conspicuously in the dado. This finding was consistent with the saturation (RH in the 95 % to 100 % range) detected by the sensors in the preliminary monitoring campaigns [22]. As a rule, moisture content was greater around the confessional in the lower areas of the wall (profiles 1, 2 and 4, Figure 4).

Substantial differences were observed among the horizontal cross-sections for the south wall (Figure 11) depending on whether they were on (profile 12, 1.0 m), above (profile 13, 2.0 m) or below (profile 11, 0.0 m) the moisture front (see Figure 4).

Figure 14 shows some of the floor cross-sections analysed on the south side of the church. In the cross-sections for profiles 15 and 16 (Figure 4), a change from a more to a less compact medium was detected at a depth of around 0.37 m, where the infill gave way to the original soil. A few reflections attributed to the pavers were observed in the profile 15 cross-section, which had no underlying structures, according to the church staff. The change from infill to soil appeared at a depth of 0.19 m in the cross-section for profile 17, sited at a farther distance from the wall. The cross-section for profile 14, which was perpendicular to the other cross-sections in Figure 14, also exhibited a reflection denoting a change of medium, represented by a white line present at a depth of 0.37 m in the profile 15 and 16 cross-sections and at 0.19 m in the cross-section for profile 17.

Figure 15 shows some of the wave transmission findings for the under-floor cross-sections alongside the north wall. Profile 31 was closest to the ERT profile (Figure 4). Overall, large areas with no reflections were observed at depths of over 0.37 m, where the medium was observed to change, as it did under the floor along the south wall. On this north side, the reflection denoting the change of medium also appeared at 0.19 m in the cross-section for profile 33, the one farthest from the wall. The GPR findings likewise confirmed that the original soil contained more moisture along the north than along the south wall. In the former, larger areas with scant reflections were found primarily in the cross-sections closest to the wall (profiles 31 and 32), which was consistent with the results of surface monitoring in this area (Figure 5).
