# A Case Study of a Large Unstable Mass Stabilization: “El Portalet” Pass at the Central Spanish Pyrenees

**Abstract:** This case study presents the engineering approach conducted for stabilizing a landslide that occurred at “El Portalet” Pass in the Central Spanish Pyrenees activated due to the construction of a parking lot. Unlike common slope stabilization cases, measures projected here were aimed at slowing and controlling the landslide, and not completely stopping the movement. This decision was taken due to the slow movement of the landslide and the large unstable mass involved. The degree of success of the stabilization measures was assessed by stability analyses and data obtained from different geotechnical investigations and satellite survey techniques such as GB-SAR and DinSAR conducted by different authors in the area under study. The water table was found to be a critical factor in the landslide’s stability, and the tendency of the unstable slope for null movement (total stability) was related to the water table lowering process, which needs more than 10 years to occur due to regional and climatic issues. Results showed a good performance of the stabilization measures

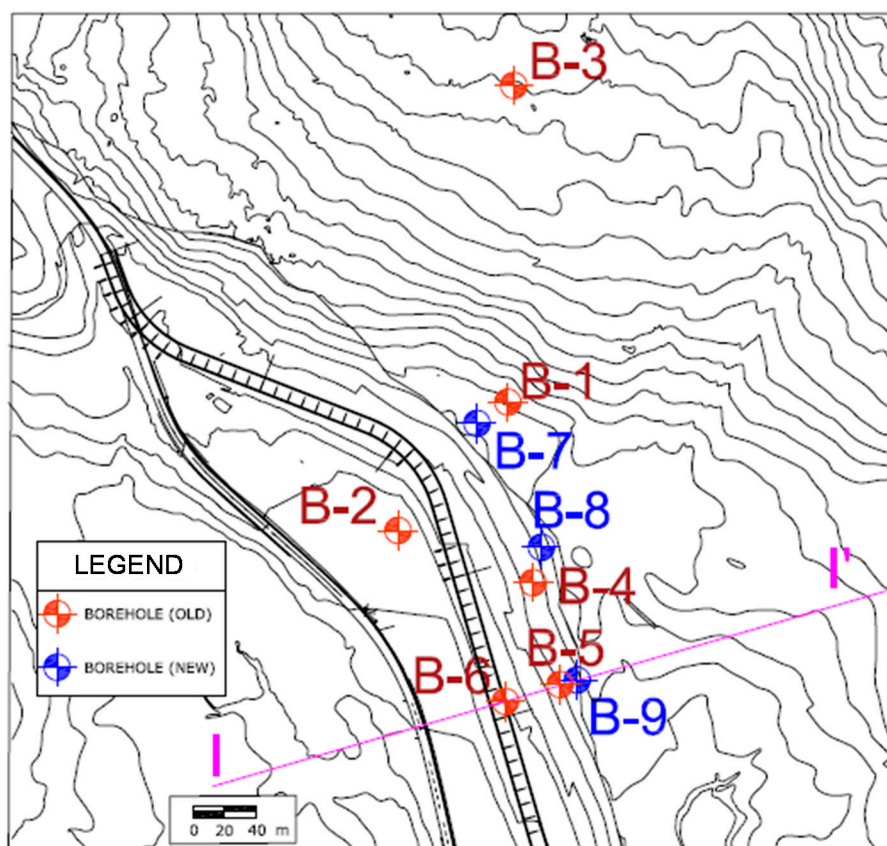
Previous geological–geotechnical investigations [15] conducted in 2005 consisted of six boreholes (location is shown in Figure 2) with depths between 24 m and 40 m. Standard Penetration Tests (SPT) were performed on each borehole when crossing soils and very weathered rocks, with a frequency of about 3 m. Disturbed and undisturbed samples were extracted from each level identified. Laboratory tests conducted on such samples included general identification tests (e.g., grain size, Atterberg limits, unit weight) and mechanical tests (uniaxial compression strength on rocks and direct CD shear tests and triaxial CU tests on soils).

**Figure 2.** Location of the boreholes performed in the previous study [15] (“old” boreholes, conducted in 2005, reprinted with permission from ref. [15], Copyright Year 2005, Copyright Owner’s F.J. Torrijo) and the new geotechnical investigation (“new” boreholes, conducted in 2016); profile I-I’ relates to Figure 5.

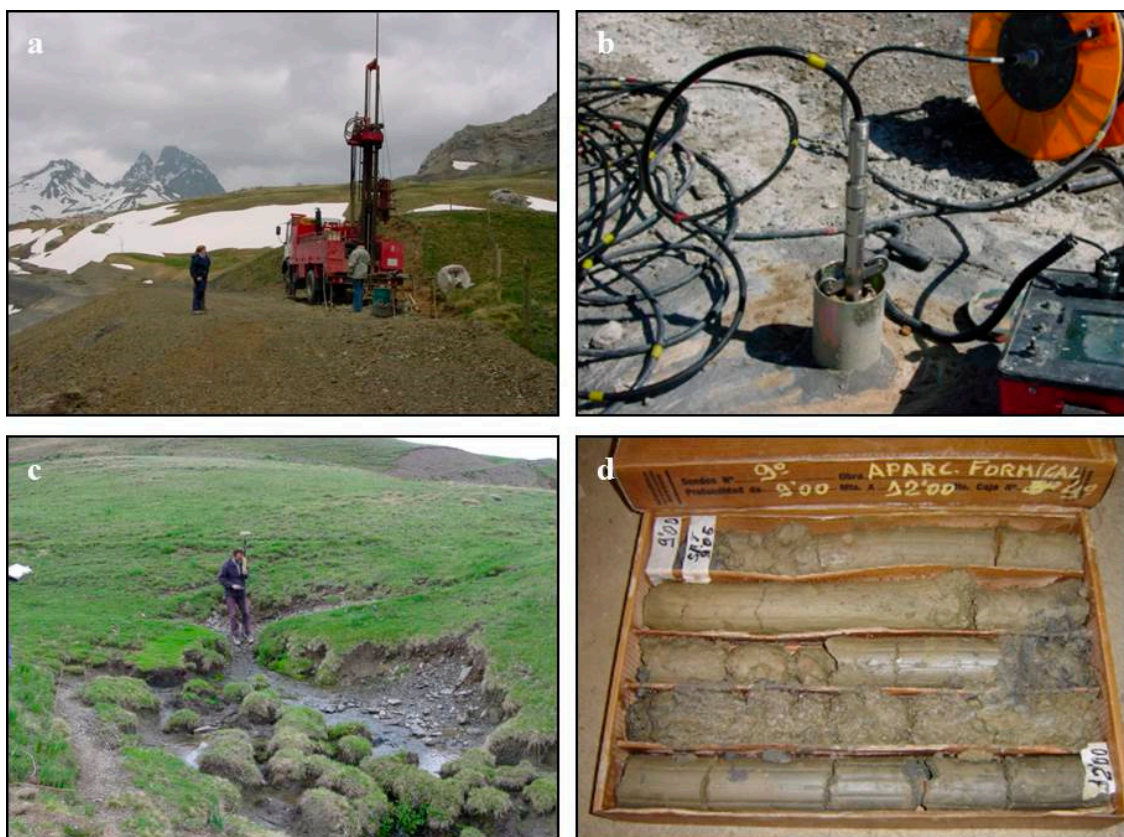
In 2016, approximately 10 years after conducting the stabilization works of the slope, three new boreholes were performed (Figure 4a) at the area under study. Those boreholes attained a depth between 30 m and 45 m and were performed close to those executed in the previous field investigation (see Figure 2). On each borehole, SPT tests were performed in soils and very weathered rocks, with a frequency of about 3 m. Disturbed samples were extracted from each level found and general identification laboratory tests were carried out (grain size, Atterberg limits and unit weight).

Similar to the actions performed in the previous geological–geotechnical investigation, inclinometers were installed on the new boreholes (Figure 4b). Besides, a new inventory of water points was carried out along the entire hillside (Figure 4c).

**Figure 4.** New geotechnical investigation works: (a) Borehole performance; (b) Inclinometer installation; (c) Inventory of water points; (d) Example of the Quaternary material obtained in the boreholes.
