EFFECT OF MANUFACTURING METHODS ON THE DECAY OF CERAMIC MATERIALS: A CASE STUDY OF BRICKS IN MODERN ARCHITECTURE OF MADRID (SPAIN)

Elena Mercedes Perez-Monserrat^{a*}, Fernando Agua^b, Rafael Fort^a, Monica Alvarez de Buergo^a, Juan Felix Conde^b, Manuel Garcia-Heras^b

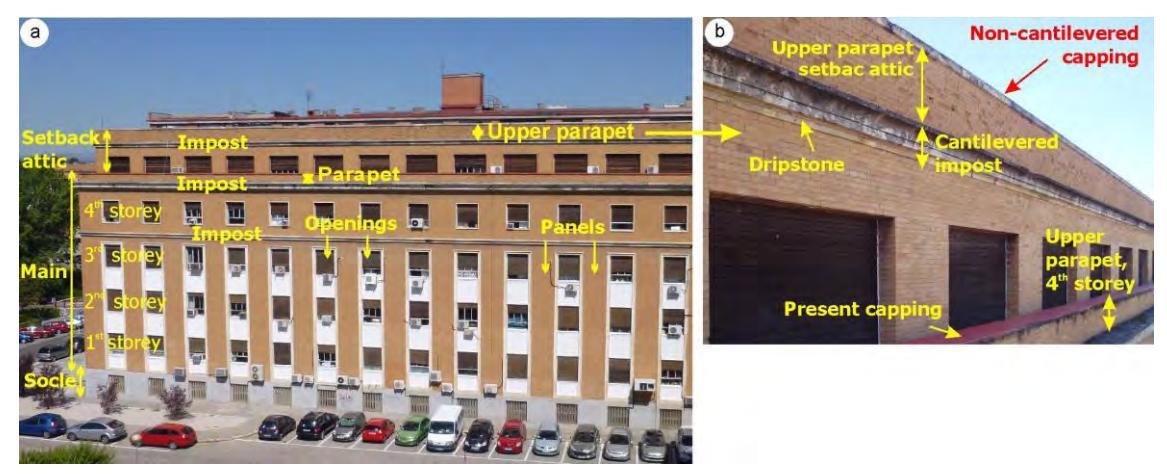
Figure 2. Faculty of Medicine façade designe.

a) three main components (from bottom up): socle, main body (4 storeys) and setback attic with terrace. b) detail of setback attic: the narrow ledge capping the upper parapet and the cantilevered cornice-like impost, fitted with a dripstone, can be shown.

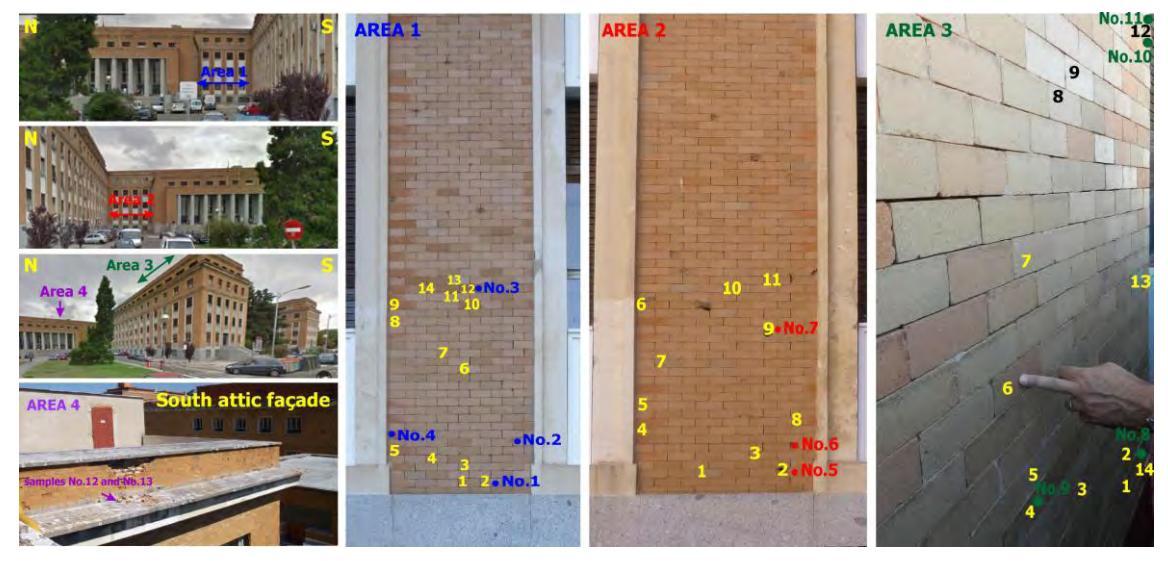
Figure 3. Areas selected on the façades for in-situ measurements (areas 1, 2 and 3) or sampling (areas 1, 2, 3 and 4). Details showing the 39 bricks measured (numbered from 1 to 39, in yellow) and the samples taken (No.1 to No.13, in blue, red or green), mostly from the same 39 bricks.
