Effect of conservation treatments on heritage stone. Characterisation of decay processes in a case study.

Preliminary studies are an imperative when determining the impact of conservation treatments on historical materials. The Romanesque apse on a church at Talamanca de Jarama, Madrid, Spain, whose dolostone was severely decayed by rainwater and salts, was treated in the past with substances that ravaged the restored area. Petrological techniques showed that salts leached out of the cement under the roof onto the stone cornice whose surface had been coated with synthetic resins. During evaporation, the salts precipitated in the stone and underneath the resin, inducing blistering, fissuring, flaking, scaling and detachment of part of the restored decorative elements.

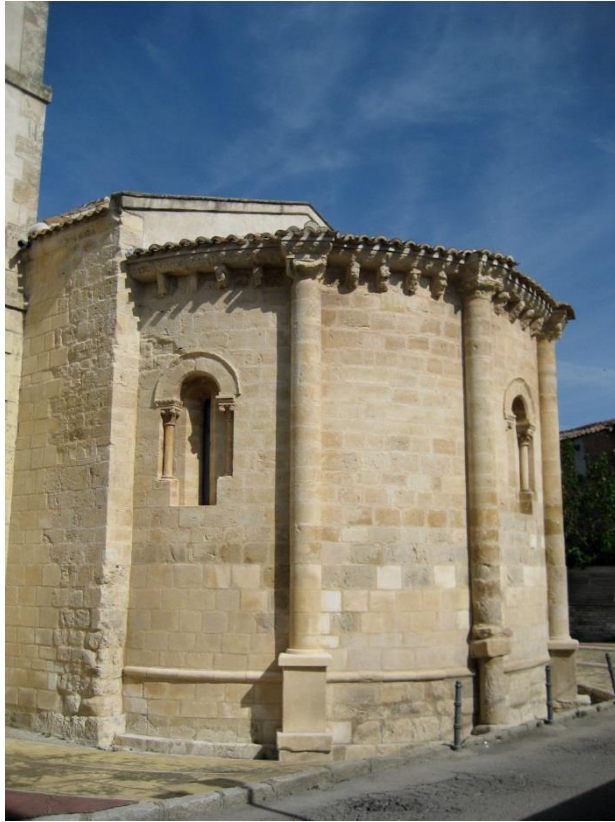
Fig. 1

513 Fig. 1. Twelfth-thirteenth century Romanesque apse on church at Talamanca de Jarama, Madrid,
514 Spain, whose upper stone ashlar are yellow and lower rough ashlar beige dolostone; occasional
515 white limestone cladding

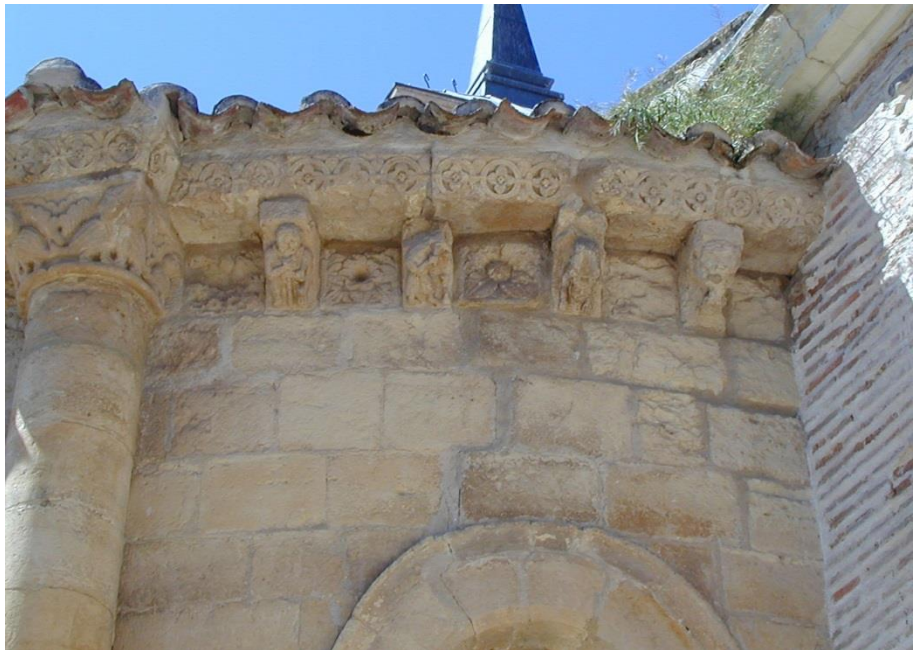
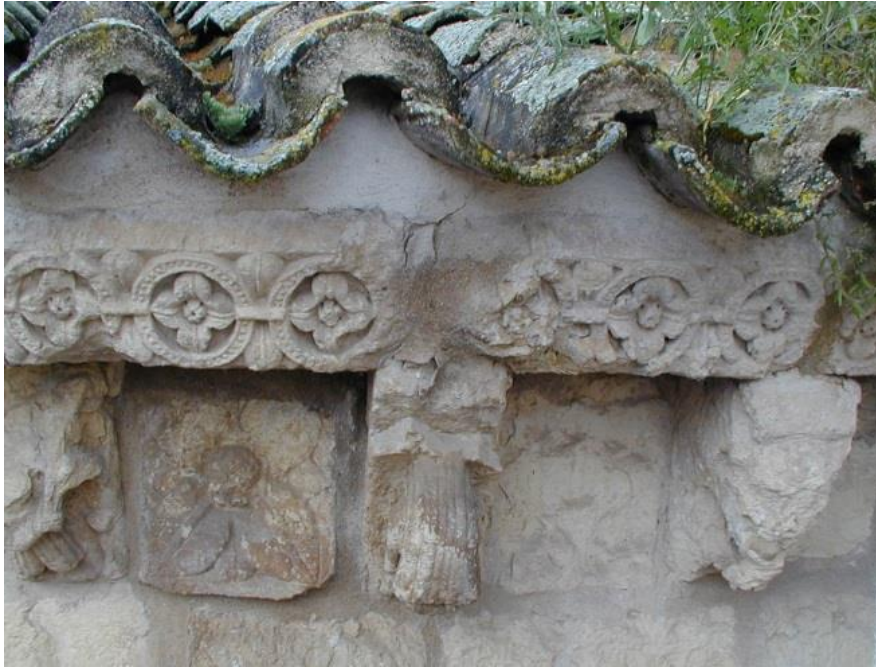
Fig. 2

516 Fig. 2. Richly carved cornice and modillions on the upper part of the church, restored in 1990:
517 cement mortar filling in inter-ashlar joints and laid directly on the cornice underneath the Spanish
518 tile roof

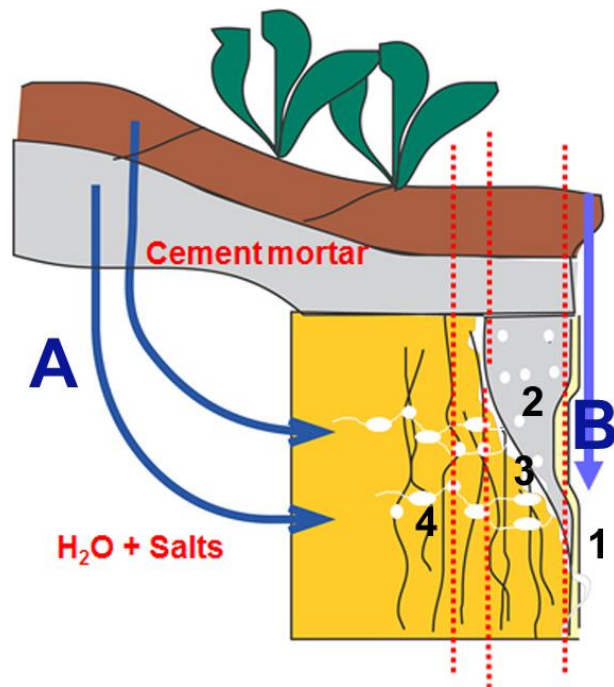
Fig. 15

The gypsum ($\text{SO}_4\text{Ca}\cdot 2\text{H}_2\text{O}$) present in this area was generated after the 1990 restoration and appeared to be the direct cause of the accelerated decay observed in the restored cornice. It adopted the form of sub-efflorescence underneath the treatments used to restore the cornice ornaments and crypto-efflorescence inside the cracked stone (Figs 8, 13 and 14). While internal, this mineral was not attributable to the dolostone, for the salts originated during stone decay, such as epsomite or hexahydrite, are magnesium sulfate-based [34]. Rather, its origin was associated with the grey portland cement mortar laid in 1990 both underneath the apse roof tiles and directly on the carved cornice, filling joints and cracks between the ashlar comprising the cornice (Fig. 3). After 1990, dissolved sulfur and calcium salt-laden rainwater leaking through the roof generated an ionic charge in the underlying cement mortar [14, 35]. These ionic solutions seeped into the dolostone beneath the cornice and flowed fairly freely inside the highly porous stone, working their way outward to the surface during the evaporation induced by the local climate (dry and very warm summers $>30^\circ\text{C}$ [20]). The restoration treatments used to reconstitute and conserve the outer ornaments prevented these solutions from exiting the stone, however (Fig. 15) [25].

Prevented by the presence of silicate consolidant inside the cracks, gypsum precipitated in the pores not penetrated by the conservation product. These pores were inter-connected by capillaries running across the treatment (Figs 14b and 15). Gypsum precipitation in the pores induced the growth of sub-spherical nodules up to $300\text{ }\mu\text{m}$ in diameter and internal stress as a result of crystallisation (Figs 8 and 14). These gypsum nodules were the saline crypto-efflorescences observed inside the dolostone, and whose formation could be explained in a similar way to the formation (controlled by substrate porosity) of evaporite nodules in sebkha zones (current geological environments characterised by climatic intense evaporation) [36-37].
