**CONTRIBUTION OF ANALYTICAL TECHNIQUES TO DETERMINING THE TECHNOLOGIES USED IN THE CERAMIC MATERIALS FROM THE FORMER WORKERS HOSPITAL OF MAUDES, MADRID (SPAIN)**

### 1.1. Ceramic materials in the Workers Hospital of Maudes: raw materials and processing

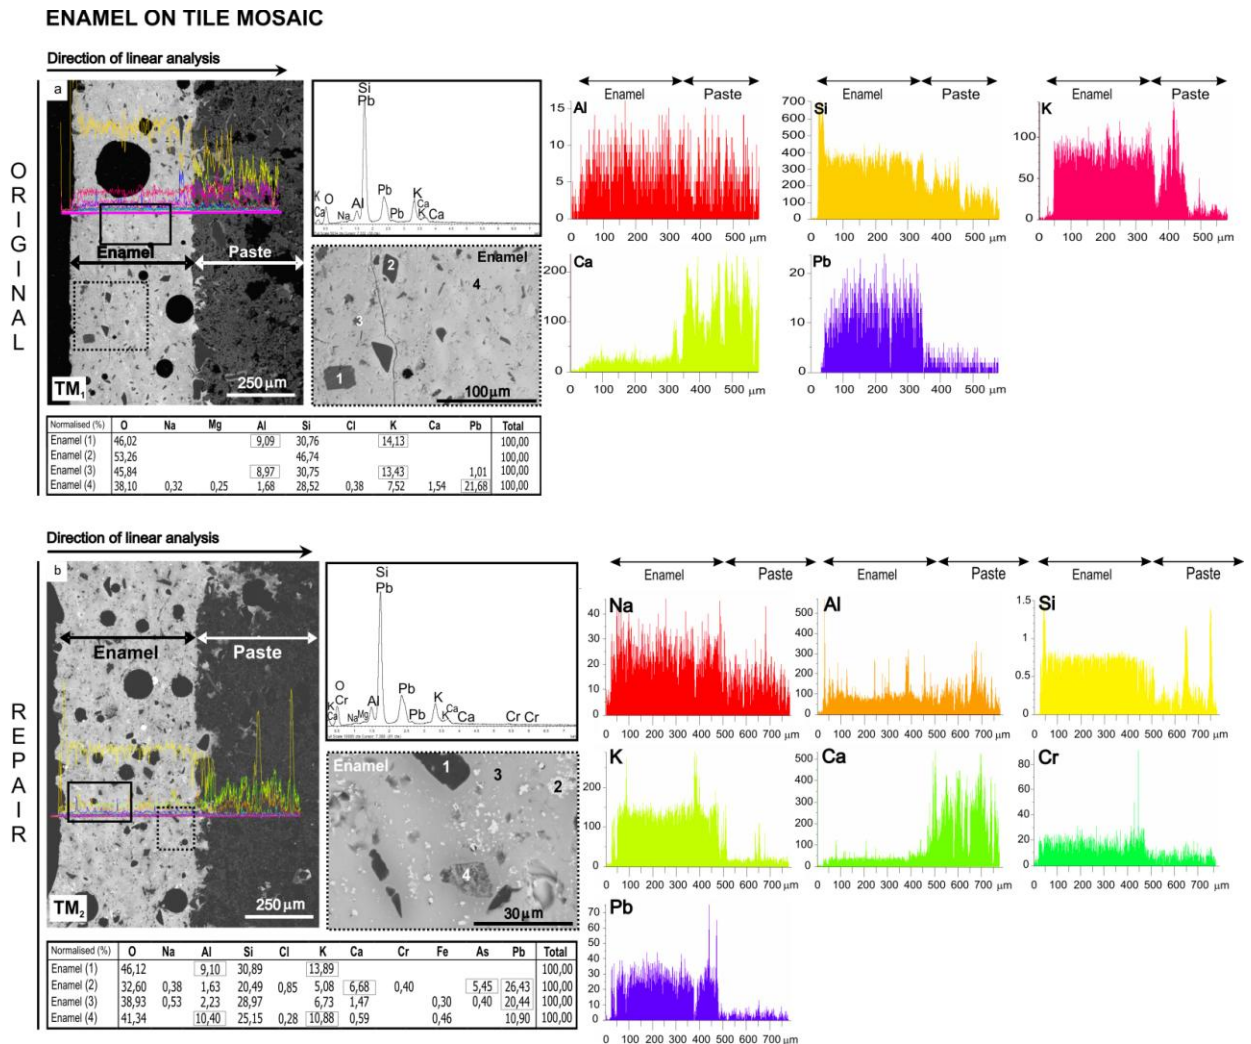
Fig. 6. Backscattered mode scanning electron microscopy (BSE-SEM) micrographs and energy dispersive X-ray spectra (EDS) of the enamels applied to original and repair mosaic tiles.

The enamel applied to the original tiles (Fig. 6a) is non-uniform and it has a constant 330  $\mu\text{m}$  thick, approximately. Its contact with the ceramic paste is continuous although slightly snarled. It exhibits circular internal gas bubbles of various sizes, some up to 150  $\mu\text{m}$  in diameter. The elements detected have been Na, Al, Si, K Ca and Pb. Si, K and Pb are the most abundant elements. The Al and K contents are particularly significant in some of the constituents of the enamel analysed. The Si forms part of some of the particles identified under the optical microscope (Fig. 3.3c). None of the elements that may have given the enamel its greenish-blue hue have been detected, no was any glaze observed.

The enamel in the repair tiles (Fig. 6b) resembles the enamel applied to the original materials very closely. Its texture is uneven and it has circular gas bubbles of different sizes (25-90  $\mu\text{m}$  in diameter). Its thickness is a very constant  $\pm 450 \mu\text{m}$ , the paste-enamel contact is essentially smooth although quite uneven. The EDS spectrum reveals the presence of Na, Mg, Al, Si, K, Ca, Cl and Pb in the enamel. Here also, Si, K and Pb are the majority elements. Some of the enamel constituents have significant Al and K contents. High proportion of Ca and As

particles are observed, probably added to attain respectively a glossy finish and opacify the enamel [39]. All the elements reported by [20] have been detected: Pb, Na, K, Si and Al. Chromium, added in the form of chromium oxide, was primarily responsible for the green hue [39], although the small amount of Fe detected might have also contributed.
