# Corrosion behaviour of silicon–carbide-particle reinforced AZ92 magnesium alloy

The corrosion behaviour of silicon–carbide-particle (SiCp) reinforced AZ92 magnesium alloy manufactured by a powder metallurgy process was evaluated in 3.5 wt.% NaCl solution, neutral salt fog (ASTM B 117) and high relative humidity (98% RH, 50 °C) environments. The findings revealed severe corrosion of AZ92/SiC/0–10p materials in salt fog environment with formation of corrosion products consisting of  $Mg(OH)_2$  and  $(Mg,Al)_x(OH)_y$ . The addition of SiCp increased the corrosion rate and promoted cracking and spalling of the corrosion layer for increasing exposure times. Composite materials revealed higher corrosion resistance in high humidity atmosphere with almost no influence of SiCp on the corrosion behaviour.

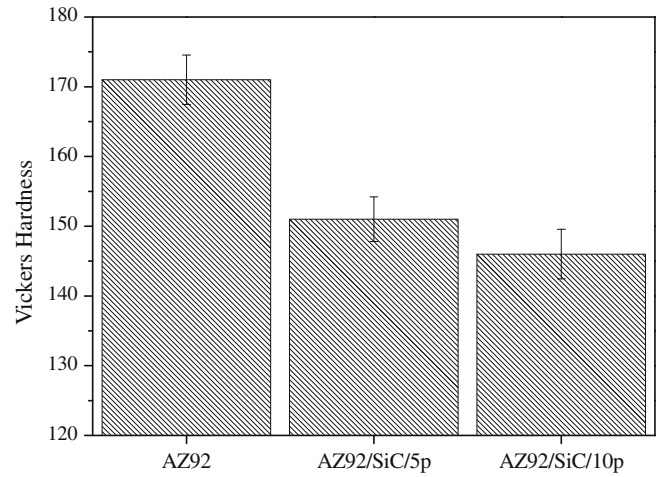
Fig. 3. Effect of SiCp addition on the surface hardness of tested materials.

The addition of SiCp up to 10% vol. slightly decreased the surface hardness of the AZ92 magnesium alloy (Fig. 3). This may be explained by the influence of the SiCp on the texture of this type of materials. Thus, for similar magnesium composites, Garcés et al. [22] found that the addition of SiCp to magnesium alloys developed a fibre texture with the 10 $\bar{1}0$  planes perpendicular to the extrusion direction that determined the mechanical behaviour of these materials [7]. Other properties like the wear resistance, out of the scope of the present study, may be improved by the incorporation of SiCp.

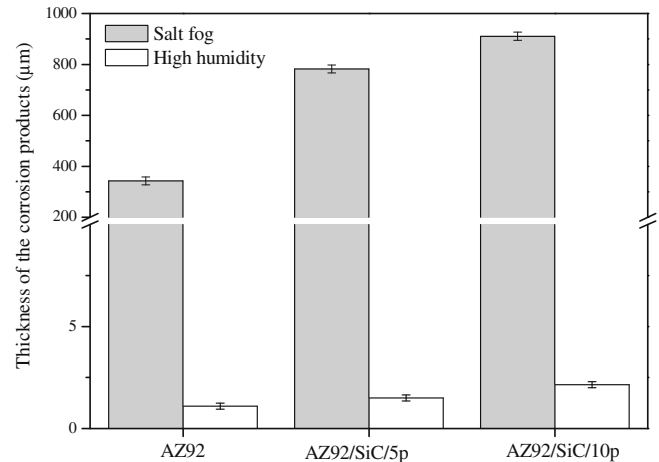
Fig. 11. Thickness of the corrosion layer for the tested materials exposed to salt fog (21 days) and high humidity (28 days) environments.

The thicknesses of the corrosion layers formed on the tested materials are presented in Fig. 11. Thickness values were the average of 20 measurements from examination of cross-sections by SEM. For salt fog specimens, the spalling of the corrosion products was not considered; therefore it is likely that the real thickness of the corrosion layer was greater than the presented values. In saline environment, the addition of SiCp increased the thickness of the corrosion layer by approximately 2–3 times compared with the unreinforced AZ92 magnesium alloy. When the materials were exposed to the high humidity environment the thicknesses of the corrosion layers were reduced by three orders of magnitude.
