**Evaluation of MF and UF as pretreatments prior to RO applied to  
reclaim municipal wastewater for freshwater substitution in a paper  
mill: a practical experience**

A pilot plant study has been carried out to compare the effectiveness of different low pressure membrane systems (microfiltration and ultrafiltration) as pretreatments for a reverse osmosis system producing high quality reclaimed water from the effluent of a municipal wastewater treatment plant receiving a high percentage of industrial wastewater. The reclaimed water will be used to substitute fresh water in a paper mill. Although the implemented systems showed several problems derived from the unstable quality of the feed water, they were solid enough to keep a constant permeate quality; i.e. percentages of salt rejection above 99%, efficiencies in the removal of microorganisms to lower values than 1 CFU/100mL, and final COD results below the detection limit ( $<5 \text{ mg}\cdot\text{L}^{-1}$ ). In short, the quality of the produced reclaimed water was good enough to be used substituting fresh water in a paper mill. An enhanced monitoring of the quality of the water feeding the municipal wastewater treatment plan

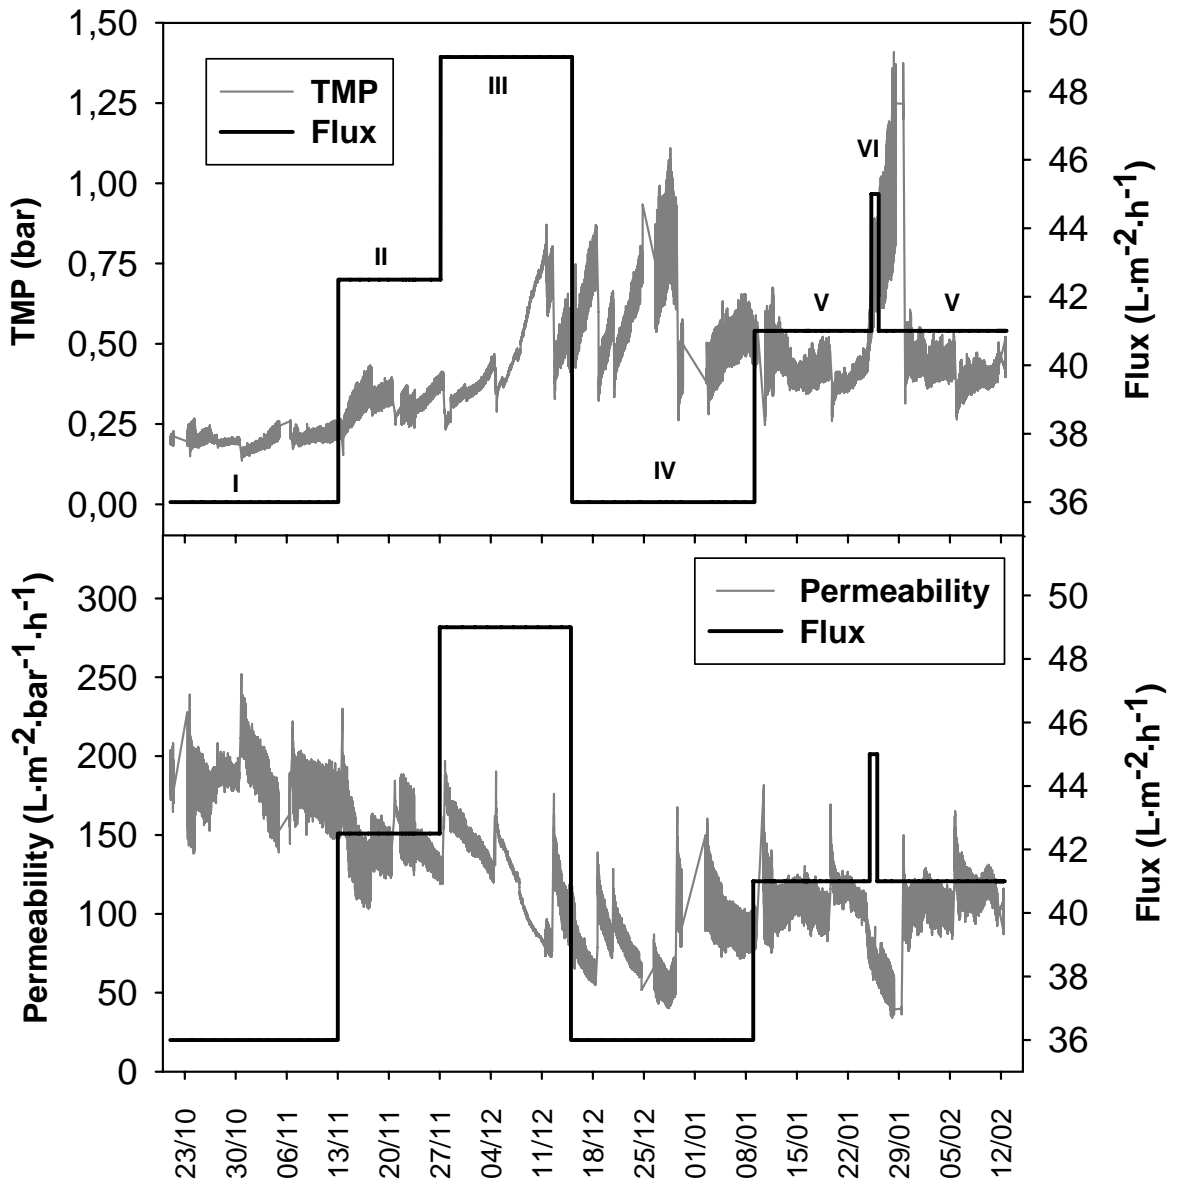
FIGURE 3

Figure 3 shows the performance of the MF system along the trial. As flux was increased in the three first stages of the experiment, TMP also increased, while permeability showed a decreasing tendency. Backwashes and chemical cleanings performed weekly kept the system stable. The performance of the membranes resulted worse during stage III, from December 5<sup>th</sup>, when COD, TSS and silica content began to rise in the feed water, and a long weekend started (Figure 2). As result, TMP strongly increased, but it turned down again after a chemical cleaning for a very short time. Fortunately, none of the membranes needed to be changed, and none of the security filters suffered blockage after this fouling incident.

As feed water quality turned worse, and TMP increased quickly despite the performed chemical cleaning, operating flux was reduced in stage IV to the same value of stage I, trying to recover stability in the system. However, TMP kept increasing until December 30<sup>th</sup>, when the pilot plants were stopped for New Year's long weekend, as well as the tertiary treatment of the mWWTP. This unsteady performance was attributed to maintenance and cleaning operations performed in the mills that dump effluents to this mWWTP, taking advantage of production stop during holidays. During this time, both oil and grease were found in the tertiary water at a concentration of 2 mg·L<sup>-1</sup>. Therefore, an appropriate management of the previous tertiary treatment is recommended to avoid an excessive damage to the membranes during these periods of time, especially in mWWTP fed with a high load of industrial wastewaters that show a great variability of characteristics due to production schedules.

The plant was re-started up on January 2<sup>nd</sup> under stage IV operational conditions, trying to reach certain working stability before progressing to the next stage. Along stage V, the system ran approximately one month at the best operational conditions selected from the previous information:  $J = 41 \text{ L}\cdot\text{m}^{-2}\cdot\text{h}^{-1}$ , 20 minutes between backwashes, and weekly CIP operations.

During this demonstration stage (V), another change in water quality happened, and TMP reached 1.3 bar, the maximum allowed pressure for this type of membrane. Although iron concentration in the feed water began to increase from mid-December onwards, it was not until the January 22<sup>nd</sup>, matching up with this TMP increase, when its value raised over 1.5 mg·L<sup>-1</sup> (Figure 2), severely affecting the system. This fouling episode did not affect the membranes irreversibly, and they recovered TMP optimal values as soon as chemical cleaning was performed. As backwashes were run every 20 minutes, hardly scouring the membranes with air, the foulant cake did not have enough

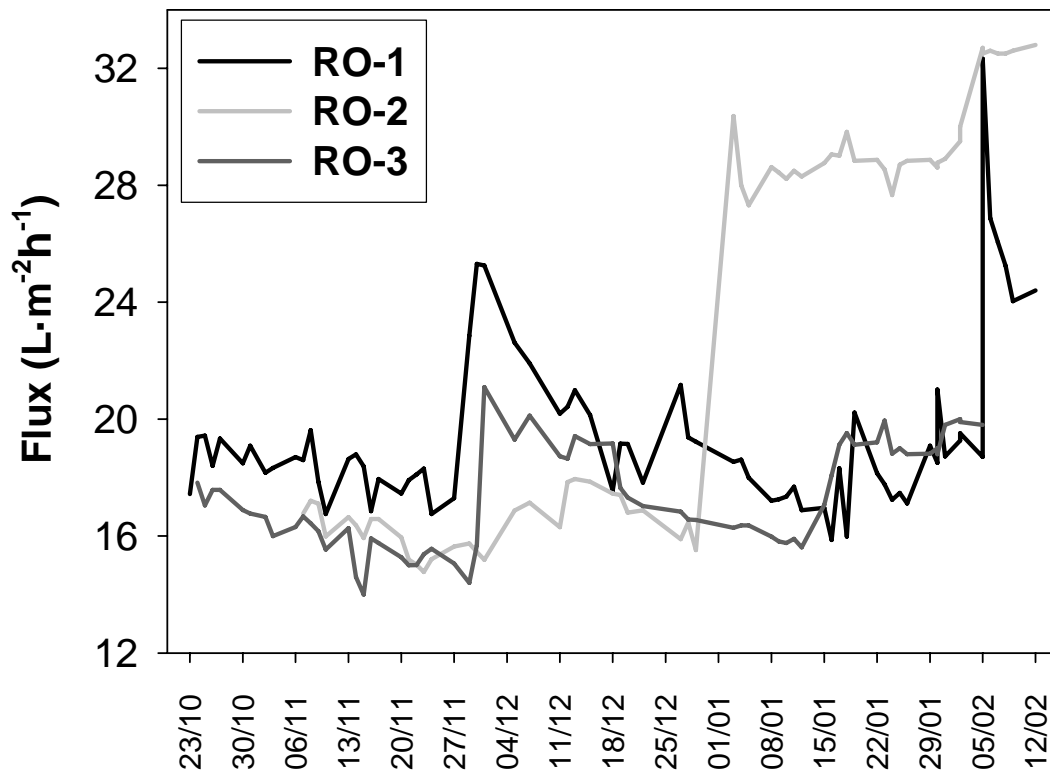
FIGURE 7

It is important to notice that fluxes after these last effective cleanings were higher than the ones reflected at the beginning of the trial (Figure 7). This implies that membranes were already fouled when RO systems started to work. This may have been caused by a non-adequate conservation of the membranes under good aseptic conditions while the pretreatments were stabilizing. The type of fouling was mainly organic and biological, since acid chemicals did not have any positive effect when used as cleaning agent. Contrary, after this type of cleaning, both systems showed a decreasing trend of the flux, RO-1 system particularly, which required six chemical cleanings more than RO-3 to keep the flux stable. Despite cleanings, flux never recovered the values of November 28<sup>th</sup>, which means that fouling was partially irreversible.
